## Technical Service Bulletin (TSB)

### Engine Overheat

| REFERENCE: | TSB: 07-006-26<br>GROUP: 07 - Cooling | Date: | August 21, 2026 | REVISION: | — |
| VEHICLES AFFECTED: | 2026 - 2027 (DJ) RAM 2500 Pickup<br>2026 - 2027 (D2) 3500 Pickup<br>2026 - 2027 (DD) RAM 3500 Cab Chassis<br>2026 - 2027 (DP) RAM 4500/5500 Cab Chassis<br>This bulletin applies to vehicles built on and after April 23, 2026 (MDH 0423XX) and on or before May 06, 2026 (MDH 0506XX) equipped with 6.4L V8 Hemi Upgrade HD Engine (Sales Code ESL). | | | MARKET APPLICABILITY:<br><div><input checked="" type="checkbox"/> NA<input checked="" type="checkbox"/> MEA</div> <div><input type="checkbox"/> EE<input type="checkbox"/> IAP</div> <div><input checked="" type="checkbox"/> SA<input type="checkbox"/> CH</div><br>NOTE: This bulletin applies to the North and South America and Middle East & Africa markets. | |

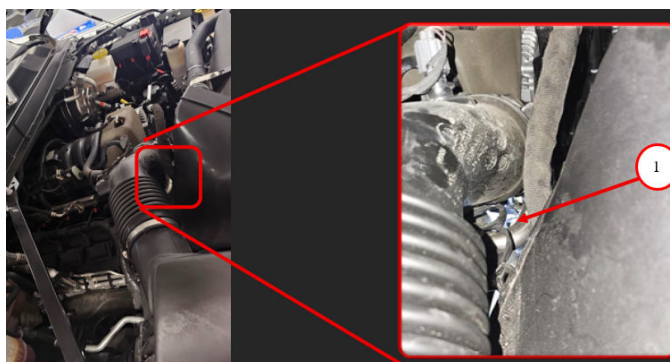
**Fig. 1**  
Thermostat Part Number Location

1. Determine adequate thermostat function on vehicles equipped with 6.4L BGE thermostat (potential no opening condition).
2. Record the vehicle's VIN, engine serial number and if any issue was found during the inspection.
3. Check the thermostat date code using a borescope and take a picture of the date code [Fig. 1](#), [Fig. 2](#):

4. Does the thermostat have a date code of **3375** or **3365**?
  - YES>>> Proceed to [Step 5](#).
  - NO>>> This bulletin has been completed. Use Inspection LOP (07-40-01-95) to close the active RSU.
5. Replace the thermostat. Refer to the detailed service procedures available in DealerCONNECT/Service Library under: Service Info> 09 - Engine, 6.4L / Engine Cooling / Thermostat / Removal and Installation.
