SIB 11 07 23

## VOLUNTARY EMISSION RECALL 23E-A05: REPLACE SWITCHABLE ROCKER ARM

2026-08-05

The return springs on the exhaust camshaft followers (switchable rocker arm) may break.

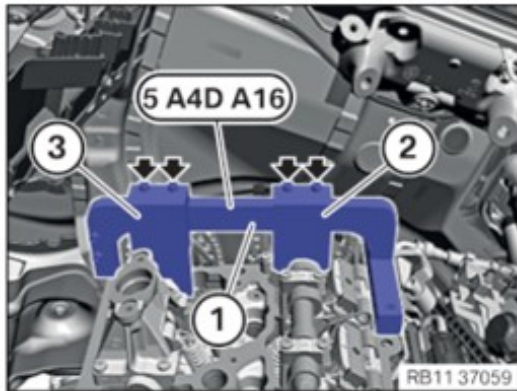
**The repair instructions state to install specific tools to set the camshaft timing after reinstalling the exhaust camshaft.**

**You must install all of the tools shown in this step to ensure the timing is correct on both the intake and exhaust camshafts. Always tighten the screws to the proper torque.**

**Improper camshaft timing can result in various VANOS faults and or Mixture Adaptation faults.**

- Position the setting gauge 0.5° (3) from the set of special tools 5 A4D A16 between the exhaust camshaft and the basic carrier (1) from the set of special tools 5 A4D A16.
- Position the setting gauge 0.7° (2) from the set of special tools 5 A4D A16 between the intake camshaft and the basic carrier (1) from the set of special tools 5 A4D A16.
- Tighten screws (arrows).

Test gauge to basic carrier

M6

Tightening torque

8Nm

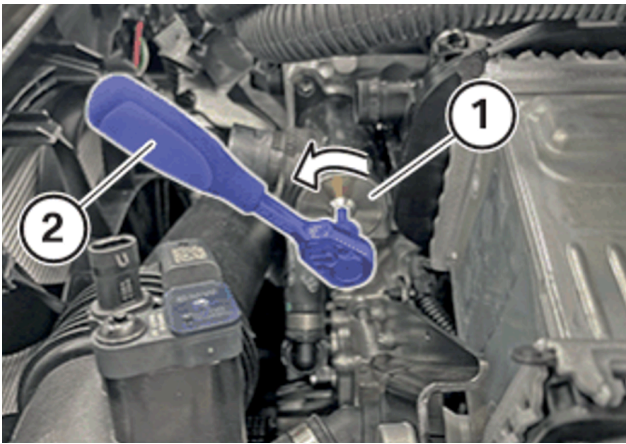
Cylinder 6 intermediate lever may interfere when trying to install the intake camshaft timing tools.

Place the variable valve timing (VVT) motor in minimum lift before installing the camshaft timing tools.

Use a 4 mm Allen socket (1) and a ratchet (2) to turn the VVT motor counter clockwise until it stops at the minimum lift end stop.

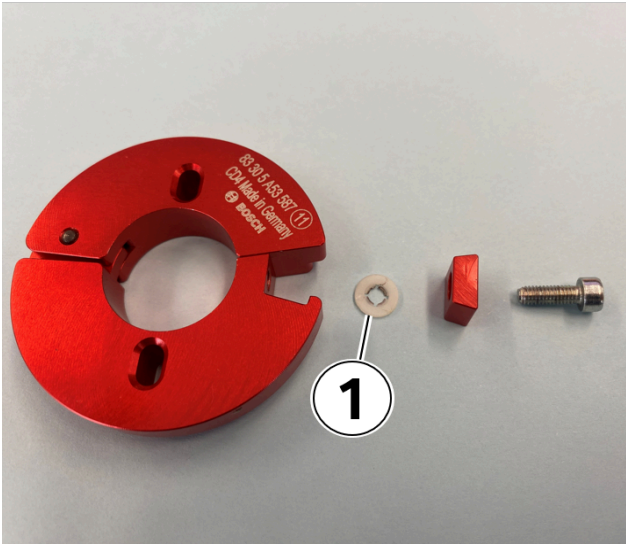
Tool 83 30 5 A53 587 may bind when removing it from both of the VANOS adjusters, the plastic washer (1) may be binding the tool and will not allow it to collapse when the screw is loosened.

Using a fine metal file, reduce the outside diameter of the plastic washer by approximately 1 mm to avoid this interference.

Removing the washer entirely could result in the screw and wedge falling into the engine, the washer avoids loosening the screw too much.

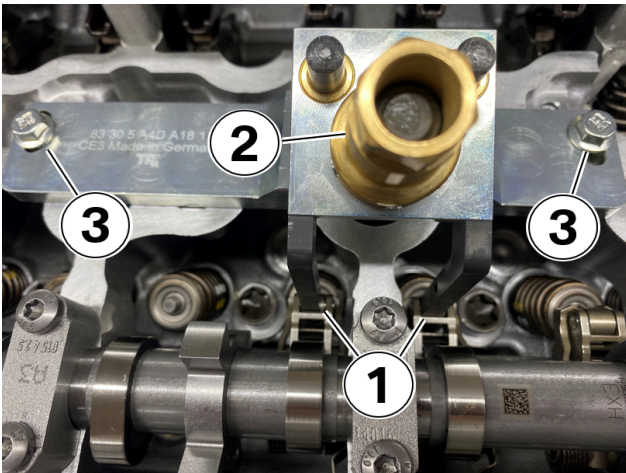
Special tool 83 30 5 A4D A18 must aligned properly with the rollers (1).

Turn the brass nut (2) to make contact with the rollers.

Tighten the screws on the base plate of the tool (3).

Finish compressing the springs with the brass nut (2).

The tool must remain installed during the entire camshaft removal and installation procedure.
