**SIB 18 01 26****DELIVERY STOP: REPLACE THE EXHAUST GASKET RING**

2026-08-14

| E-Series | Model Description | Production Date |
|---|---|---|
| G05 | X5 Sports Activity Vehicle | May 2, 2026 – May 7, 2026 |

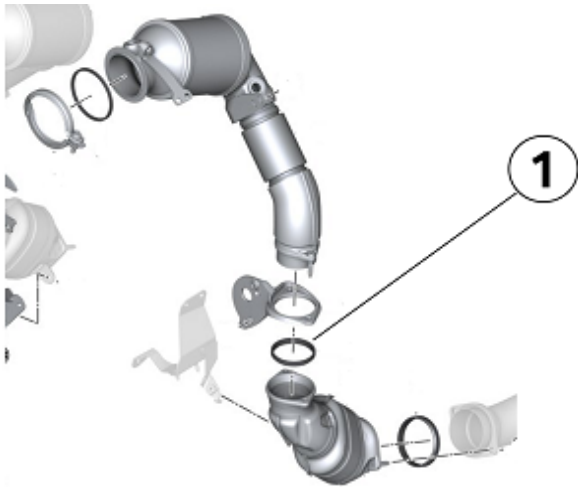
An exhaust gas sealing ring between the lower catalytic converter and upper catalytic converter may be missing (1).

The result can cause hot exhaust gases to escape. Exhaust gases escaping into the engine compartment can be smelled.

Replace the exhaust gasket rings between the lower and upper catalytic converters.

Follow **Repair Instruction RA 1832162 Removing and installing/replacing both lower catalytic converters**.
