SIB 63 05 26

SPORADIC FAILURE OF THE AMBIENT LIGHTING WITH I-LEVEL 26-03-5XX  
2026-08-19

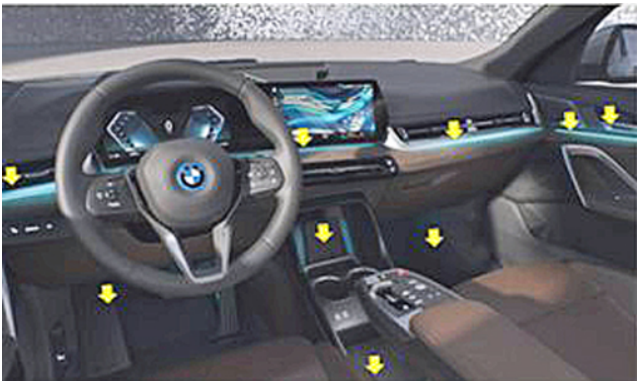
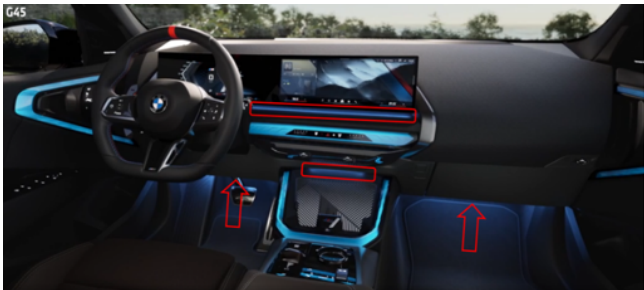
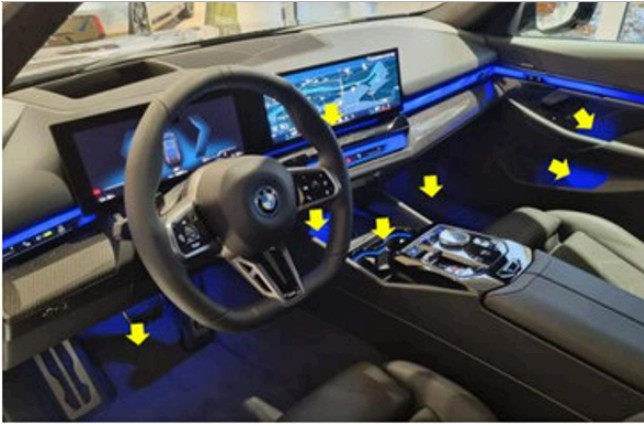
After programming the vehicle via ISTA/RSU to I-level ...26-03-5xx, some of the interior ambient lighting strips (arrows) may begin to fail sporadically after a deep sleep cycle.

Unfavorable basic central platform (BCP) software.

**Note: Performing a Remote Software Update (RSU) is the preferred method to update the vehicle's software to address the issue described in this Service Information Bulletin.**

- Connect the battery charger to the vehicle
- Connect the programming system to the vehicle (ISTA 4)
- Determine measures plan
- Accept and fully work through the measures plan with the control units to be programmed/encoded and enabled
- Follow the rework list
- **Depending on the rework list, carry out a vehicle test and delete the fault memory if needed**
