SIM 63 04 26

SPORADIC FAILURE OF THE AMBIENT LIGHTING WITH I-LEVEL 26-03-5XX  
2026-08-20

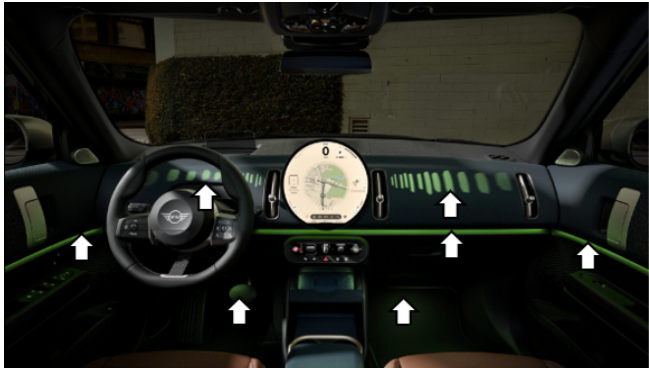
After programming the vehicle via ISTA/RSU to I-level ...26-03-5xx, some of the interior ambient lighting strips (arrows) may begin to fail sporadically after a deep sleep cycle.

Unfavorable basic central platform (BCP) software.

If the I-level is currently at ...26-07-500 or a more recent version:

- Do not program the vehicle
- Continue with standard diagnosis

If the I-level is currently between ...26-03-500 and ...26-07-500

- Connect the battery charger to the vehicle
- Connect the programming system to the vehicle (ISTA 4)
- Determine measures plan
- Accept and fully work through the measures plan with the control units to be programmed/encoded and enabled
- [Follow the rework list](#)
- **Depending on the rework list, carry out a vehicle test and delete the fault memory if needed**
