**SIB 61 06 26****SERVICE ACTION: Replace Chassis Module****2026-08-05**

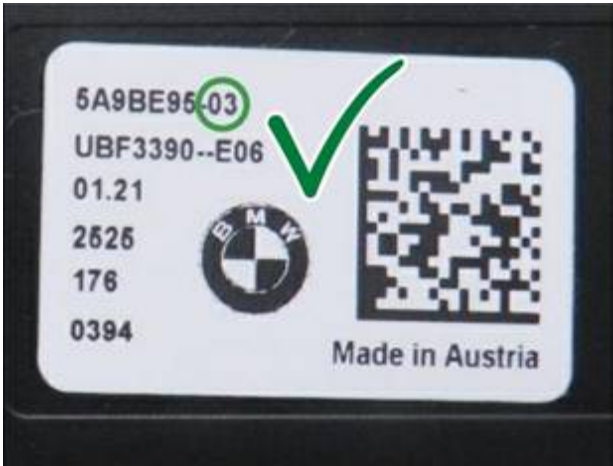
Due to ongoing quality inspection it has been determined that due to inadequate sealing of the chassis module (61 35 5 A9B E95 with revision indexes of 01, and 02) moisture can get into the control unit.

As a result the moisture and cause corrosion which can lead to malfunctions of the chassis module.

The chassis module 61 35 5 A9B E95 with revision index **01 or 02** must be replaced with revision index **03** see image to reference where to find the index below. **If the unit already has revision index 03, do not replace.**

All chassis modules with part number 5 A9B E95-01 or -02 must be replaced in accordance with the model-specific repair instructions in AIR “61 35 015 – Replace chassis module 1” (if applicable, for R 1300 GS additionally “61 35 016 – Replace chassis module 2”) with a new chassis module part number **61 35 5 BB3 CE2**.
