SIB 34 02 26

DELIVERY STOP: DYNAMIC STABILITY CONTROL (DSC) HYDRO UNIT  
2026-08-26

B34 02 26

## DELIVERY STOP: DYNAMIC STABILITY CONTROL (DSC) HYDRO UNIT

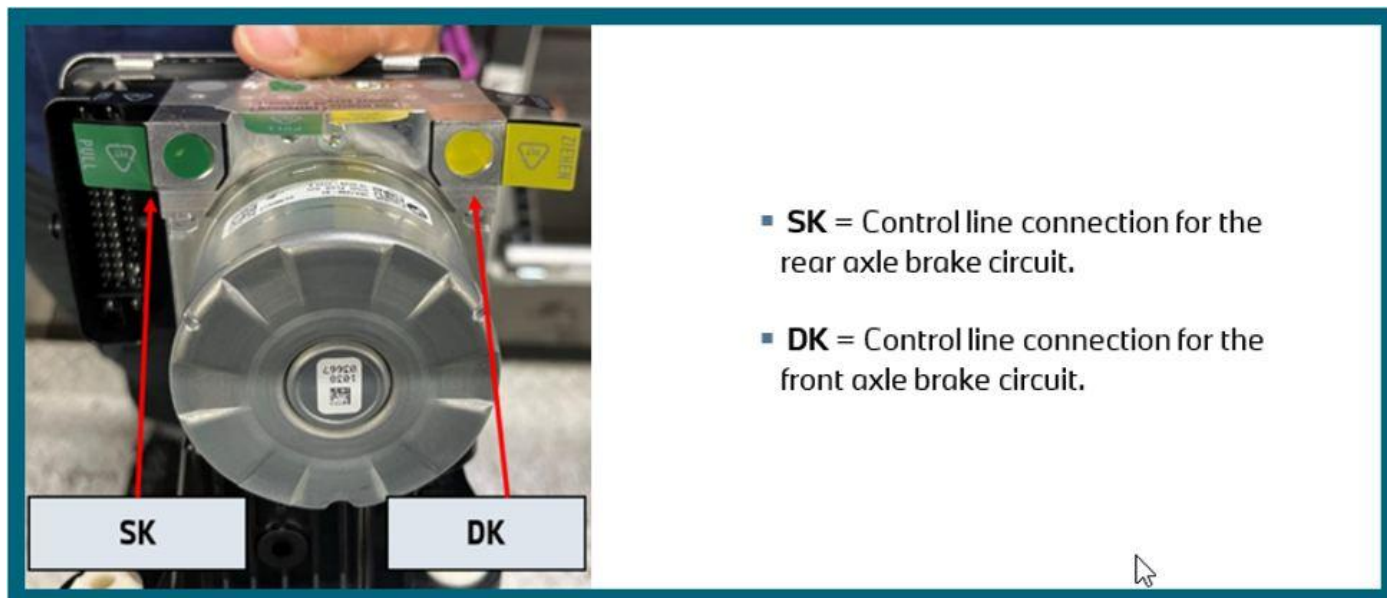
**Pic 1-** Example image of the 2 connections for the control lines on the DSC unit

The protective film which covers the 6 threaded connection holes on the DSC hydro unit may not have been completely removed before the brake line was fastened. This can lead to a gradual loss of brake fluid at the threaded connection. As a result, the driver is alerted at an early stage by a red Check Control Message stating "Brake system defective. Stop carefully. Do not continue driving. Call BMW Roadside Assistance". However, there is no functional limitation of the brake.

Error during the factory installation process of the brake lines to the DSC hydro unit.

Open all 6 connections on the DSC unit and check whether the protective film or any residue from the protective film is present (Pic 1 and Pic 2).

- If the protective film or residues of the protective film are present in the area of the 2 control lines on the DSC unit (Pic 1):

Replace the DSC hydro unit as per **REP 34 51 601** Replace hydraulic unit (following vehicle diagnosis).

Replace the tandem brake master cylinder as per **REP 34 31 505** Remove and install/replace tandem brake master cylinder. **Note: REP 34 31 505 is not available in ISTA/AIR; see attachment for repair instructions**

**Note:** Before installation of the DSC unit and the tandem brake master cylinder, the two control lines must be purged with compressed air.
