| GROUP | MODEL |
|---|---|
| ELE | 2023-2025MY<br>Multiple Models |
| 426 | August 2026 |

## TECHNICAL SERVICE BULLETIN

### AVN GEN 5.0 WIDE SOFTWARE UPDATE

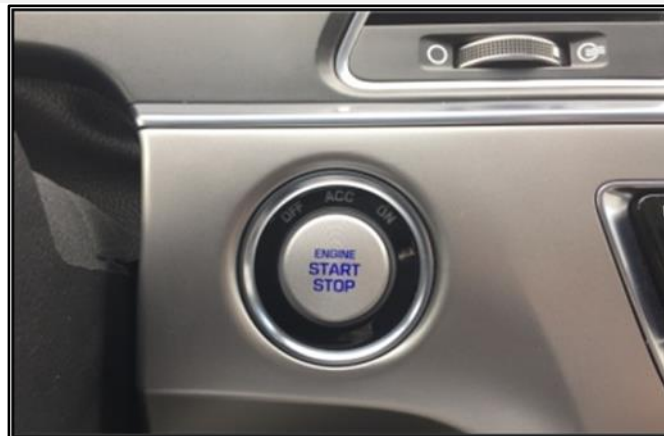
1. Turn the vehicle On and select Confirm on the Head Unit screen.

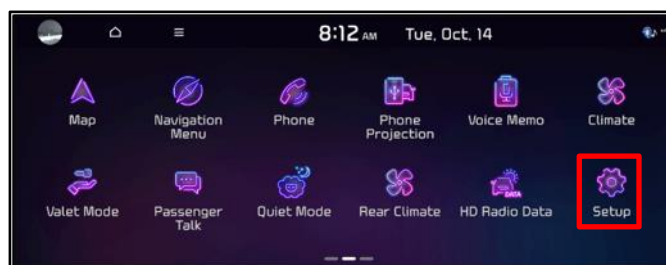
2. Press the 'Setup' button.

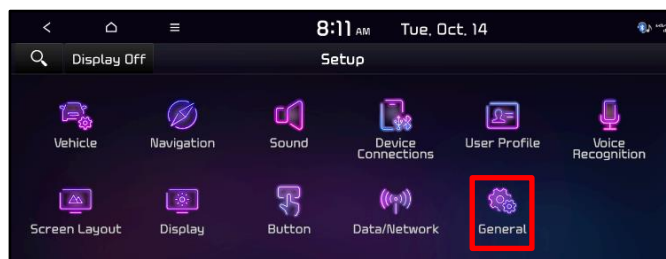
3. Press the 'General' button.

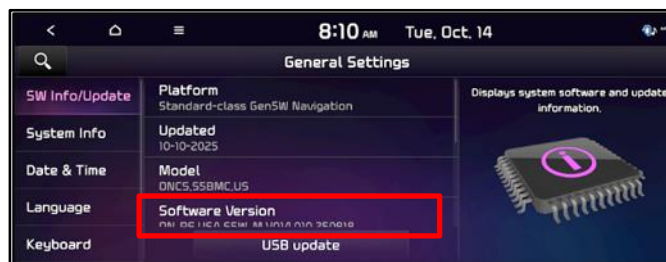
4. Confirm that the software version currently installed is valid.
