# Service Bulletin

Bulletin No.: PIC6661

**Subject:** Diagnostic Tip - Tail Lights Stay on After Vehicle is Shut Off

| Brand: | Model: | Model Year: | | VIN: | | Engine: | Transmission: |
|---|---|---|---|---|---|---|---|
| Cadillac | OPTIQ | 2025 - 2027 | | All | All | All | All |

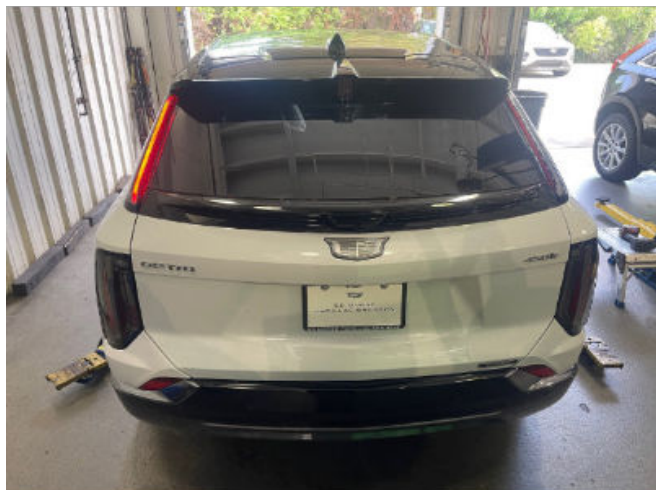
7200499

| <b>Cause</b> | Possibly water intrusion in rear tail lamp connector. |

Technicians are asked to verify if any water intrusion in rear tail lamp connector before following normal SI diagnostics.

If water intrusion is present or corrosion is found, repair or replace affected components per SI instructions, as necessary.
