# Service Bulletin

Bulletin No.: PIT6534

**Subject: Loss Of All Features Related To Onstar Module**

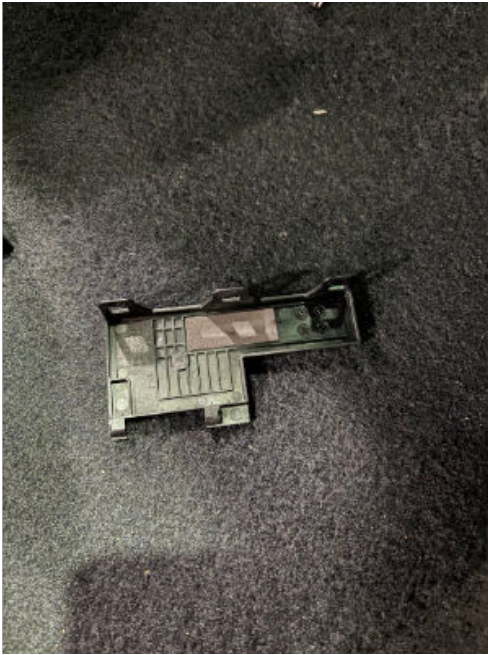
7200163

Photo of OnStar module and backup battery cover below:

-Use SI to determine the location of the OnStar/Telematics Communication Interface Control Module (TCICM).

-Gain access to the TCICM.

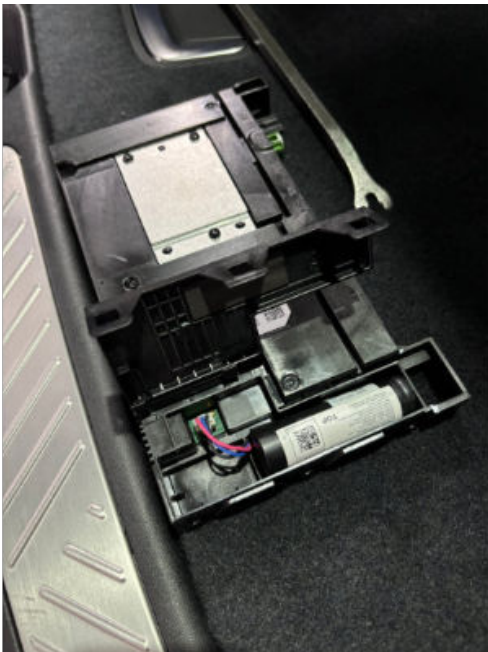
7200164

Photo of OnStar module and backup battery in case below:

-Disconnect and remove the TCICM to gain access to the backup battery.

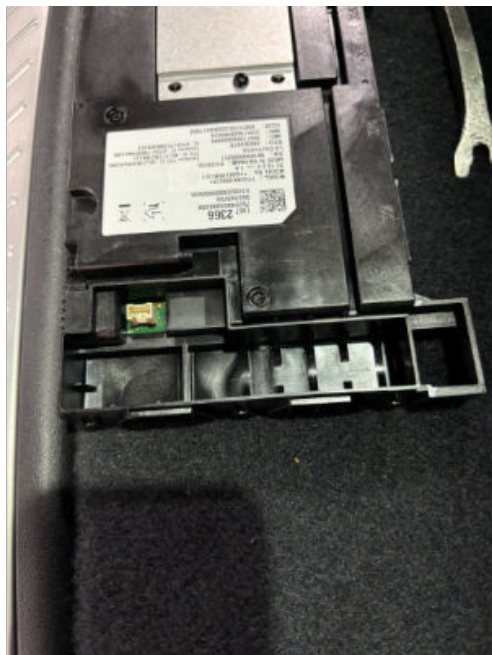
7200165

Photo of backup battery removed below:

-Carefully access the backup battery connector, disconnect it from the OnStar module and remove the backup battery.

- Wait five minutes, then reinstall and connect the backup battery and OnStar module. This procedure resets the OnStar module.
- Reassemble the vehicle.
- Clear all diagnostic trouble codes.
- Start the vehicle and verify that the indicator next to the OnStar blue button is green.
- If the concern is not resolved, refer to SI for normal diagnostics.
- Advise the customer that Engineering is actively investigating this concern. The vehicle may continue to be driven; however, if the condition reoccurs, an additional system reset may be required.
