# Service Bulletin

Bulletin No.: PIC6660

**Subject: No Air Flow from Dash Vents When Using A/C After Extended Driving**

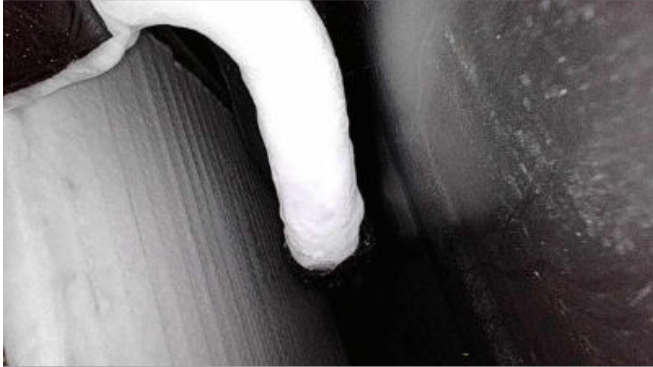
7200500

| <b>Cause</b> | After a continuous extended drive time of greater than .5hrs, the air conditioning evaporator may completely ice over.<br>When the condition is present it can stop all airflow across the evaporator, greatly reducing air flow from dash vents. |

See images below showing condition.

Verify that the A/C system has the correct refrigerant capacity.

If the system is low on refrigerant, follow SI procedures for locating source of the leak.

If the system has the correct refrigerant capacity, no further repair attempts should be made.
