# Service Bulletin

Bulletin No.: PIT6452E

**Subject: Poor Heater Performance On Drivers OR Passengers Side**

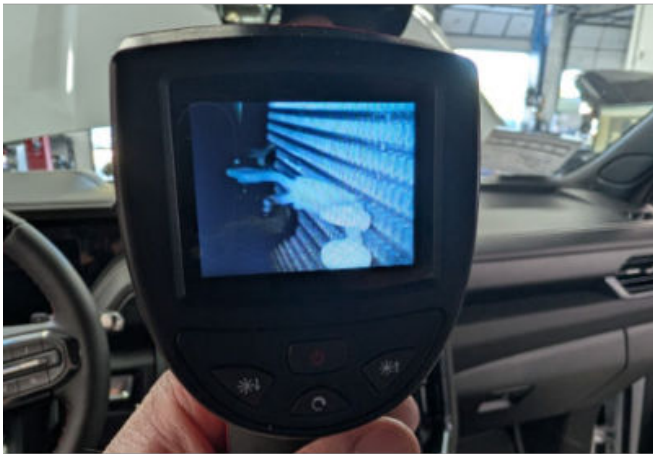
7020910

- Access the view through the upper vents or the HVAC evaporator temperature sensor openings.
- Using a borescope, inspect for a disconnected temperature door link. ( Note: The mode will have to be set to the vent position, and you will have to enter at the center dash vent for the affected side.)
- Move both the driver's and passenger's temperature doors through their full range of travel while monitoring with the borescope.
- Watch for any binding or resistance that may cause the white temperature door link to separate from the doors or produce a popping noise.

If any door exhibits these symptoms, proceed to Step 2.
