SIB 61 12 26

SERVICE ACTION: INSPECT BASIC CENTRAL PLATFORM (BCP) AND WIPER HARNESS  
2026-08-27

# Service Information Bulletin

## SERVICE ACTION: INSPECT BASIC CENTRAL PLATFORM (BCP) AND WIPER HARNESS

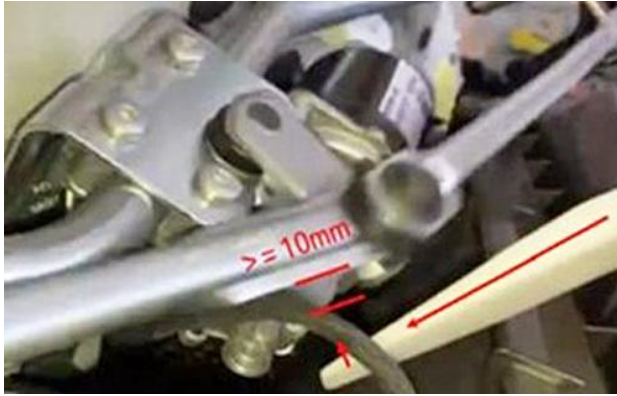
1. Remove the windshield panel cover in accordance with repair instructions **REP 5113116** "Removing and installing the cowl panel cover".
2. Visually inspect the wiper harness during wiper motor operation to verify that it does not contact the wiper linkage. The wiper harness must maintain at least 10 mm of clearance between the harness and the linkage's rotating area. Ensure that the harness cannot enter this area. If necessary, use a plastic wedge to check whether the harness can move towards the linkage.

Wiper harness example image: The wiring harness must be at minimum 10 millimeters below the area where the wiper linkage travels.

8. If the wiper harness is damaged, repair the wires with the connectors listed below and, if necessary, move the clips to achieve better wire routing. Then install a new wiper console.
9. If scorch marks are visible on connector A258\*2B (Con2), replace the connector and then install a new BCP21. Even if no scorch marks are visible, the BCP may need to be replaced (await feedback from the BMW Product Engineer).
10. Return the exchanged wiper console and, if necessary, the BCP in the original packaging via the special defective part process.

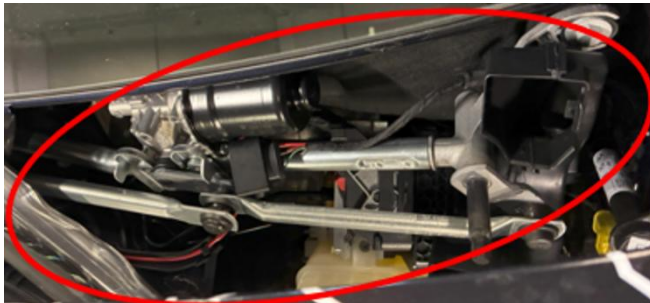
Example image: Overview image of the wiper console.

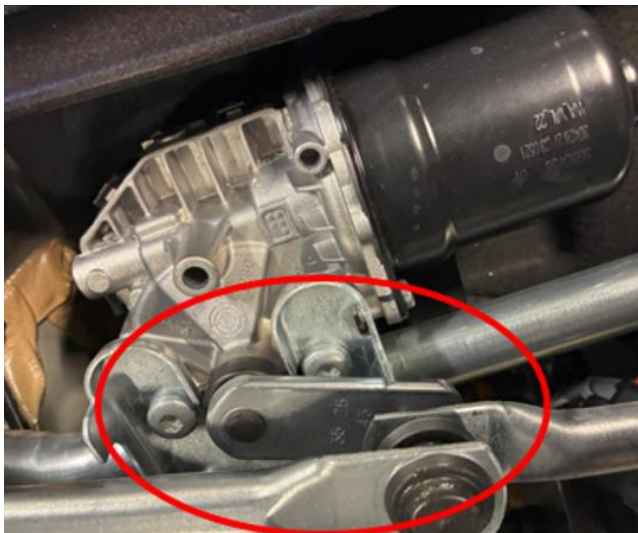
Example image: Image of the angle of the crank to the linkage at standstill/ in the park position.

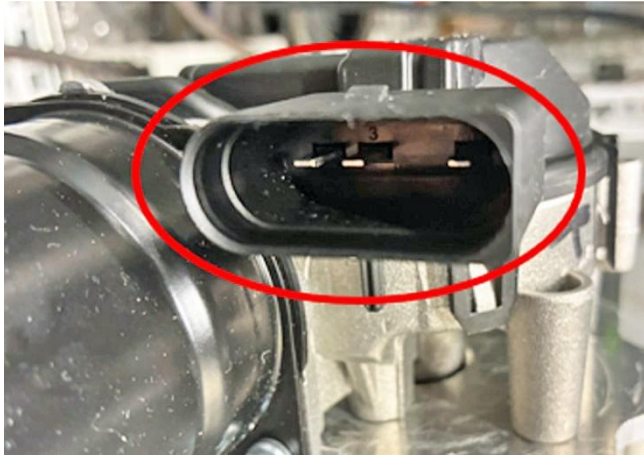
Example image: Male electrical connector contacts on the wiper motor

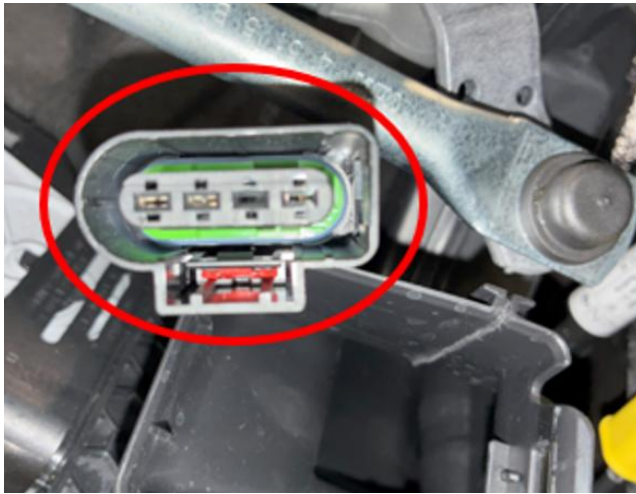
Example image: Female electrical connector contacts on the wiper motor

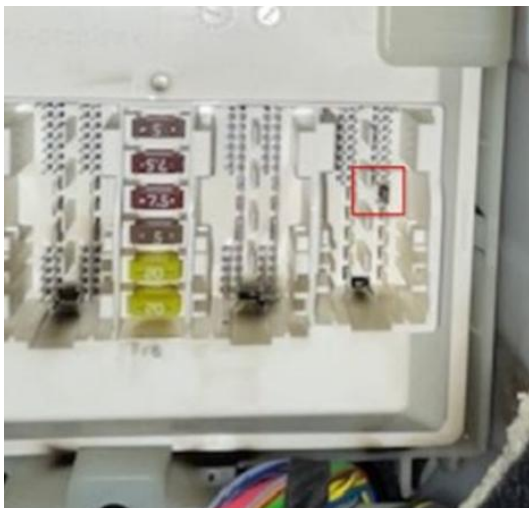
The BCP controls several vehicle functions, including the windscreen wipers and air conditioning actuators. Low current flow may cause excessive current in parts of the BCP circuit board and damage the unit. If a fault occurs, the wipers or air flap controls may operate incorrectly or fail. A wiper failure is indicated by a yellow warning light and the "Windscreen wiper fault" Check Control message.

Example image: Scorched pins at BDC connector
