GENERAL MOTORS  
DCS7565  
URGENT - DISTRIBUTE IMMEDIATELY

Subject: UPDATE: N252541251-02– Customer Satisfaction Program  
No Rear Turn-Signal Outage Notification  
Additional Vehicles Added

Models: 2020-2024 Chevrolet Corvette

## N252541251 No Rear Turn-Signal Outage Notification

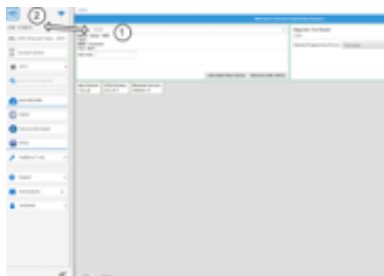
7001095

**IMPORTANT:** The service technician always needs to verify that the VIN displayed in the TLC left side drop down menu (1) and the top center window (2) match the VIN plate of the vehicle to be programmed prior to using Service Programming System 2 (SPS2) for programming or reprogramming a module.

1. Reprogram the Lighting Control Module. Refer to *K219 Lighting Control Module: Programming and Setup* in SI. Carefully read the programming and setup document for further instruction.
