**SIB 61 06 25****GEN5 BEV "DRIVETRAIN" CHECK CONTROL MESSAGE / FAULT 224188 STORED**

2026-08-31

This Service Information bulletin (Revision 1) supersedes SI B61 06 25 **dated May 28, 2025.**☐ THIS REPAIR IS MOBILE FRIENDLY**What's New:**

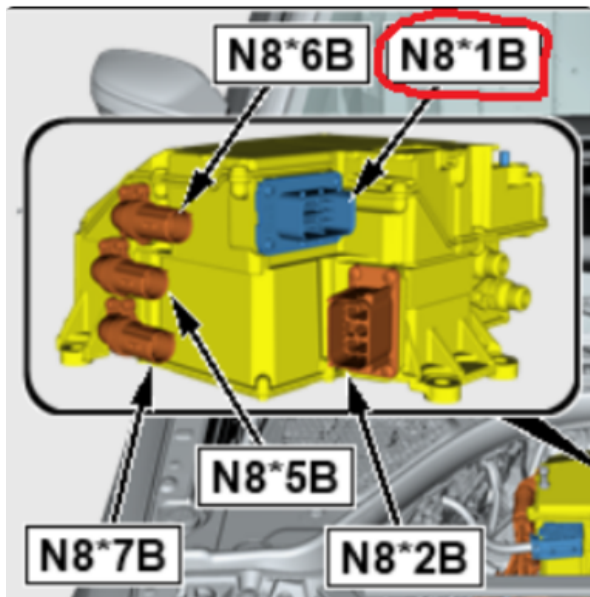
Galvanic corrosion may develop on the surface of the low-voltage harness contact pins of the 12V plug connector to the CCU (N8\*1B) resulting in intermittent faulty contacts at these connections, setting the fault code.

Plug IN and OUT the connector N8\*1B several times (at least three times). The connector must be locked in place completely each time in effort to scrape and clean the corrosion coating from the pin contact surfaces.

**Note: It is important to make sure the connector is fully disconnected and then reconnected for the process to be effective**

Retest the vehicle after the procedure to verify the repair.
