SIB 64 08 26

## EVAPORATOR CONDENSATE DRAIN COMES LOOSE

2026-08-28

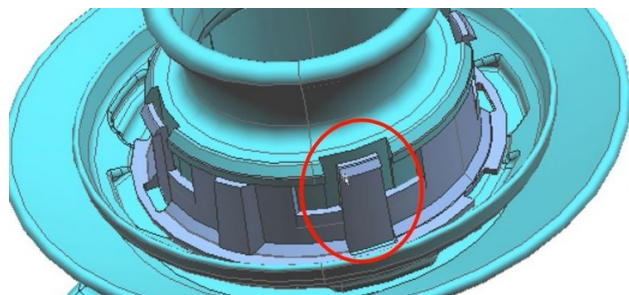
The two-piece evaporator condensation drain was not fully locked together (lock tab circled in red) when assembled and has come apart. Its lower half can thereby bounce around under the vehicle.

Replace the lower half of the evaporator condensation drain with the correct part number.

1. Confirm that the lower half of the evaporator condensation drain is no longer in place. If part of it is still hung up under vehicle near the exhaust heat shield or driveshaft, remove it from vehicle.
2. Replace the lower half of the evaporator condensation drain. The lower half 'snaps' into the upper half which should still be retained in the vehicle body from above.

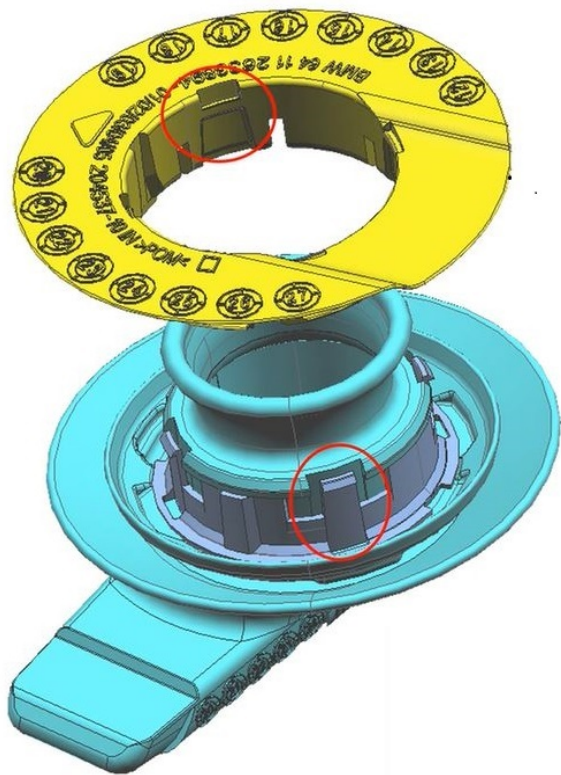
Used in vehicles produced **UP TO** February 28, 2025. The clip locations circled in red indicate the design change.

When replacing the lower half of the 'condensation water drain' it must match the production date of the upper retaining ring for condensate'. See ETK page 64\_2843 for your specific vehicle. You must use the old upper and lower together, or the new upper and lower together; don't mix parts!

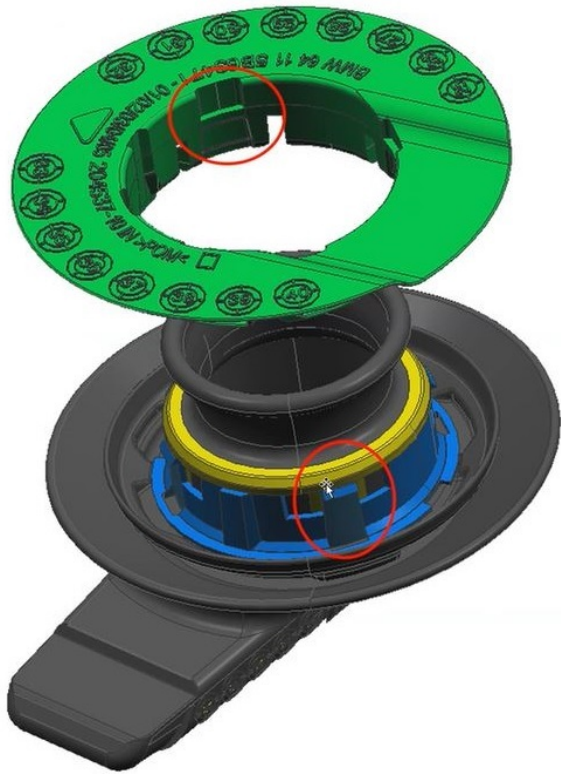
Used in vehicles produced **FROM** February 28, 2025. The clip locations circled in red indicate the design change.
