| Topic | ODIS Error Message – Best Practice When Performing Baseline (BiL) Updates |
| Brand | Bentley |
| Transaction No. | 2078962/7 |

### 24-26MY Bentayga | 25-26MY Continental GT/GTC/Flying Spur

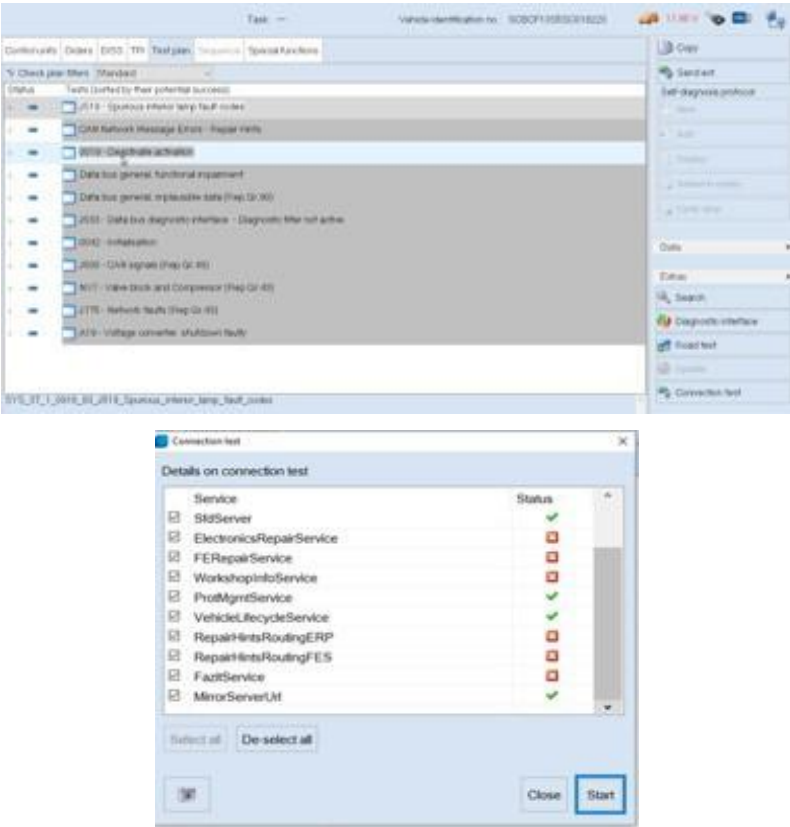
| Step | Action | Images |
|---|---|---|
| <p>Check that the D3 Edge Box is connected</p> | <ul style="list-style-type: none"> <li>Perform the 'connection test' within the extra menu <ul style="list-style-type: none"> <li>Navigate to "Extras" -&gt; "Connection Test" -&gt; Select "Bentley" (If Multi Brand) -&gt; "Select ALL -&gt; Start</li> <li>If the Mirror Server does not return a green ✓ -&gt; Check your D3 setup and IP settings as per the next step.</li> </ul> </li> </ul> | |

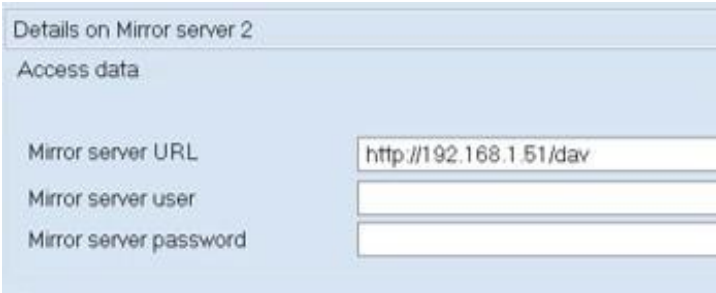
| Step | Action | Images |
|---|---|---|
| <p>Mirror Server Settings</p> | <ul style="list-style-type: none"> <li>Check that the URL in the Mirror Server 2 is correct for the new D3 edge box. <ul style="list-style-type: none"> <li>Refer to "Operating Modes" -&gt; "Admin" -&gt; "Connections" -&gt; "Mirror Server 2;;.</li> </ul> </li> <li>Ensure that the URL is http://.. And NOT https://</li> <li>Enter the mirror server URL into a web browser, and ensure that the flash files are visible on the server.</li> </ul> | |

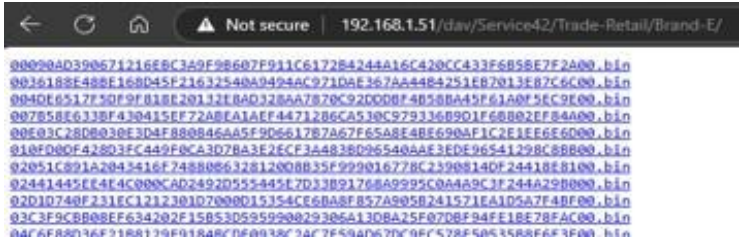
| | <ul style="list-style-type: none"> <li>Copy &amp; paste the Mirror server address into a web browser e.g Microsoft edge) -&gt; Navigate to the flash files location: XXX.XXX.XX/DAV/Service42/Trade-Retail/Brand-E/</li> </ul> | |

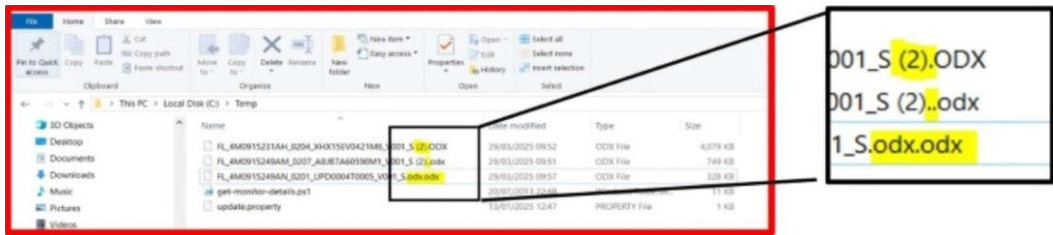
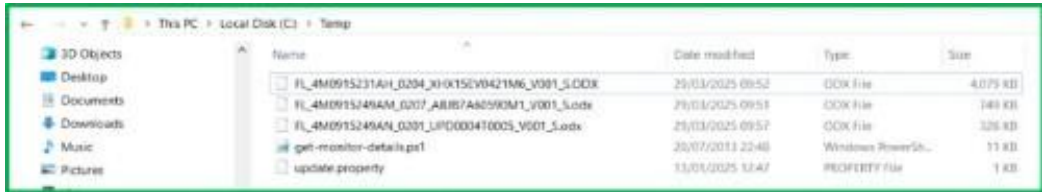
| Type of Flash Container | Best Fixes | | | | | | | | | | | | | | | | | | | | | | | | | | | | | | | | | | | | | | | | | | | | | | | | |
|---|---|---|---|---|---|---|---|---|---|---|---|---|---|---|---|---|---|---|---|---|---|---|---|---|---|---|---|---|---|---|---|---|---|---|---|---|---|---|---|---|---|---|---|---|---|---|---|---|---|
| Local Flash Containers (Using files from c:/temp) | <ul style="list-style-type: none"><li>If a flash file is being used locally, eg ED40, ED42 download from atheer – this means that the flash container is extracted directly form the C:/temp folder on the users ODIS tester.</li><li>If the flash files are downloaded incorrectly, or not extracted from the ZIP folders correctly, this means ODIS cannot identify the correct flash file.</li></ul> <p>Example of Bad file structure / naming:</p> <p>The screenshot shows a Windows File Explorer window with the address bar set to 'This PC &gt; Local Disk (C:) &gt; Temp'. The file list shows the following files:</p> <table><tr><th>Name</th><th>Date modified</th><th>Type</th><th>Size</th></tr><tr><td>FL_4M0915231AH_0204_X0X15EV0421M6_V001_S_02.ODX</td><td>29/03/2025 09:52</td><td>ODX File</td><td>4,079 KB</td></tr><tr><td>FL_4M0915249AM_0207_A8B7A60590M1_V001_S_02.odx</td><td>29/03/2025 09:51</td><td>ODX File</td><td>749 KB</td></tr><tr><td>FL_4M0915249AM_0201_LPD0004T0005_V001_S_02.odx</td><td>29/03/2025 09:57</td><td>ODX File</td><td>328 KB</td></tr><tr><td>get-monitor-details.ps1</td><td>20/07/2013 22:46</td><td>Windows PowerShell Script</td><td>11 KB</td></tr><tr><td>update.property</td><td>11/01/2025 12:47</td><td>PROPERTY File</td><td>1 KB</td></tr></table> <p>The file '001_S (2).ODX' is highlighted with a black box. The file extension '.odx' in the filename '001_S (2).odx' is highlighted with a yellow box.</p> <ul style="list-style-type: none"><li>Duplicated Download Suffix</li><li>Multiple or incorrect file extension types</li></ul> <p>The screenshot shows a Windows File Explorer window with the address bar set to 'This PC &gt; Local Disk (C:) &gt; Temp'. The file list shows the following files:</p> <table><tr><th>Name</th><th>Date modified</th><th>Type</th><th>Size</th></tr><tr><td>FL_4M0915231AH_0204_X0X15EV0421M6_V001_S_02.ODX</td><td>29/03/2025 09:52</td><td>ODX File</td><td>4,079 KB</td></tr><tr><td>FL_4M0915249AM_0207_A8B7A60590M1_V001_S_02.odx</td><td>29/03/2025 09:51</td><td>ODX File</td><td>749 KB</td></tr><tr><td>FL_4M0915249AM_0201_LPD0004T0005_V001_S_02.odx</td><td>29/03/2025 09:57</td><td>ODX File</td><td>328 KB</td></tr><tr><td>get-monitor-details.ps1</td><td>20/07/2013 22:46</td><td>Windows PowerShell Script</td><td>11 KB</td></tr><tr><td>update.property</td><td>11/01/2025 12:47</td><td>PROPERTY File</td><td>1 KB</td></tr></table> | Name | Date modified | Type | Size | FL_4M0915231AH_0204_X0X15EV0421M6_V001_S_02.ODX | 29/03/2025 09:52 | ODX File | 4,079 KB | FL_4M0915249AM_0207_A8B7A60590M1_V001_S_02.odx | 29/03/2025 09:51 | ODX File | 749 KB | FL_4M0915249AM_0201_LPD0004T0005_V001_S_02.odx | 29/03/2025 09:57 | ODX File | 328 KB | get-monitor-details.ps1 | 20/07/2013 22:46 | Windows PowerShell Script | 11 KB | update.property | 11/01/2025 12:47 | PROPERTY File | 1 KB | Name | Date modified | Type | Size | FL_4M0915231AH_0204_X0X15EV0421M6_V001_S_02.ODX | 29/03/2025 09:52 | ODX File | 4,079 KB | FL_4M0915249AM_0207_A8B7A60590M1_V001_S_02.odx | 29/03/2025 09:51 | ODX File | 749 KB | FL_4M0915249AM_0201_LPD0004T0005_V001_S_02.odx | 29/03/2025 09:57 | ODX File | 328 KB | get-monitor-details.ps1 | 20/07/2013 22:46 | Windows PowerShell Script | 11 KB | update.property | 11/01/2025 12:47 | PROPERTY File | 1 KB |

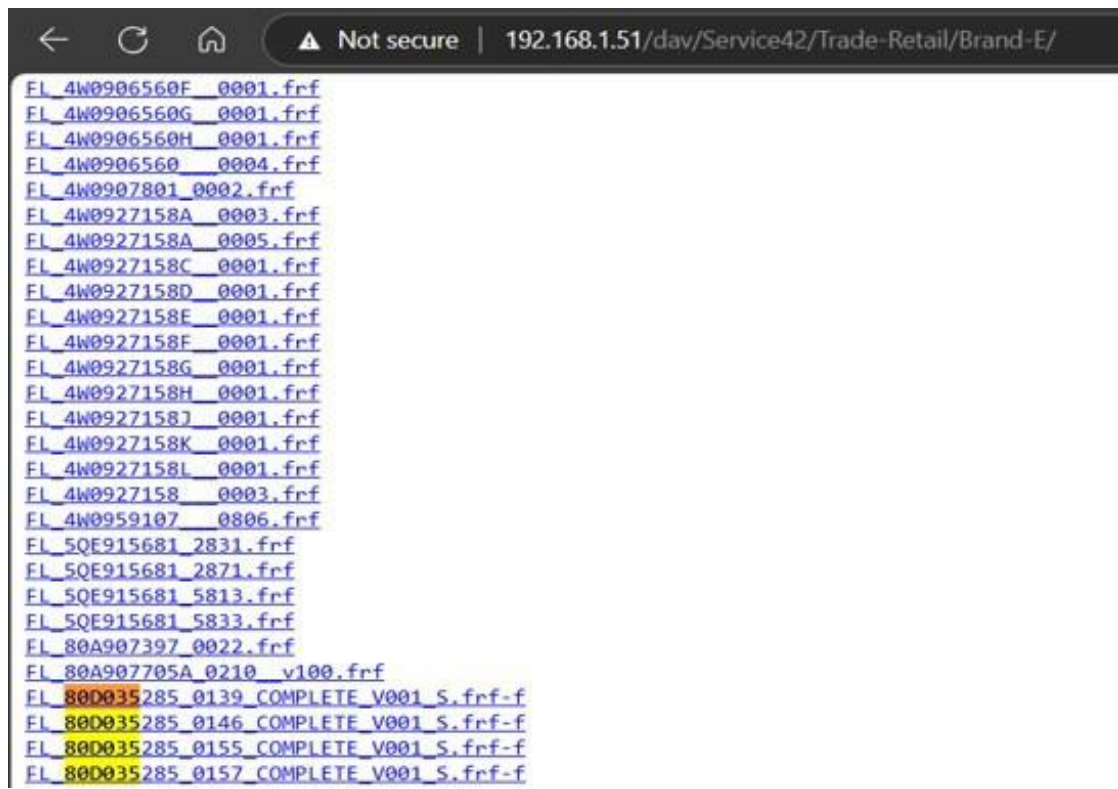
| <p>Online<br/>Link Flash<br/>Containers<br/>(using an<br/>SVM<br/>Code)</p> | <ul style="list-style-type: none"> <li>• When an ECU requires a software update through SVM, ODIS will pull the file from the mirror server/ D3 edge box.</li> <li>• If the Flash Container can not to be linked, check if the files is present on the mirror server</li> <li>• To do this: <ul style="list-style-type: none"> <li>– Enter the mirror server URL into a web browser, and ensure that flash files are visible on the server.</li> <li>– Copy &amp; paste the mirror server address into a web browser (eg Microsoft edge) -&gt; Navigate to the flash files location: XXX.XXX.X.XX/dav/Service42/Trade-Retail/Brand-E/</li> </ul> </li> <li>• Then press 'ctrl' + 'f' and search the Mirror Server for that flash container.</li> <li>• In this example, the FRF file is available to be flashed with ODIS:</li> </ul> |
