## Thor Motor Coach Technical Service Bulletin

| TSB # | <b>TSB 26-05</b> | | |
| Description/Title: | DC/DC Charger wiring | | |
| Affected Product Line(s): | Certain model year 2026-2027<br>Eddie Bauer Van, Palladium, Sanctuary, Talavera, Tranquility | | |

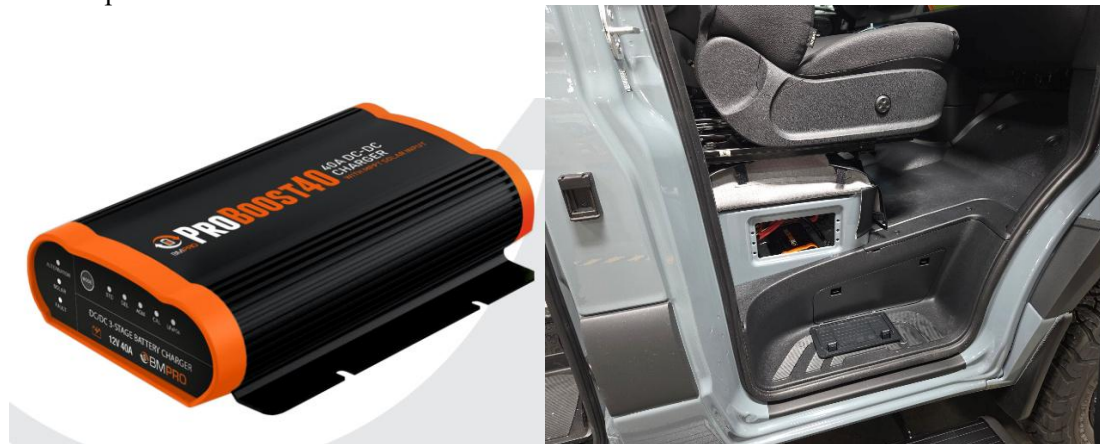
1. Locate the DC/DC Charger under the passenger seat using the access door on the side of the pedestal.

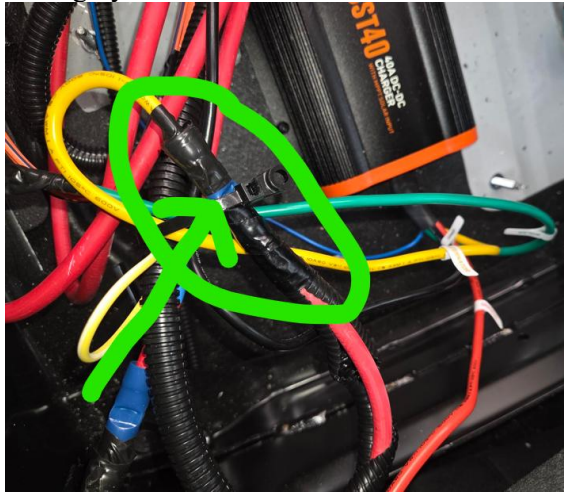
2. Locate the Red (may appear Orange) & Yellow wires leading into the DC/DC Charger.
3. The Yellow lead wire is an input from the chassis battery and is connected to a 6 gauge Red wire.
4. The Red (may appear Orange) is an output to the house battery and is connected to a 6 gauge Red wire.
5. Note the voltage at both chassis and house battery prior to doing anything. Use this as a reference in the following criteria:
  - a. shore power cord unplugged
  - b. house disconnect switch in the OFF position
  - c. chassis engine idling for roughly 2 minutes
    - i. test the voltage where the Yellow and 6 gauge Red wire are connected. It should be roughly 13+ Volts.

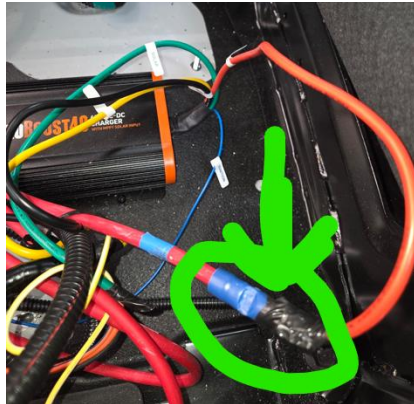
- ii. Test the voltage where the Red (may appear Orange) and 6 gauge Red wire are connected. It should be the same as the current house battery voltage.
