## Preview Solution CBR-159-8

### **Mack Trucks Equipped With A Cummins Engine - Engine Preheat Icon Does Not Illuminate In The Instrument Cluster (IC) During Engine Pre-heat (Intake Air Heater) Operation - Vehicles With 2018 Instrument Cluster Update, Model Year 2018 And Newer**

Published 10 August 2026

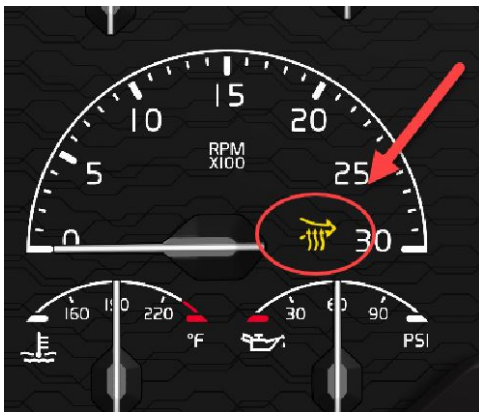
If the Preheat Icon does not illuminate while Engine Preheat is active as shown below:

#### **A. Update Instrument Cluster Software (SW) to enable the parameter.**

1. In Premium Tech Tool (PTT), run Operation [1700-22-03-06 Accessory Kit](#). The operation can be found under the Program tab.
2. When prompted, enter Accessory Kit Number [85153771](#).
3. Press the Program button in the lower right-hand corner of the screen.
4. Allow the programming operation to complete.
