| | | <b>Tesla, Inc.</b><br>Service Bulletin | | <b><i>Replace or Rework HVAC Inlet Duct Assembly - HEPA</i></b> | |
| <b>SB-26-18-002</b><br>August 15, 2026 | | | | | |

On some Model Y vehicles built before February 28, 2026, the design of the HVAC inlet duct may lead to water ingress into the air filter and/or vehicle interior.

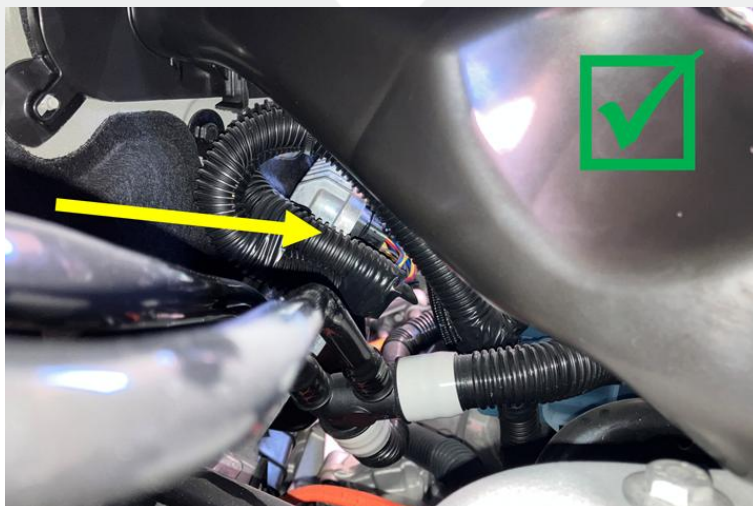
Figure 1

1. Test-fit the new HVAC inlet duct on the vehicle.
  - If there is no interference between the inlet duct and the car computer coolant lines (Figure 1), go the next step.

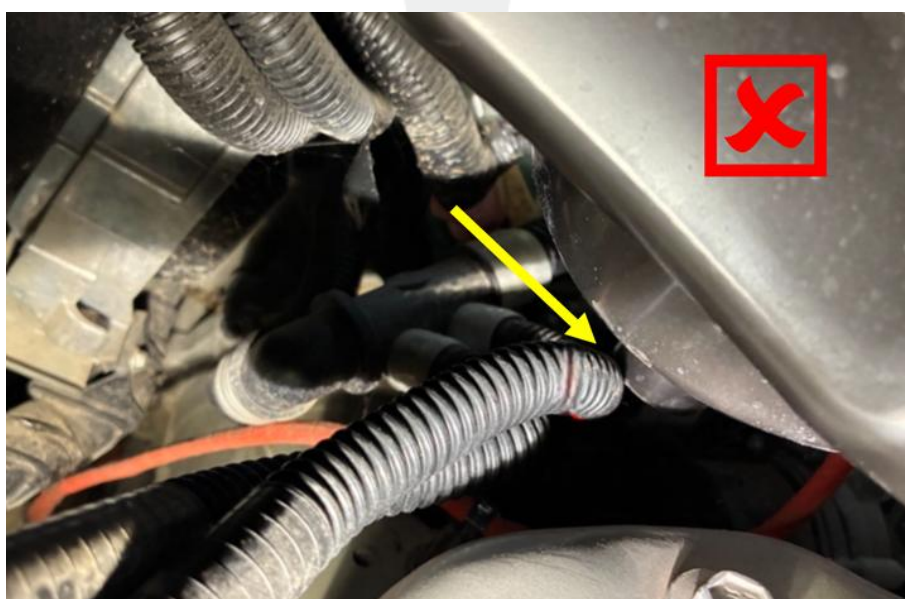
Figure 2

- If there is interference between the inlet duct and the car computer coolant lines (Figure 2), continue to the [Rework Procedure](#).

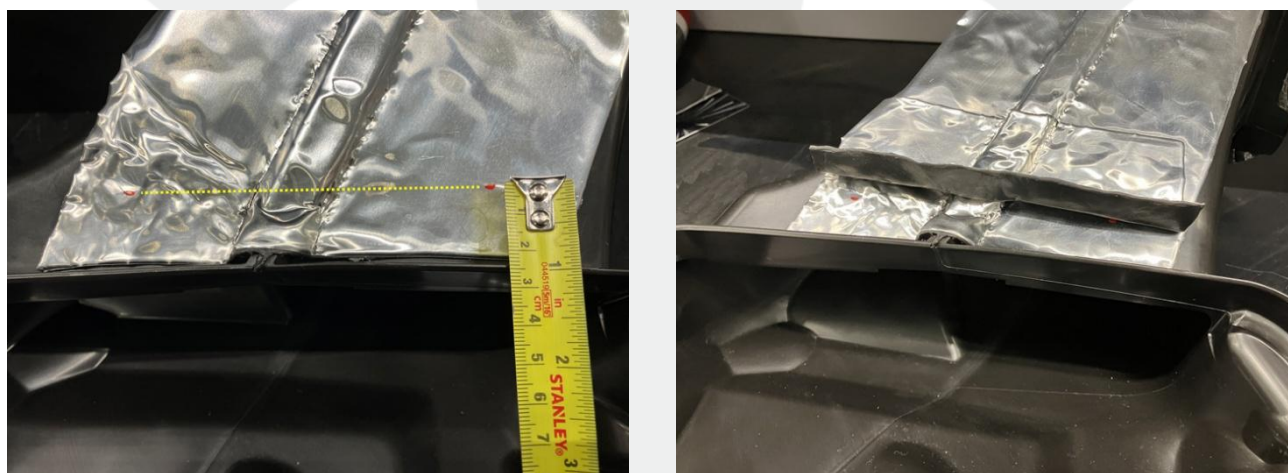
Figure 8

**NOTE:** The L-shape along the vertical wall acts to divert water from the intake duct opening.

Peel off the outer backing, then slightly heat up the butyl patch by moving a heat gun set at 100°C at a distance of at least 5 cm (2 in) from the patch for 10-20 seconds. Do not use excessive heat. Apply the patch at approximately 2.5 cm (1 in) above the intake duct opening (Figure 8).
