**Countries:** CANADA, MEXICO, UNITED STATES **Document ID:** IK1201501  
**Availability:** ISIS, NotSIR **Revision:** 7  
**Major System:** ENGINE **Created:** 1/6/2025  
**Current Language:** English **Last Modified:** 8/6/2026  
**Other Languages:** NONE **Author:** Gintarus Andriusis  
**Viewed:** 9456

**Title:** S13 Gear Housing Leak (By The Air Compressor)

**Applies To:** S13 Integrated Powertrain LT RH HX

The purpose of this document is to properly identify and repair a leak at the rear gear housing boss.

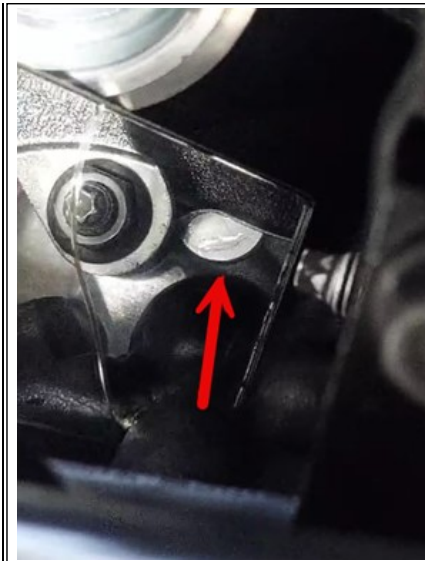
**Figure 2 - Using a mirror to inspect between the lower compressor stud and the block**

| Step | Action | Decision |
|---|---|---|
| 2 | <b>DIAGNOSTIC:</b><br>Use Figure 2, Figure 3, and Figure 4 below to assist in inspecting for oil seeping past the machined exposed boss surface<br><br>*NOTE* The International S13 engine has oil dye added from the plant<br><br>*NOTE* If oil is noticed, clean it using a degreaser and verify that the oil is coming through the machined surface<br><br>*NOTE* For the highest likelihood of identifying the leak source, inspect the engine while it is warm or operating at normal temperature<br><br><b>YES/NO QUESTION?</b><br><br>Is there oil leaking at the machined boss area? | <b>Yes:</b> Go to Repair Steps |

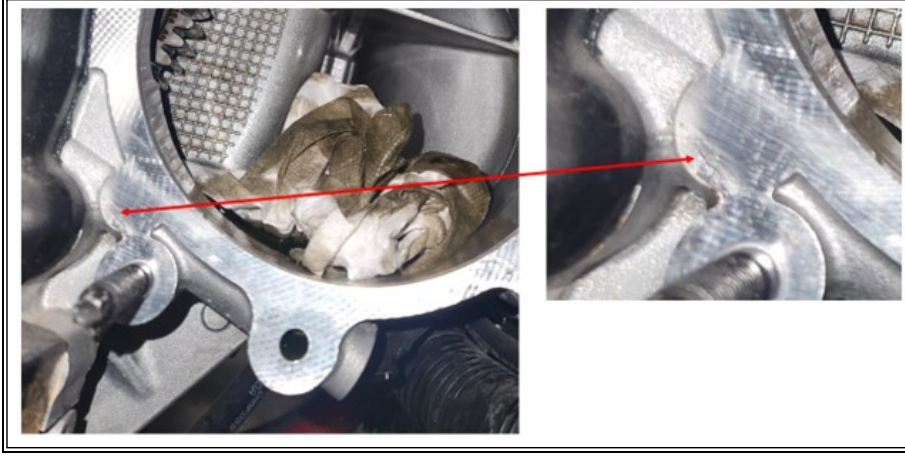
Figure 4

**\*NOTE\*** - Below Figure 4, the air compressor is removed to assist in showing the area in question; the compressor does not need to be removed to inspect for the boss leak

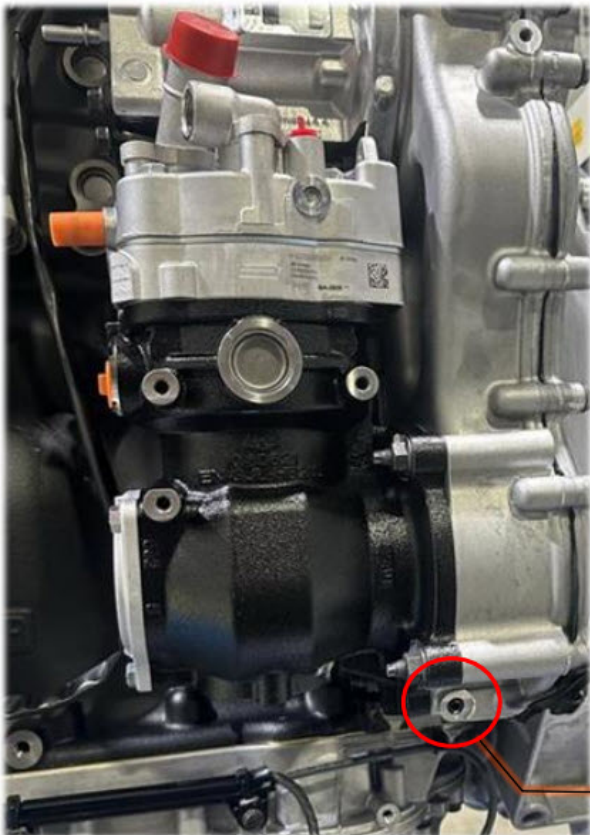
**Figure 5**

**Cap Screw**

3. Clean off the area around the cap screw (reference Figure 5) with engine degreaser to ensure no debris could be introduced into open oil system

4. Remove the cap screw at the bottom of the gear housing (reference Figure 5) to expose the oil galley and allow the residual oil to drain
