# HYUNDAI

## Technical Service Bulletin

**26-01-040H-1**

**SUBJECT:** INSIDE REAR COMBINATION LAMP ASSEMBLY INSPECTION – REPLACEMENT OR WASHER INSTALLATION (LIMITED COVERAGE CAMPAIGN LA19)

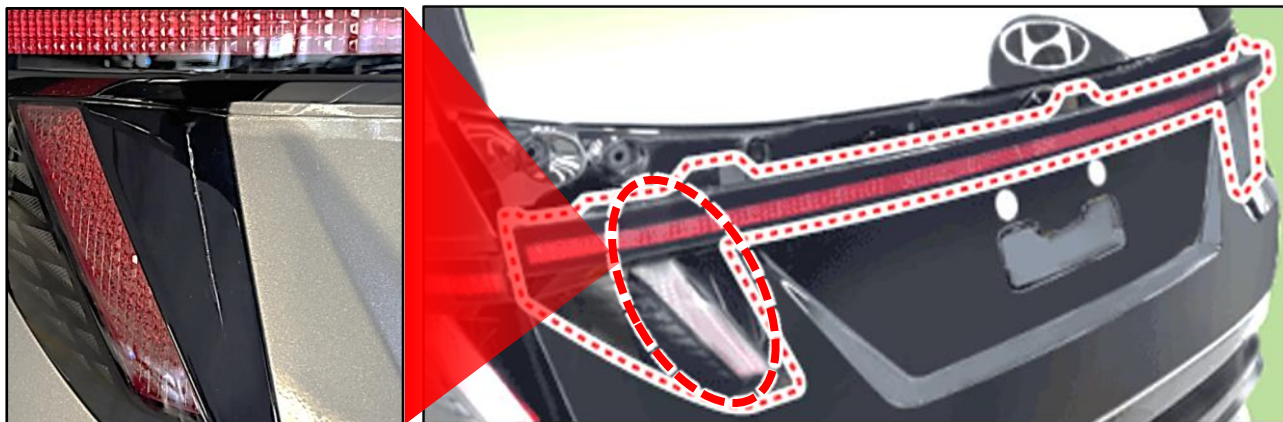
**Description:** Certain Tucson (NX4A) vehicles equipped with bulb type "inside rear combination lamp assembly" may have a crack on the left-hand side. This bulletin provides instructions to inspect the "inside rear combination lamp assembly" and replace it if a crack is found, or to install washers to prevent a crack from developing.

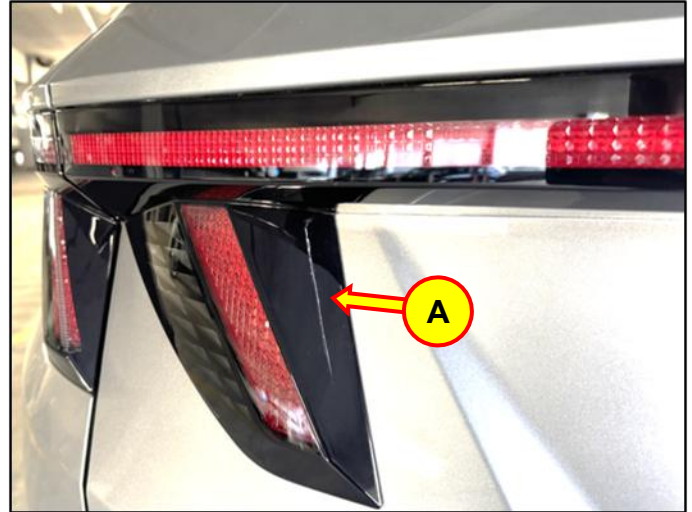
1. Visually inspect the LH side of the removed inside rear combination lamp assembly for a crack (A).

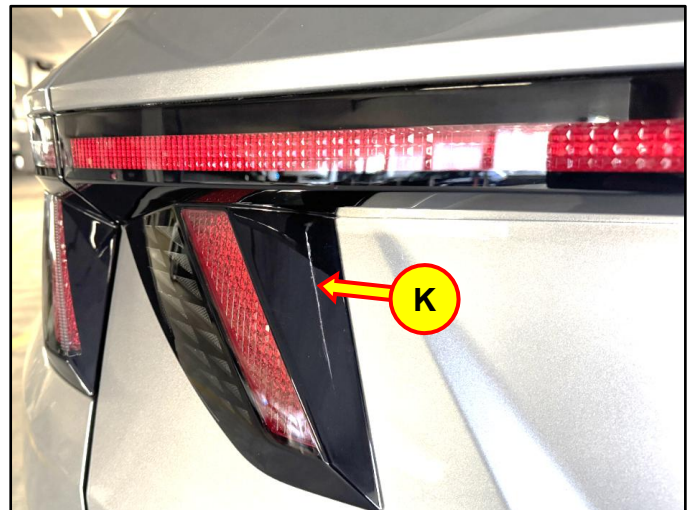
12. If the inside rear combination lamp assembly is cracked (K), then proceed to the [Inside Rear Combination Lamp Assembly Replacement](#) procedure.

If the inside rear combination lamp assembly is intact, then proceed to the [Washer Installation](#) procedure.

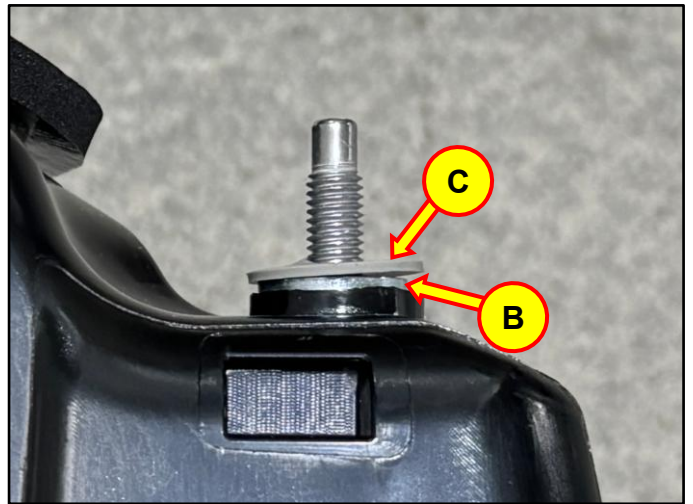
The metal washers **MUST** be installed before the rubber gaskets. Installing the metal washers after the rubber gaskets may damage the tailgate body and may **NOT** provide an adequate seal, potentially leading to water ingress into the tailgate panel.

2. On each stud, install the supplied metal washer (B) first, then replace the rubber gasket (C).
