## Technical Service Bulletin

NUMBER  
**26-EV-007H**

MODEL(S)  
**IONIQ 5 (NEA EV)**

**SUBJECT:** UNDER-TORQUED RELAY BOLT – INVERTER REPLACEMENT –  
DTC P1E3000

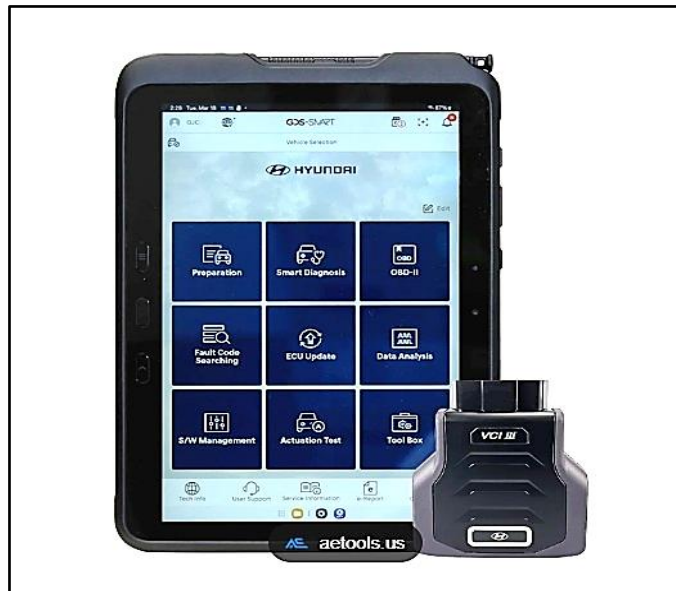
1. Use GDS to scan for **DTC P1E3000**:
  - If detected, proceed to **step 2**.
  - If **NOT** detected, then this TSB does **NOT** apply. Follow the normal diagnostic process.
