SF732  
Creation Date: July 2026  
Revised Date: August 2026

Subject: Power Acumen Fuse

**PROBLEM:** On specific vehicles, the power acumen fuse was not installed.

**SOLUTION:** A DTNA authorized facility will inspect and install the fuse if necessary.

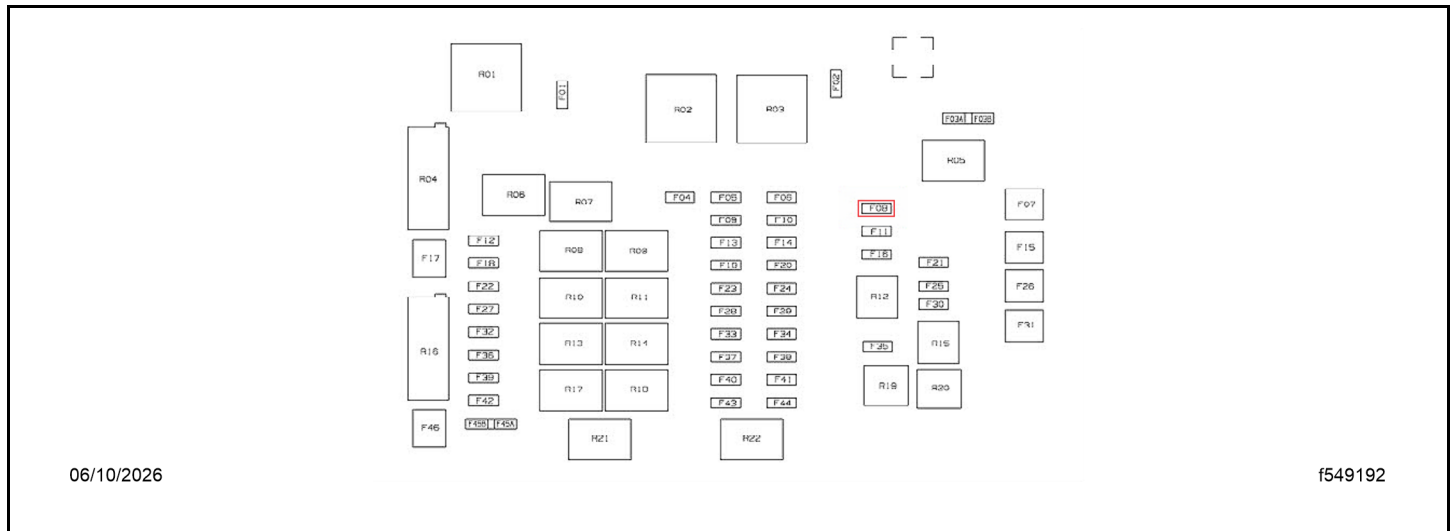
**Fig 4, Location of the Fuse Box**

**NOTE:** Install the 5-amp fuse as specified. The circuit is designed and rated for up to 15 amps, but the 5-amp fuse is intended for this application and provides the required circuit protection.

5. Inspect fuse location F08 for 5A fuse. If found move to the next step or if missing install 5A fuse (BUS BK/ATM 5). See [Fig. 4](#).
