# Draining Water Trapped in the Upper A-Pillar

## TSB-60-167 FTL

- Cascadia
- New Cascadia

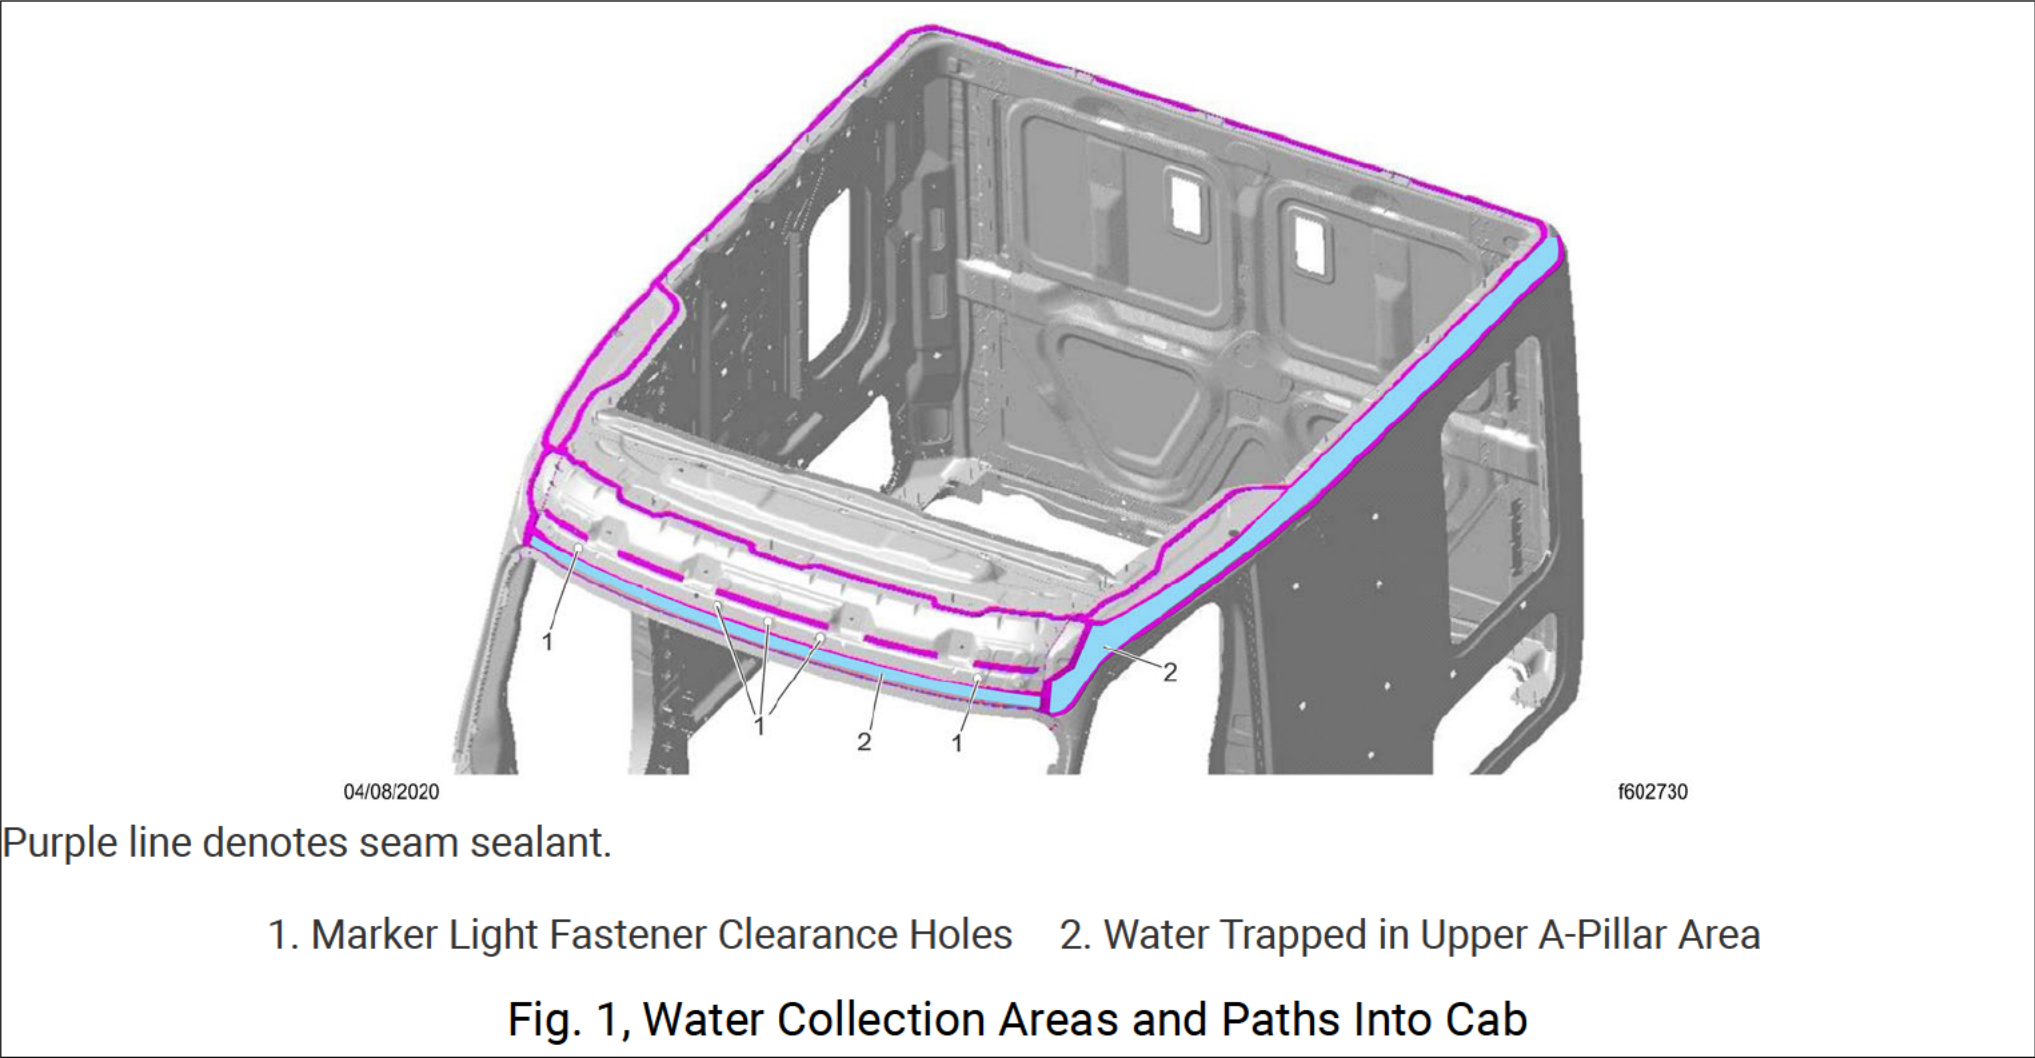
A water leak in the seams between the cab roof and cab side wall or back wall can result in water becoming trapped in the upper A-pillar area in some Cascadia and New Cascadia vehicles. This water may migrate inside the cab and eventually spill through the marker light fastener clearance holes and drip on the dash. See Fig. 1.

If water is dripping on the dash and no other leaks can be found, follow these instructions to check for and drain the collected water and create a path to drain any future water intrusion.

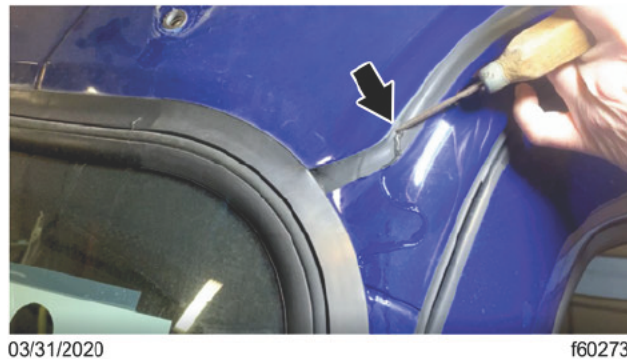
**Fig. 2, Draining Collected Water**

2. ☐ Use a pick or knife to make a hole in the seam sealant an inch or two above the windshield gasket on each upper A-pillar to inspect for water that may have collected there. See Fig. 2.

- a. ☐ If no water is found, stop and reseal the hole using Sikaflex 295UV sealant following the directions in step 5. Continue testing using the instructions in Section 60.05, Subject 100, of the applicable workshop manual.

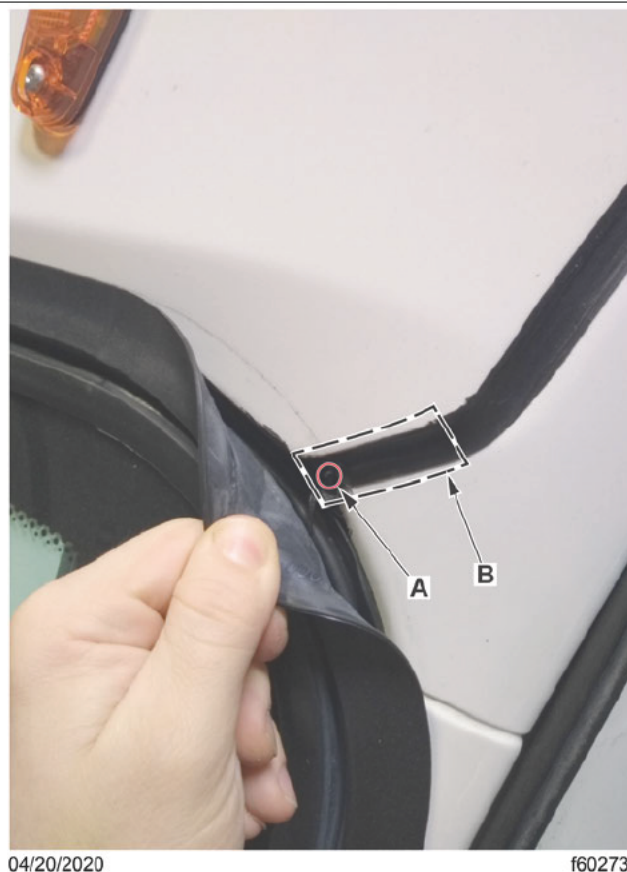
**Fig. 3, Seam Sealant Opening and Area to Cut**

A. Drain Opening for Future Water Intrusions.

B. Area of Seam Sealant to Cut.

4. ☐ Using a box knife, razor, pick, and/or pliers, remove approximately 1-1/2 in (4 cm) inches of the seam sealant along the downward curve of the cab roof toward the windshield to drain the water. See Fig. 3.

5. ☐ Reseal the seam using Sikaflex 295UV sealant, leaving the bottom of the seam that will be hidden by the windshield gasket flange open to drain future water intrusions.
