# Vehicle Interface Controller (VIC) Software Update

## TSB-54-030-TBB

► eB2

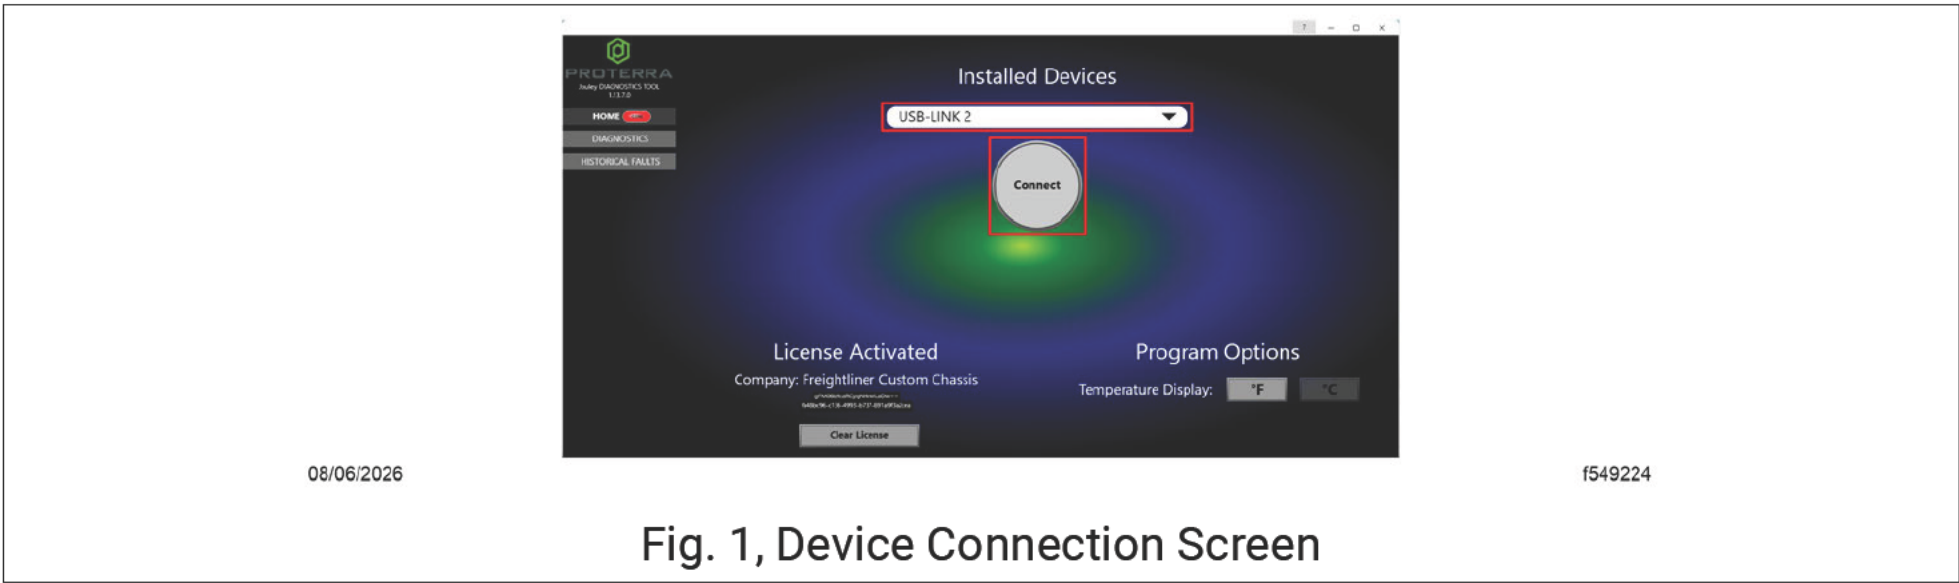
eB2 Gen 1 vehicles equipped with the Emperor battery pack may report erroneous faults during vehicle operation or charging. In addition, charging interoperability issues may occur with SparkCharge, XOS Hub, and Aplitrionics charging systems. Vehicles exhibiting this condition may also experience missing Diagnostic Trouble Code (DTC) reporting and erroneous Battery Thermal Management System (BTMS) coolant pump commands. The following procedure provides instructions to diagnose and correct these conditions.

- ☐ Park the vehicle on a level surface, place the vehicle in neutral, shut down the vehicle, and set the park brake. Chock the tires.
- ☐ Connect a laptop to the vehicle and launch the Jouley Proterra Diagnostic Tool.
- ☐ Select the appropriate adaptor from the dropdown menu, then select 'Connect'. See Fig. 1.
