# 54–334 Front Lighting Ground Splice Pack Failure

## TSB-54-334-FTL

Creation Date: 2021-12-31

- ▶ Business Class M2
- ▶ 108SD
- ▶ 114SD

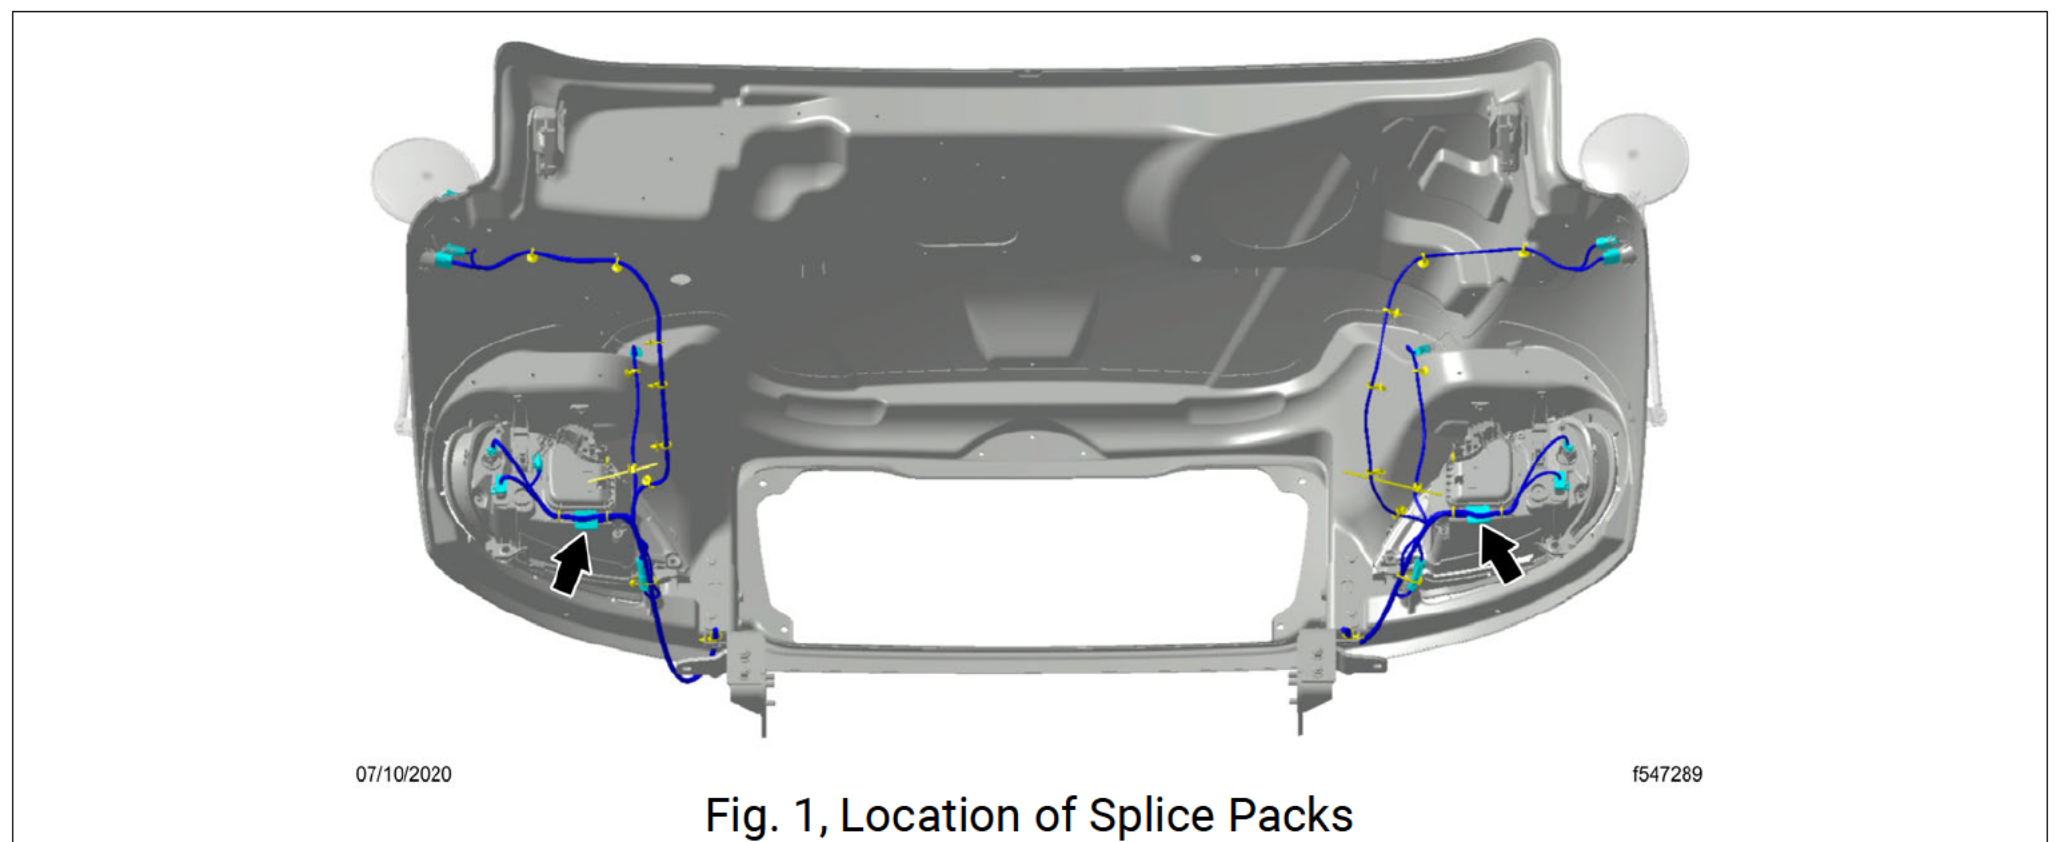
The left and right hood lighting of these vehicles have separate ground paths to the frame and use the same splice pack parts. The splice packs are part of the hood commodity and located near the headlight assemblies. See Fig. 1.

These splice packs can fail, resulting in either the left or right lighting becoming intermittent or inoperative. There are no reports of a vehicle losing both headlights or both sets of hood lighting at the same time.

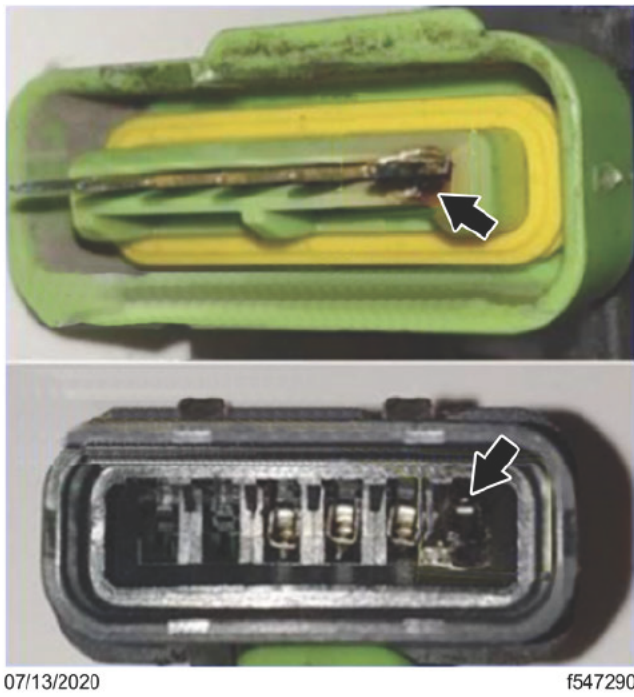
Failures can be easily identified by removing the green end cap from the splice pack and looking for burnt sections of the comb or burnt terminals. See Fig. 2.

Fig. 2, Failed End Cap Comb and Burnt Terminal in Splice Packs

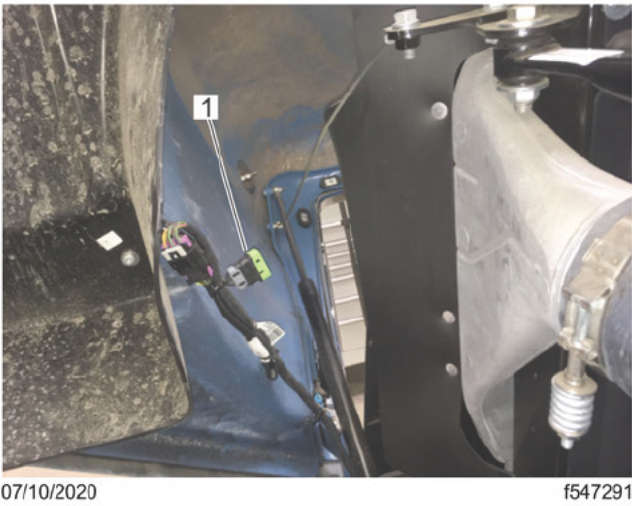
1. Splice Pack  
Fig. 3, Splice Pack Location (LH side shown, RH side similar)

1. ☐ Park the vehicle on a level surface, apply the parking brakes, and shut down the engine. Chock the tires.
- 
2. ☐ Disconnect the batteries.
- 
3. ☐ Open the hood.
- 
4. ☐ Locate the splice pack on the side of the vehicle with the intermittent or inoperative hood lighting. See Fig. 3.

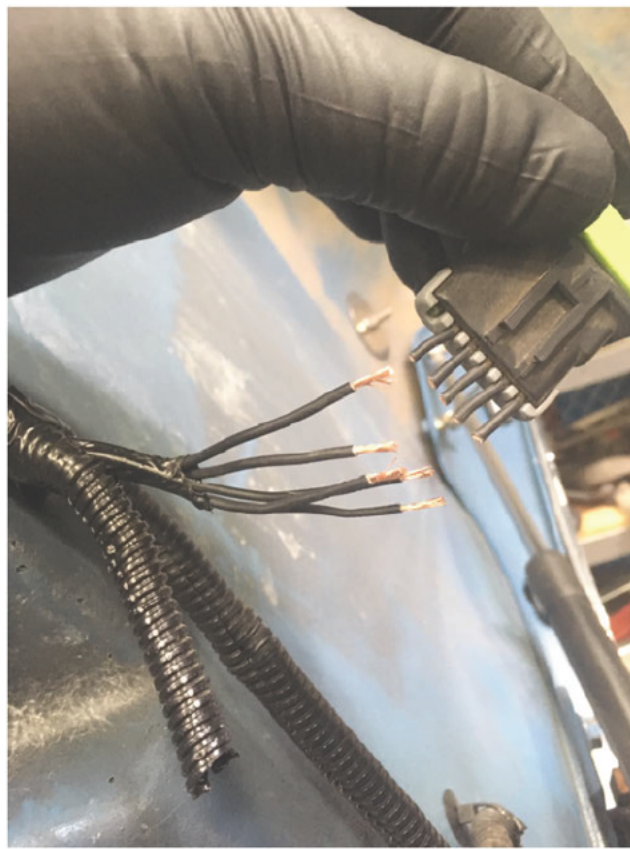
**Fig. 4, Splice Pack Removed, Wires Stripped**

- 
5. ☐ Unbundle and unwrap the wires to expose approximately four inches of each wire leading to the splice pack.
- 
6. ☐ Remove the original splice pack and strip each of the wires about ½ inch (13 mm). See Fig. 4.

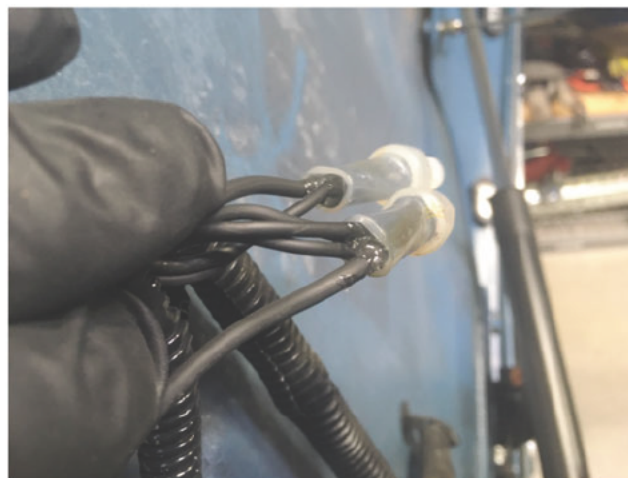
**Fig. 5, Wires Sealed with Protective Gel**

- e. ☐ Using a heat gun, carefully shrink the closed-end connector until gaps are removed and a protective gel seals the wiring. See Fig. [5](#).

- b. ☐ Using a heat gun, carefully shrink the closed-end connector until gaps are removed and a protective gel seals the wiring. See Fig. [5](#).
