2022-2024MY  
Carnival (KA4)

358

## TECHNICAL SERVICE BULLETIN

## HORN ASSEMBLY INSPECTION/REPLACEMENT (WTY048)

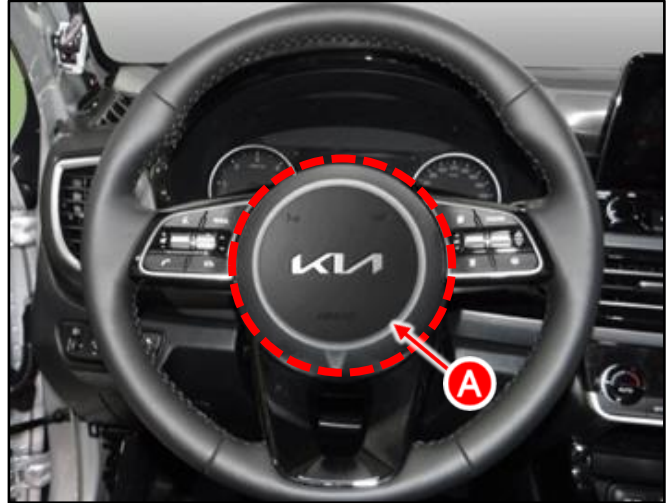
1. Press the Horn Pad (A) to confirm normal operation:
  - If the horn operates **normally**, this TSB does not apply. **Claim inspection only labor op 262068R0.**
  - If the horn is **inoperative** or the **tone is distorted**, proceed to the 'Replacement Procedure' below.
