**UPDATED - August 19, 2026 – Charge for lost labels added, see ordering section.**

## Emissions Recall 8026C – Battery Label Concern - affecting 2026 CX-50 Hybrid vehicles

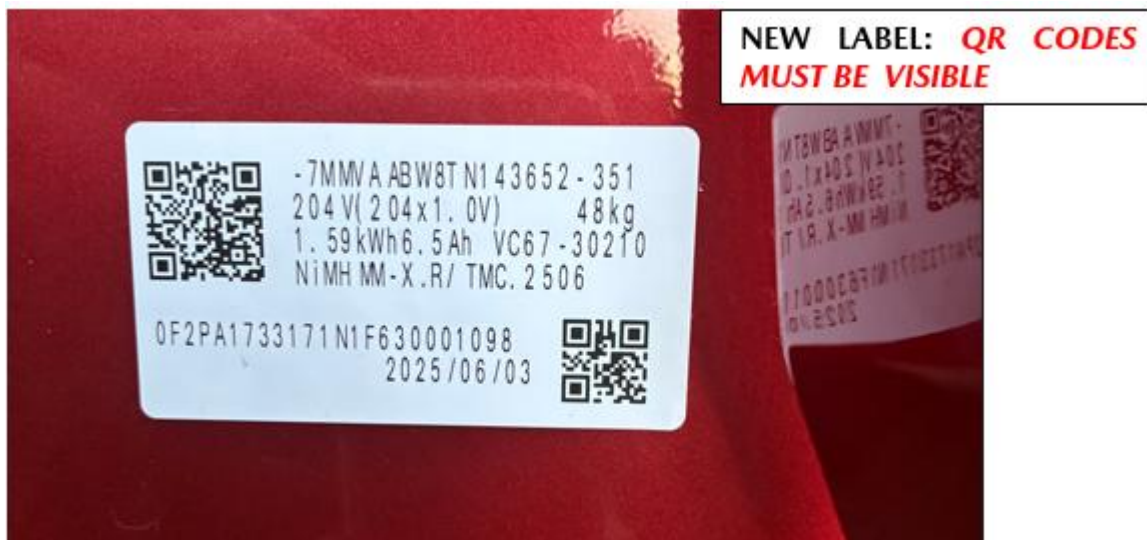
**PHOTO #1:**

| | Battery Label Kit Replacement |
|---|---|
| D40 Photo Requirements (you must have three correct (3), D40 attachments) | Photo 1 – B-pillar NEW Label after install<br>Photo 2 – B-pillar OLD and NEW Label in same photo<br>Photo 3 – Hybrid battery after install |

Add battery label on the center B-pillar: Remove the incorrect battery label and attach the NEW label.  
Add battery label on the traction battery: Attach the NEW battery label slightly to the right of the original label, then take all 3 required photos.
