## Technical Service Bulletin (TSB)

### Tingling/Vibration When Turning The Steering Wheel

| REFERENCE: | TSB: 19-004-26<br>GROUP: 19 - Steering | Date: | August 29, 2026 | REVISION: | — |
| VEHICLES AFFECTED: | 2023 - 2026 (B1) Jeep Renegade (Brazil) | | | <b>MARKET APPLICABILITY:</b><br><div><input type="checkbox"/> NA<input type="checkbox"/> MEA</div> <div><input checked="" type="checkbox"/> SA<input type="checkbox"/> IAP</div> <div><input type="checkbox"/> EE<input type="checkbox"/> CH</div><br><b>NOTE:</b> This bulletin applies to South America markets. | |

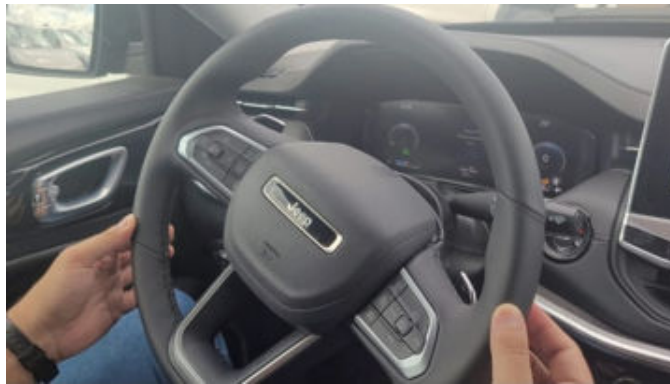
**Fig. 1**

Position Where You Can Feel The Tingling

2. If a tingling sensation or vibration is felt while the steering wheel is held in a turned (off-center) position [Fig. 1](#), replacement of the steering column is **NOT REQUIRED**, as this behavior is considered normal for the component.
3. **IMPORTANT!** The condition described above is not considered a noise concern. It may only be felt when the steering wheel is held off-center while the vehicle is stationary. If the customer's concern involves a noise condition, continue the diagnostic procedure until the root cause is identified.
