**Technical Service Bulletin (TSB)**  
**Water Leak In Rear Cargo Area**

| REFERENCE: | TSB: 23-036-26<br>GROUP: 23 - Body | Date: | August 25, 2026 | REVISION: | — |
| VEHICLES AFFECTED: | 2024 - 2026 (JL) Jeep Wrangler<br>This bulletin applies to vehicles equipped with Sky One-Touch Power Top (Sales Code STJ). | | | MARKET APPLICABILITY:<br><div><input checked="" type="checkbox"/> NA<input type="checkbox"/> CH</div> <div><input type="checkbox"/> EE<input type="checkbox"/> IAP</div> <div><input type="checkbox"/> SA<input type="checkbox"/> MEA</div><br><b>NOTE:</b> This bulletin applies to the North America markets. | |

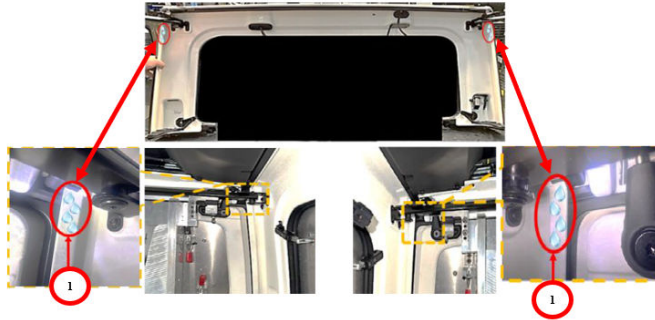
**Fig. 1**  
Water Leak Path Indicating Weatherseal Wet-Out

- If the water follows the path shown in Fig. 1, this may indicate a potentially insufficient wet-out area on the weatherseal.

1 - Water Leak

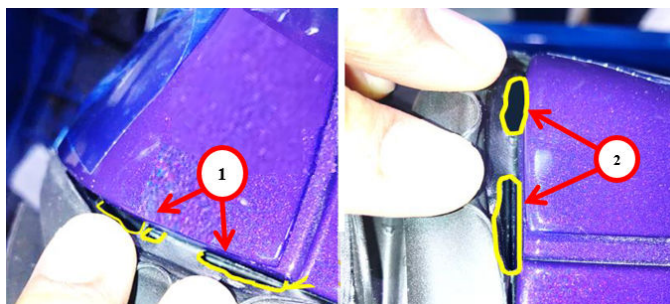
**Fig. 4**  
Confirmation of Insufficient Wet-Out

1 - Non Wet-Out

2 - Confirmed Wet-Out / Gaps or Voids Detected

2. If gaps or voids are visible, this indicates that the weatherseal is not properly wet-out. This condition may be present along the entire length of the weatherseal; however, it is most commonly found at the corners.
