## Technical product information

| <b>Topic</b> | Sunroof blind not retracting Bentayga Series |
| <b>Brand</b> | Bentley |
| <b>Transaction No.</b> | 2078373/4 |

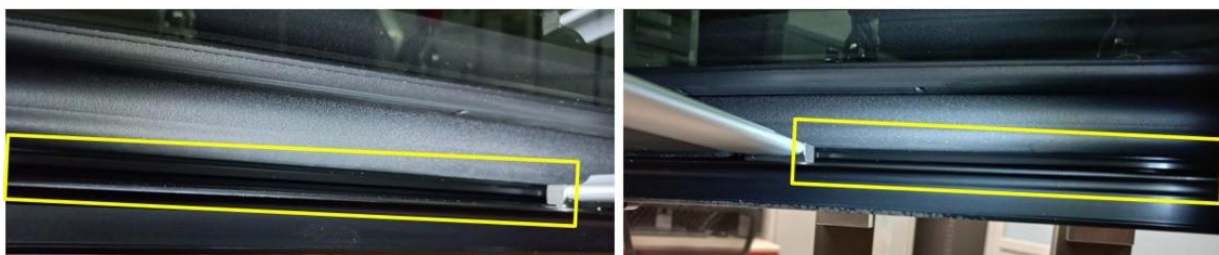
**Figure 2** Contamination of roof / guides for sunblind slide shoes

1. Inspect the sunroof blind frame for contamination of the guides (located under rear glass).
2. While the sunroof is stationary, visually inspect the rear section of the guide channels from underneath the rear glass. Check for small materials such as:
  - Small stones
  - Excessive dirt or dust
  - Organic matter (e.g., pine needles, leaves).

The guides must be completely clean and free from all contamination to ensure smooth operation.

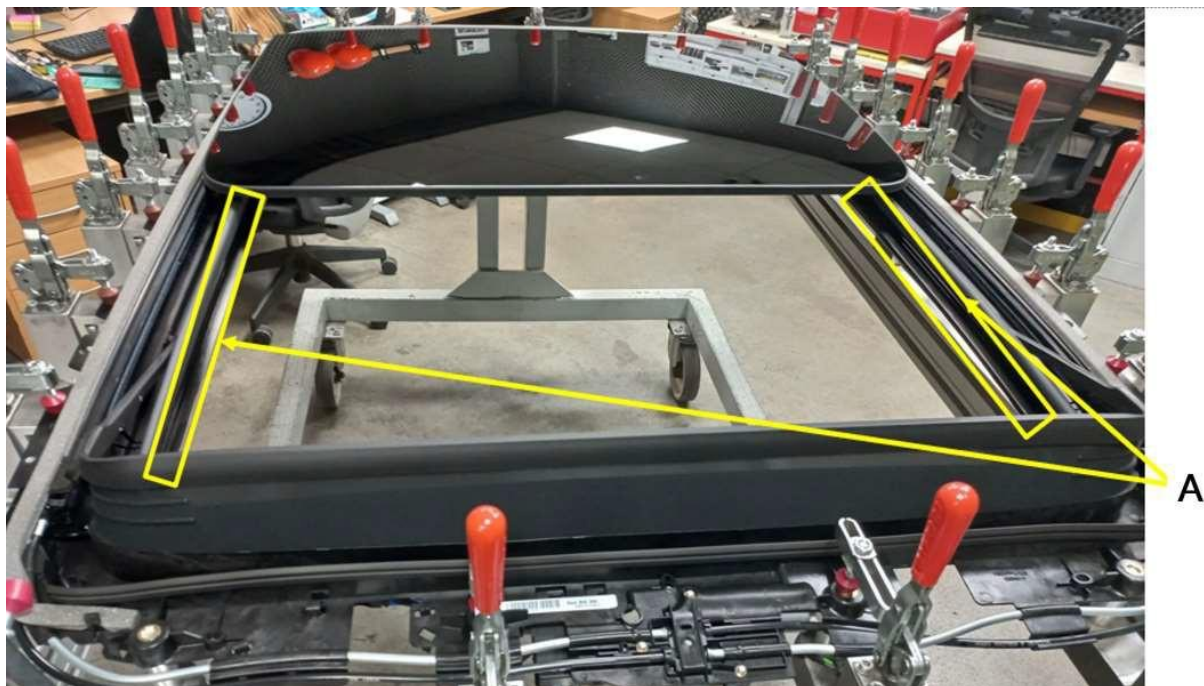
**Figure 3** Contamination of roof check

3. Inspect areas 'A' labelled in figure 3 of the frame for contamination.
- The yellow markings highlight the area most likely to become contaminated when the roof is opened.

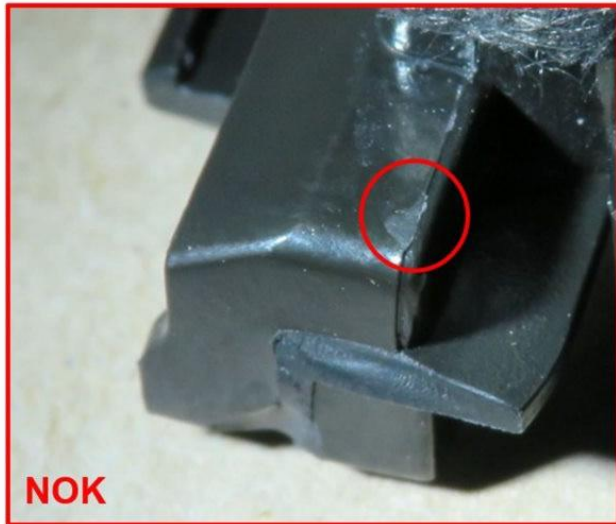
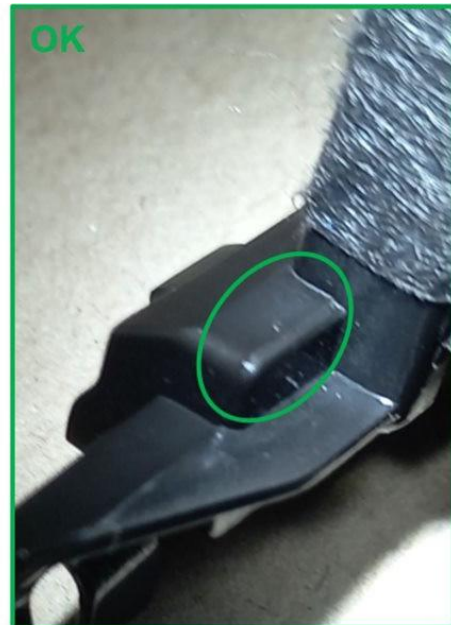
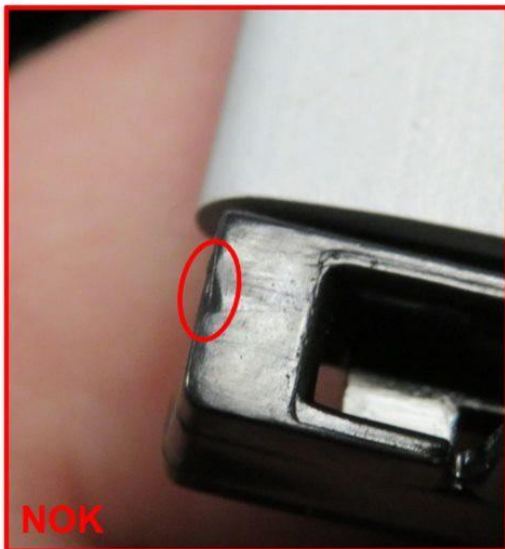
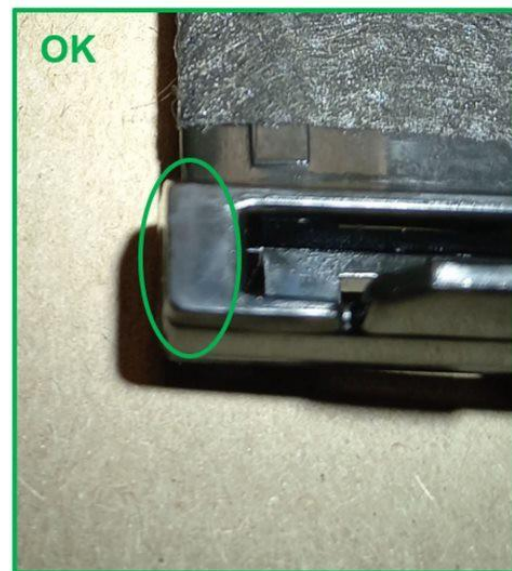
**Figure 4** Damage of the sunroof blind slide shoes due to contamination check

4. Inspect the sunroof blind slide shoes for:

- Cracks
- Wear
- Missing plastic components
- Distortion from misalignment.

All slide shoes must be intact and free of visible damage.

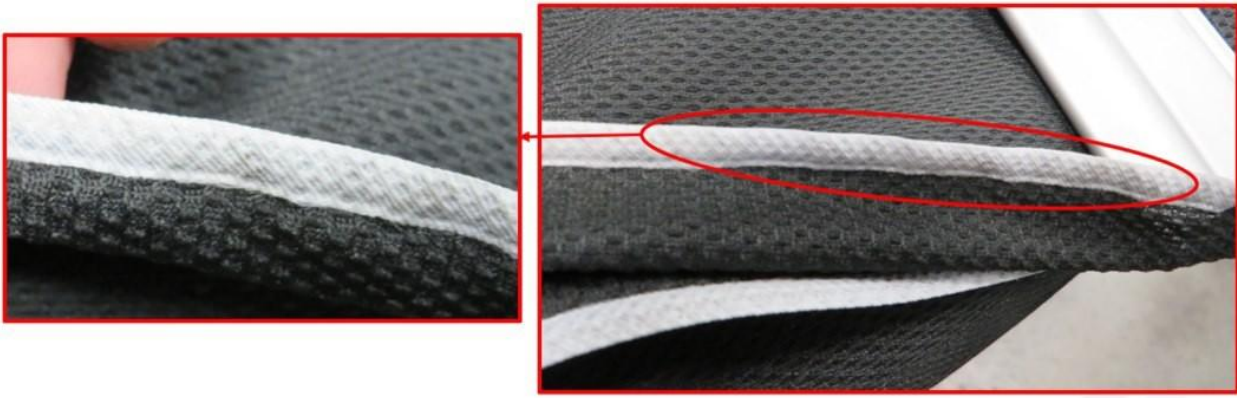
**Figure 5** Contamination of roof / PDF strip check

5. Inspect the PDF strip of the blind material, check for contamination on areas corresponding to the slide shoe path. If the guide is contaminated it is likely that the PDF strip is also contaminated or damaged.

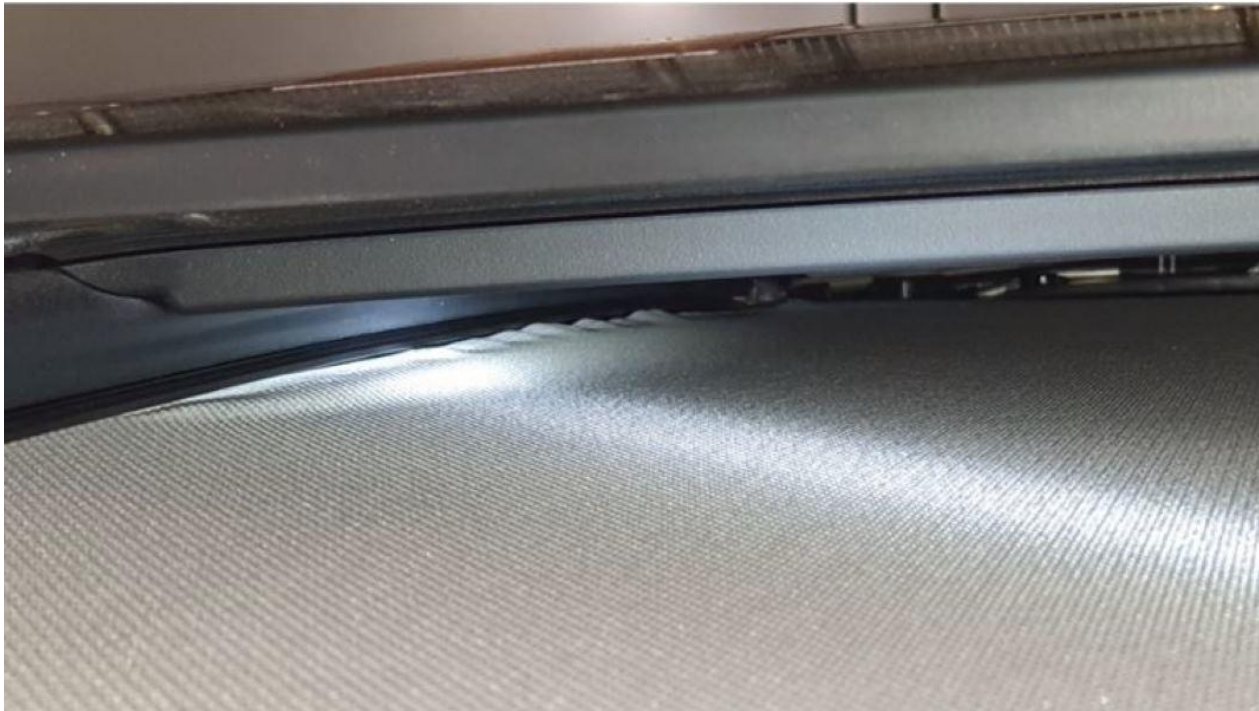
**Figure 6** PDF strip derailment check

6. Inspect the blind guides if they are coming off the runners and check the PDF strip for any derailing issue or NOK welding of the PDF strip.

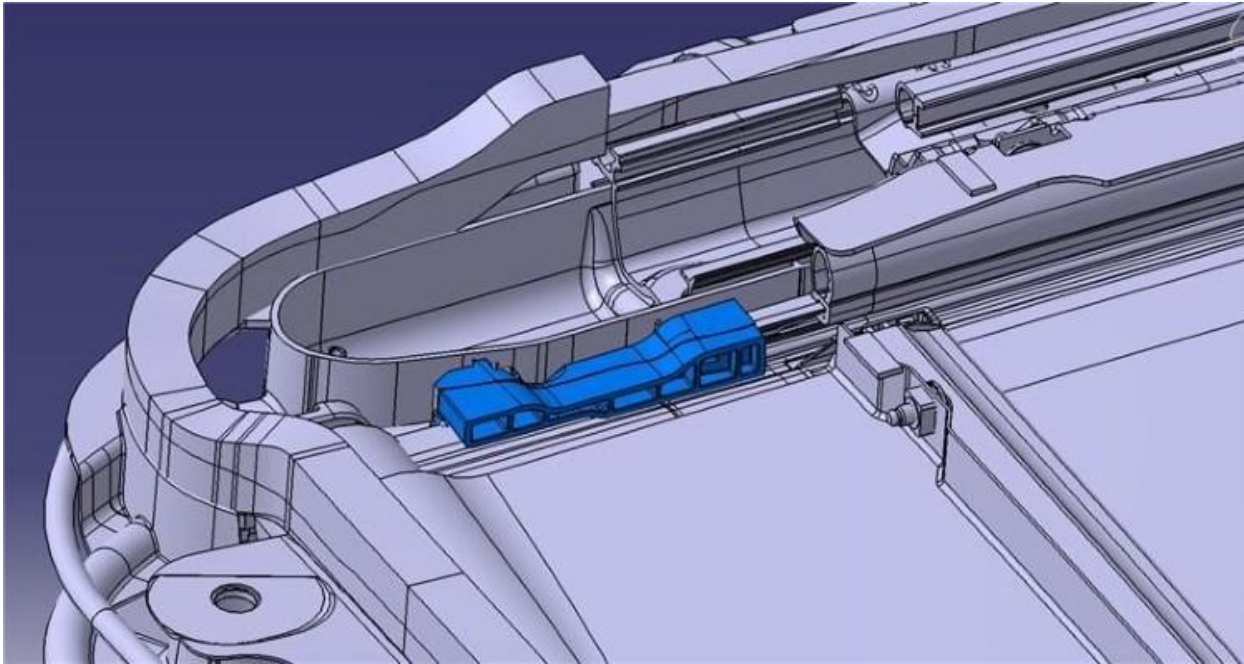
**Figure 7** *Guide part location*

Inspect the guide part by removing headliner (refer to ElsaPro Repair Group 70 'Headlining – To remove and fit').

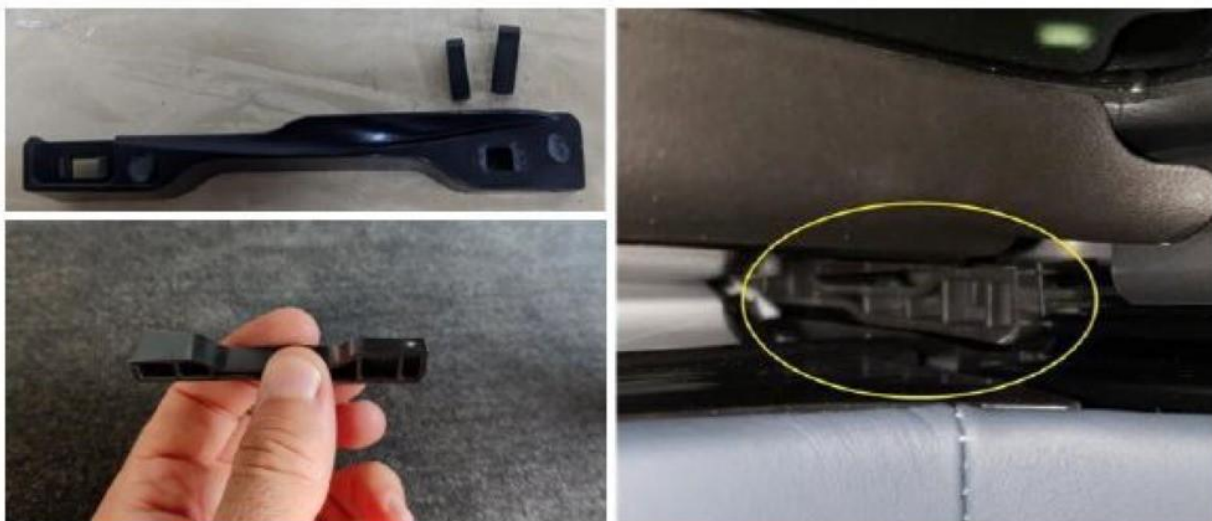
**Figure 8** *Examples of missing, loose and damaged guide parts*

If part 4M0 898 924 damaged or missing (see figure 8), then replace following the instructions below:

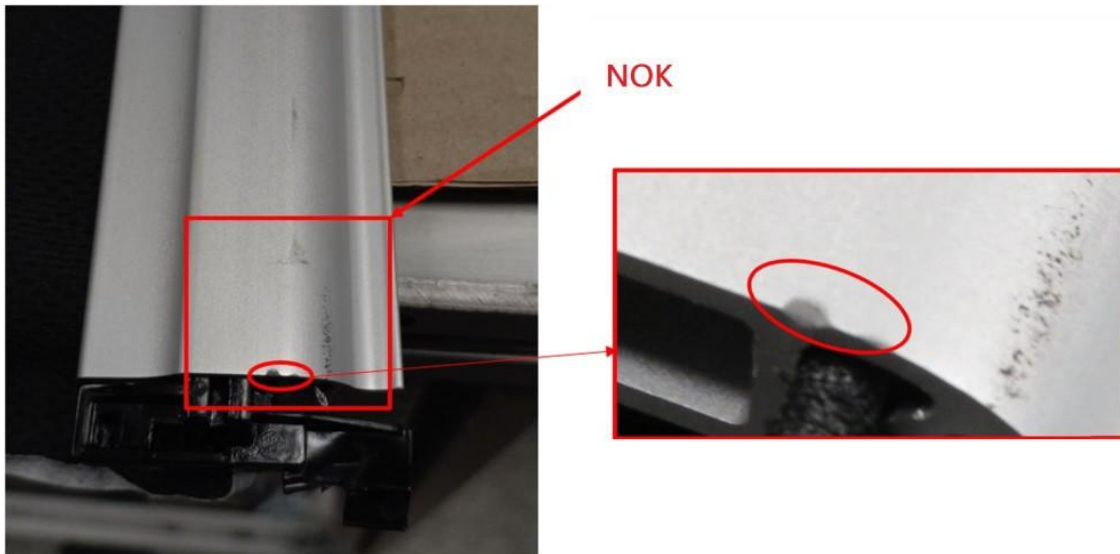
**Figure 12** Sunblind beam check

7. Inspect the sunblind beam for scratches or damage. Damage would indicate presence of external contamination.

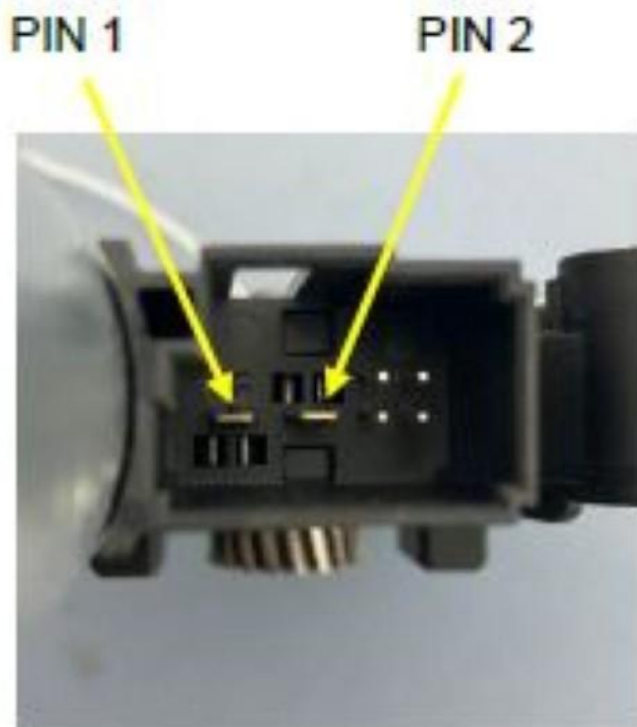
**Figure 14** Location of pins on motor

9. Measure and record resistance across Pins 1 and 2 and include reading in DISS ticket.

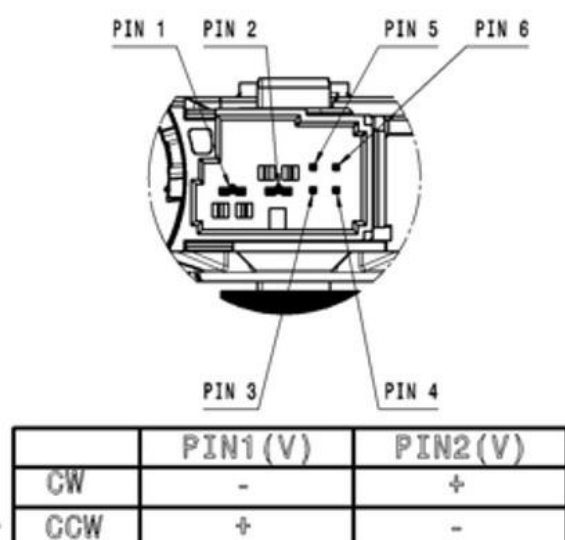
**Figure 15**

CW (Clockwise) direction: Pin 1 (-), Pin 2 (+)

CCW (Counterclockwise) direction: Pin 1 (+), Pin 2 (-)

- If the blind operates correctly under external voltage, investigate sunroof control module position detection concerns.
- If the blind does not operate, suspect a sunroof blind motor fault or excessive resistance within the mechanism.

**Important:** Apply the polarity so the blind moves away from its current end position (open the blind if currently closed or close the blind if currently open) to prevent over-travel.

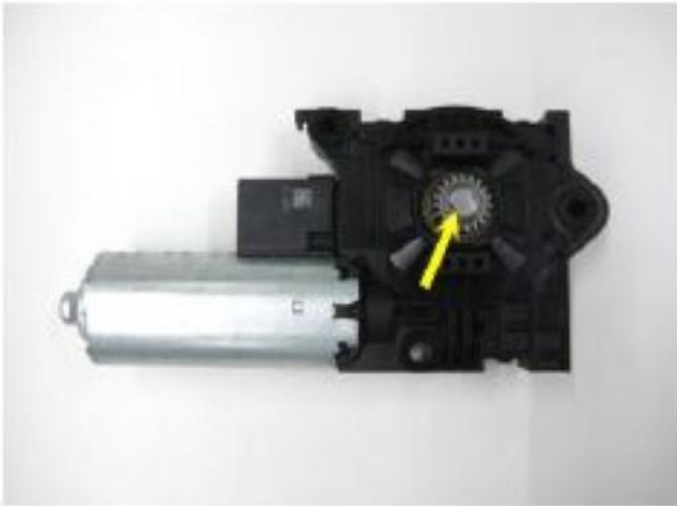
**Figure 16** *Position of motor shaft*

10. While the motor is disengaged from the drive cables, rotate the motor shaft using a soft jaw wrench and verify that it operates correctly in isolation.

If operation does not resume, replace sliding motor 4M0 959 591/A (refer to ElsaPro Repair group 60 'Sunroof motor – To remove and fit').

11. Apply grease to the motor unit pinion and reassemble the motor to the sunroof blind.
