## SERVICE BULLETIN

**APPLICABILITY:** 23-25MY Outback/Legacy Models (including Wilderness models)  
 23-26MY Ascent Models  
 24-26MY Impreza  
 24-26MY Crosstrek (including Wilderness models)  
 24-26MY WRX  
 25-26MY Forester  
 26MY Forester Wilderness

**NUMBER:** 15-305-22R  
**DATE:** 11/15/22  
**REVISED:** 08/20/26

**SUBJECT:** Reprogramming File Availability for Optimization of Gen 4.5 Denso CP1.5 Infotainment Systems

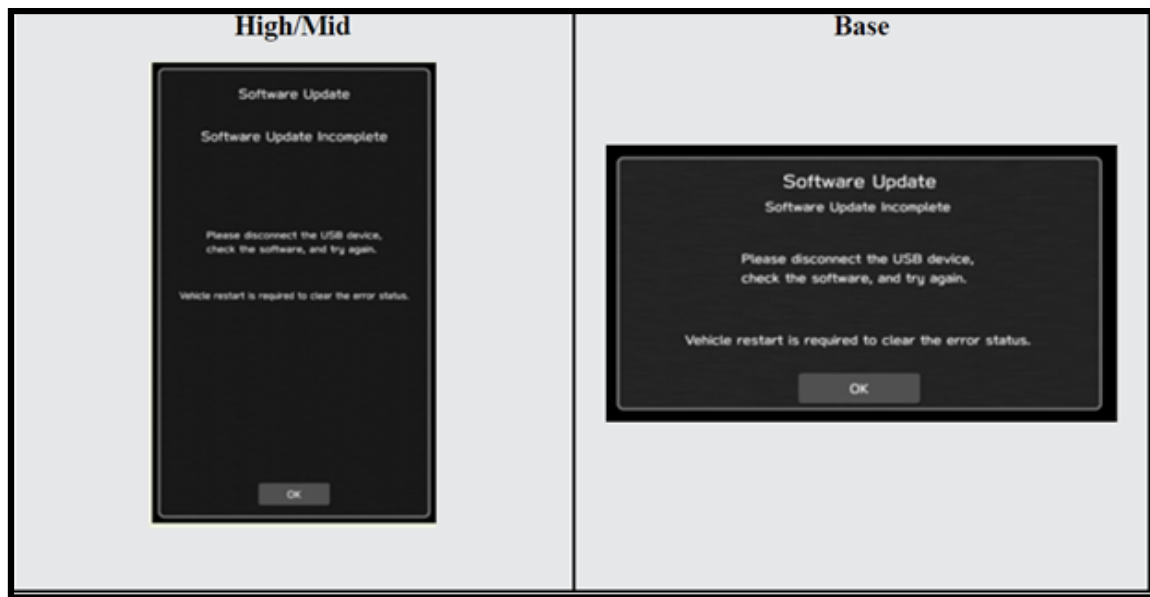
If you get the message **Software Update Incomplete** as shown below, please don't replace the hardware but retry updating the software according to the instructions in [Appendix 6](#).

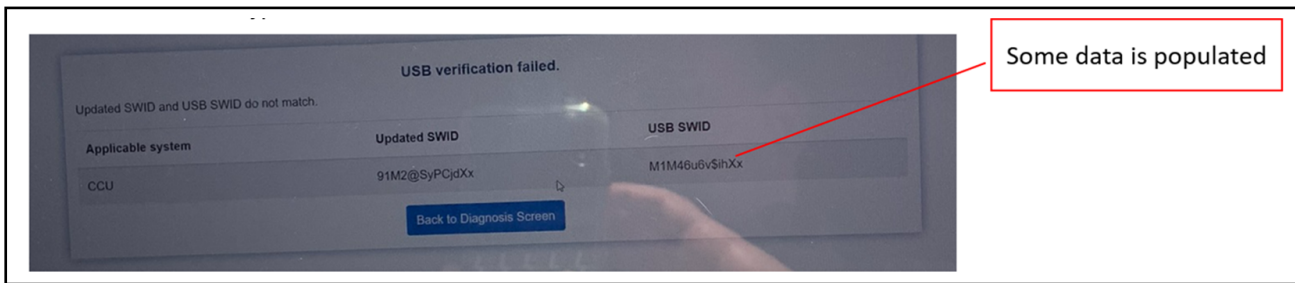
This is not to be confused with a typical USB verification failure due to data mismatch.

The recovery steps are outlined below.

- Perform a soft reset of the CP1 by holding down the CID volume knob. Please leave USB Drive connected.
- Once the CP1 has restarted, retry step ii on the previous page and then press the “Start Reprogramming” button. Please wait for 2 minutes after CP1 has restarted, before press the “Start Reprogramming” button.
- If the same failure is encountered again, please proceed with the diagnostic of failure by checking the USB drive data integrity.

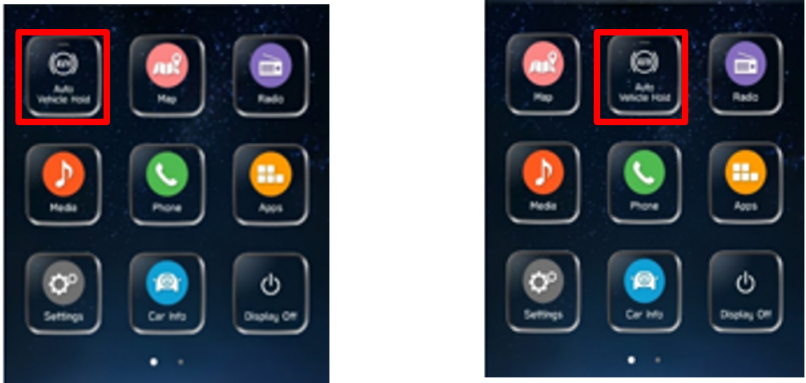
| Number | Category | Symptoms to be Improved: |
|---|---|---|
| 6 | Display | <p>The AVH icons on the HOME screen are initially lined up next to the Valet-Mode icon. However, in some cases they are placed at the top (upper left corner of the first page) or next to the MAP icon.<br/>(only applicable to HIGH and MID trim)</p> <div data-bbox="602 300 1403 680"> </div> <p>After switching the clock function to AUTO, the CID screen display may become distorted.<br/>(only applicable to HIGH and MID trim)</p> <div data-bbox="841 812 1159 1278"> </div> <p>It may take accessive time to start the CID screen after ignition on.</p> |

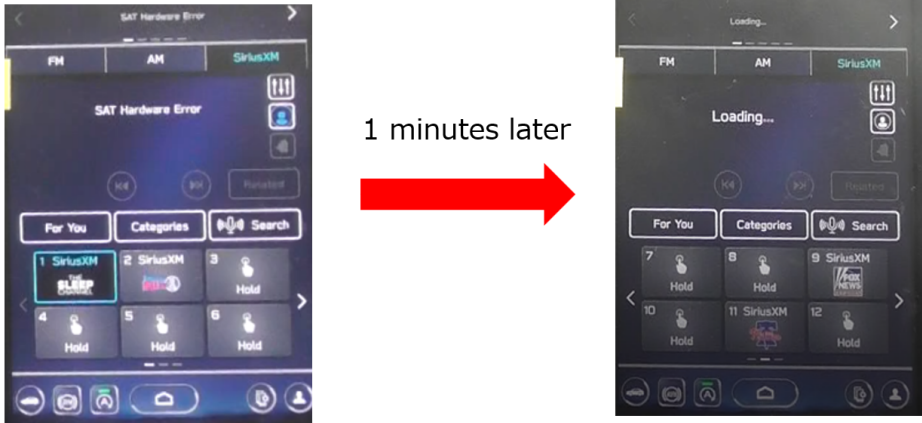
| Number | Category | Symptoms to be Improved: |
|---|---|---|
| 7 | SXM | <p>The first time ignition on after the CCU software update added the SXM360 functionality, the SXM playback screen may remain at “Loading...” after the CCU software update.</p> <div data-bbox="540 1493 1456 1913"> </div> |

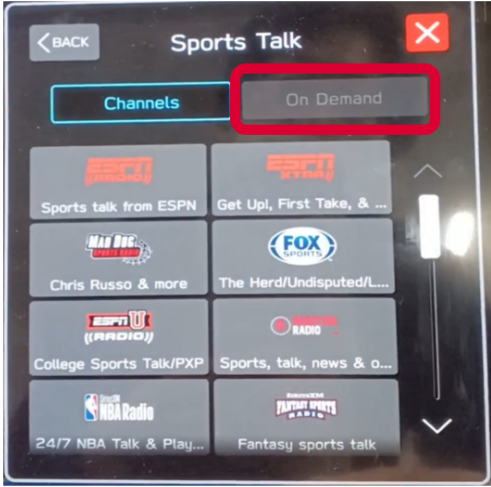
| Number | Category | Symptoms to be Improved: |
|---|---|---|
| 7 | SXM | <p>In the SXM screen, the On Demand button in the upper right corner is grayed out and cannot be operated in the Sports→ Sports Talk screen.<br/>(only applicable to HIGH and MID trim)</p> |

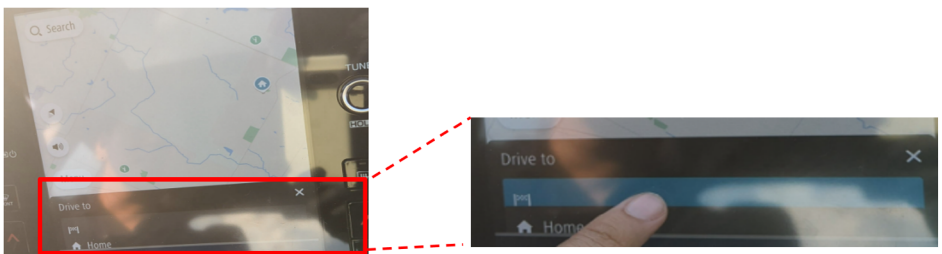
| Number | Category | Symptoms to be Improved: |
|---|---|---|
| | | <p>Three destination suggestion displays in the navigation system are sometimes displayed overlapping each other. Originally, up to three destination suggestions are displayed at the bottom of the screen when the navigation system is started.<br/>(only applicable to HIGH trim)</p> |

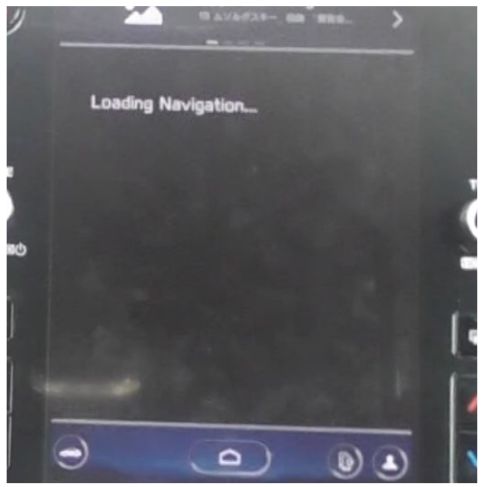
| Number | Category | Symptoms to be Improved: |
|---|---|---|
| 8 | Navi | <p>When turning ignition off and on while the Map screen is displayed, the message ""Loading Navigation..." may remain on the screen, and the Map screen may not be displayed.<br/>(only applicable to HIGH trim)</p> |

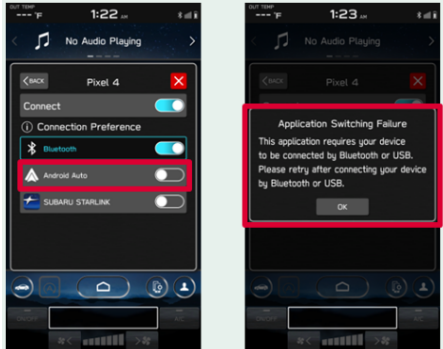
| Number | Category | Symptoms to be Improved: |
|---|---|---|
| | | <p>- When you toggle on Android Auto from the Manage Device screen in CID while the Android device is not connected via USB, there may be a failure to start Wireless Android Auto (not applicable to BASE trim)</p> |

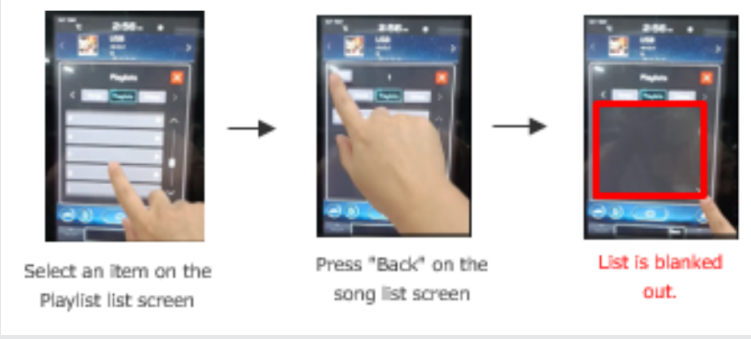
| Number | Category | Symptoms to be Improved: |
|---|---|---|
| 6 | Audio | <p>- When returning to the Playlist List screen by pressing "Back" after selecting a Playlist on page 4 or later in the Playlist List screen, the Playlist List is displayed blank.</p> <p>Select an item on the Playlist list screen → Press "Back" on the song list screen → List is blanked out.</p> |

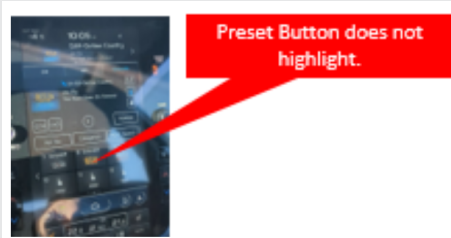
| Number | Category | Symptoms to be Improved: |
|---|---|---|
| 8 | Radio | <p>- When pressing a preset button for a registered radio channel, you can play the channel. But the button you pressed does not highlight, and you cannot operate through presets using the steering wheel controls (not applicable to WRX)</p> <p>- While listening to the radio, the audio suddenly cuts out (not applicable to WRX)</p> <p>- FM / AM radio is not available after turning ignition on</p> <p>- After pressing the radio icon from the HOME screen, FM radio may not have sound</p> <p>- The radio presets are all blank</p> |

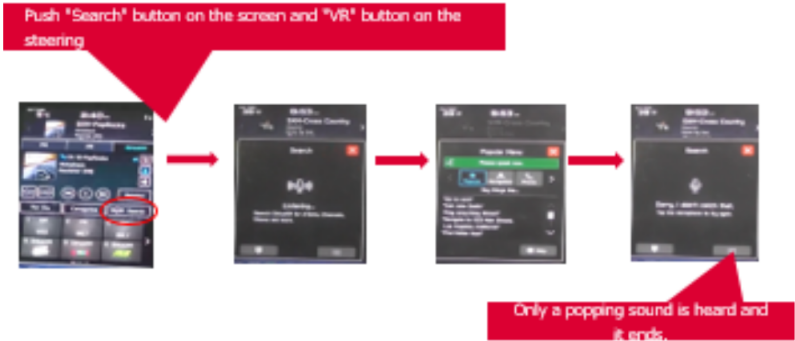
| Number | Category | Symptoms to be Improved: |
|---|---|---|
| | | <p>- The voice recognition function encounters an error and ends, when initiating the SXM Search feature simultaneously with the activation of the CCU unit's voice recognition</p> |

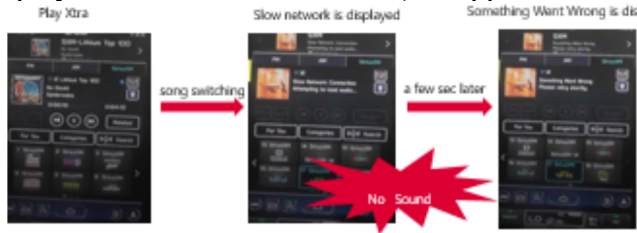
| Number | Category | Symptoms to be Improved: |
|---|---|---|
| 9 | SXM | <p>- SXM sound stops sounding after conditions listed below:</p> <ol style="list-style-type: none"> <li>1. Register FM station A, an SXM sports channel that is not in the middle of a game, and FM station B in the order in which they are listed in the radio presets.</li> <li>2. Use the steering wheel switch to switch from FM station A to FM station B, skipping the SXM sports channel that is not in the middle of a game.</li> <li>3. Just before the playback of FM station B starts, operate the steering switch seek to return to the previous channel.</li> </ol> <p>- While playing SXM's Xtra channel, "Slow Network" --&gt; "Something Went Wrong" is displayed and no sound is heard (not applicable to BASE trim)</p> <p>- When the preset channel on the SXM is pressed, a different channel is selected instead of the registered channel</p> |

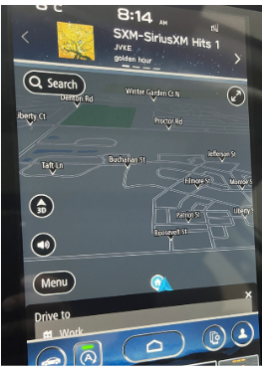
| Number | Category | Symptoms to be Improved: |
|---|---|---|
| | | <p>- In the navigation screen, the bottom of the destination suggestion list's popup screen is cut off and not fully displayed (only applicable to HIGH trim)</p> <p>- Performing the following steps may cause the map scale to change to the default scale instead of the one you've set (only applicable to HIGH trim):</p> <ol style="list-style-type: none"> <li>1. Display the map (with the set scale).</li> <li>2. Ignition off/on.</li> <li>3. Change the map display mode (North-Up → Heading-Up). "</li> </ol> |

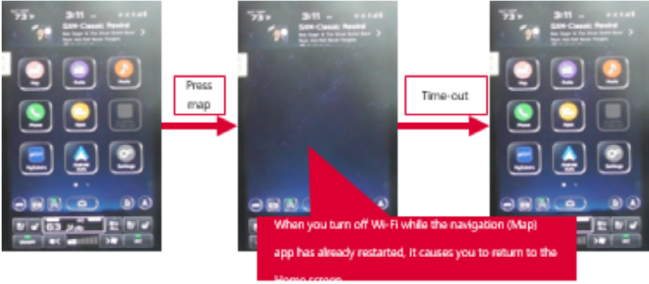
| Number | Category | Symptoms to be Improved: |
|---|---|---|
| 13 | Navi<br>Operation | <p>- During map data updates, if you switch off the Wi-Fi function from the Settings screen pressing the Map icon on the Home screen doesn't display the Map screen for a while (only applicable to HIGH trim)</p> <p>When you turn off Wi-Fi while the navigation (Map) app has already restarted, it causes you to return to the Home screen.</p> |

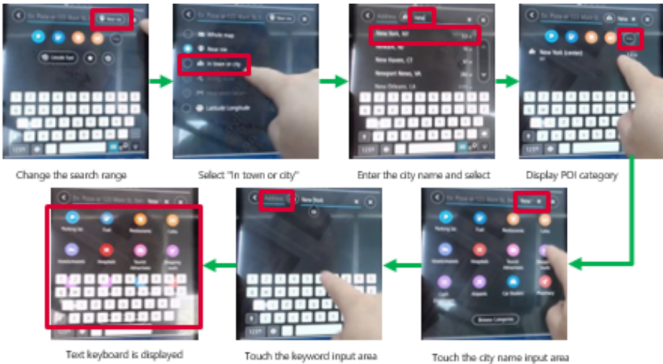
| Number | Category | Symptoms to be Improved: |
|---|---|---|
| | | <p>- The text keyboard which should not be displayed appears on top of the list of POI categories (only applicable to HIGH trim) when performing the steps below:</p> <ol style="list-style-type: none"> <li>1. Narrowing down the search range within a specific city in the navigation destination search.</li> <li>2. Move to the POI category screen.</li> <li>3. Touch the city name input area, then the keyword input area, in that order.</li> </ol> |

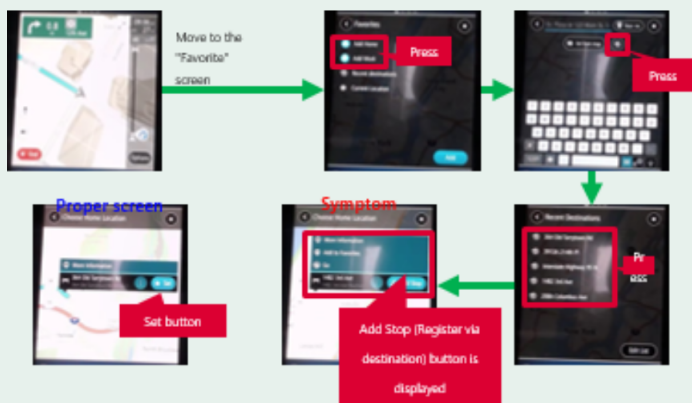
| Number | Category | Symptoms to be Improved: |
|---|---|---|
| | | <p>- Add Stop (Register via destination) button is displayed instead of Set button and Favorite registration for Home/Work cannot be done after performig the steps below moving to the ""Favorite"" screen with the navigation destination set (only applicable to HIGH trim) :</p> <ol style="list-style-type: none"> <li>1. Press Add Home/Work</li> <li>2. Select a location from the Destination History screen</li> </ol> |

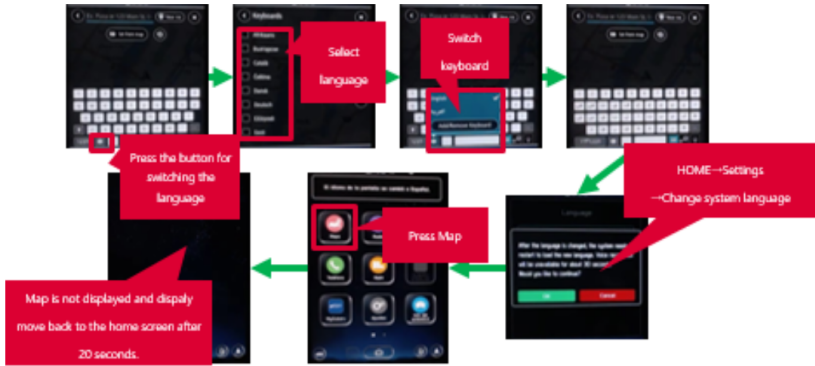
| Number | Category | Symptoms to be Improved: |
|---|---|---|
| | | <p>- Map is not displayed when Map is pressed from the home screen if switch-<br/>ing the language used for the text input keyboard on the search screen of the<br/>navigation application (only applicable to HIGH trim)</p> |

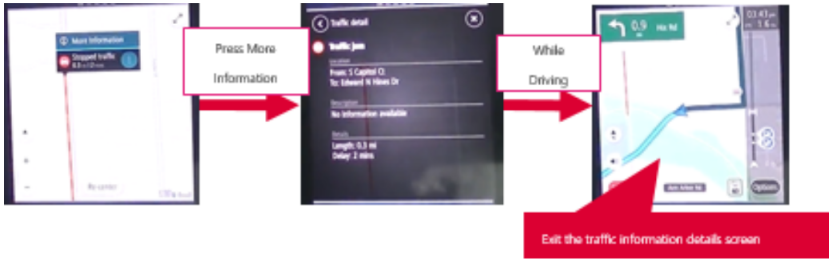
| Number | Category | Symptoms to be Improved: |
|---|---|---|
| | | <p>- While parked or driving, touch the traffic information icon on the map or the traffic information icon on the route bar and display the traffic information details screen. If you start driving with this screen displayed, it will exit the traffic information details screen and transitions back to the map screen (only applicable to HIGH trim)</p> <div style="text-align: center;"> </div> |

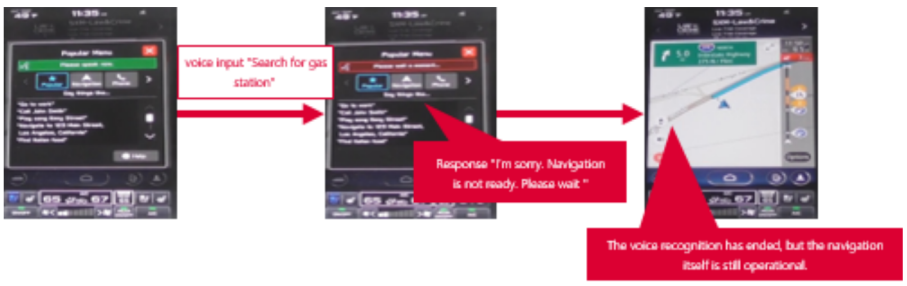
| Number | Category | Symptoms to be Improved: |
|---|---|---|
| | | <p>- When searching for navigation POIs using voice recognition, the response is "Navigation is not ready" and POI search may not start (only applicable to HIGH trim)</p> |

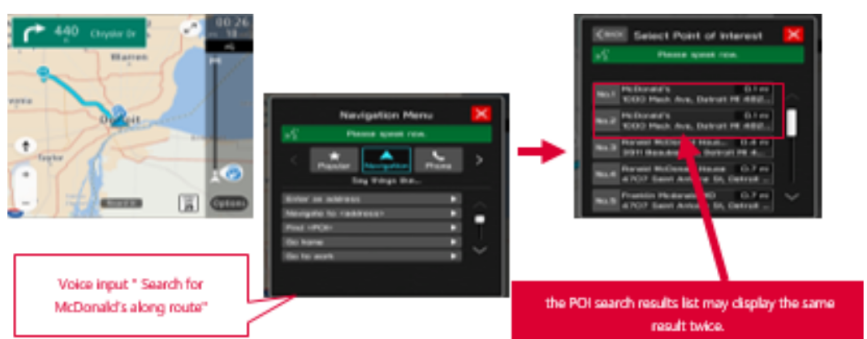
| Number | Category | Symptoms to be Improved: |
|---|---|---|
| 13 | Navi Operation | <p>- When using voice recognition during navigation to say 'Search for **** along route,' the POI search results list may display the same result twice (only applicable to HIGH trim)</p> <p>Voice input "Search for McDonald's along route"</p> <p>the POI search results list may display the same result twice.</p> |

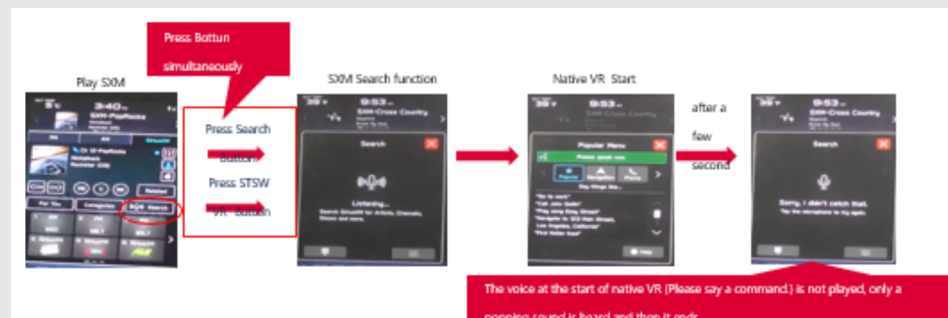
| Number | Category | Symptoms to be Improved: |
|---|---|---|
| 16 | Voice Recognition | <p>- After setting a route in the navigation system and activating voice recognition function, the route guidance is not canceled even "Cancel Route" or "Delete Destination" is completed (only applicable to HIGH trim)</p> <p>- When you say ""Call *****" using voice recognition, the meter display shows "Please wait a moment," but the call cannot be made (not applicable to WRX)<br/>(Note: "*****" indicates an actual phone number or contact name you are trying to call)</p> <p>- Starting the CCU (Cockpit Control Unit) voice recognition while using the SXM Voice Search function results in an error and ends the voice recognition (not applicable to BASE trim)</p> <p>Press Bottom simultaneously</p> <p>Press Search</p> <p>Press STSW</p> <p>Press Bottom</p> <p>Play SXM</p> <p>SXM Search function</p> <p>Native VR Start</p> <p>after a few seconds</p> <p>The voice at the start of native VR (Please say a command) is not played, only a popping sound is heard and then it ends.</p> <p>- When operating the navigation system via voice recognition, certain regional place names (states, cities, etc.) are not recognized (only applicable to HIGH trim)</p> |

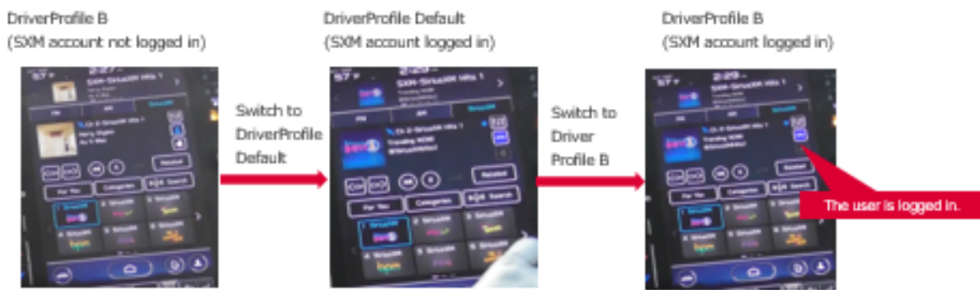
| Number | Category | Symptoms to be Improved: |
|---|---|---|
| | | - Switching the Driver Profile user causes the user to be logged into SXM even though he/she was not logged into the SXM account as the user after the switch |

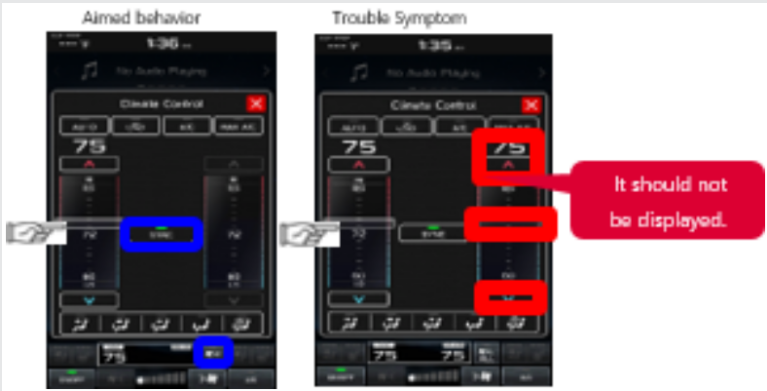
| Number | Category | Symptoms to be Improved: |
|---|---|---|
| 24 | Air Conditioner | <p>- With the air conditioning SYNC enabled and the single-seat focus set to the driver's seat tapping the temperature adjustment bar on the driver's side unexpectedly displays the temperature adjustment bar for the passenger's side, which should not be displayed (only applicable to BASE trim)</p> |

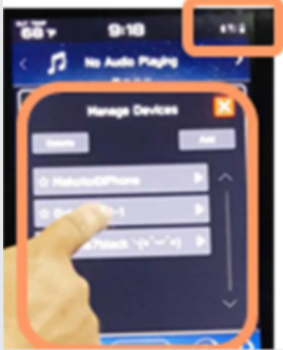
| Number | Symptoms to be Improved: |
|---|---|
| 7 | Bluetooth connection is disabled with a discrepancy in the display of status bar (showing Bluetooth devices being connected) and the “Manage Devices” screen (showing no Bluetooth devices being connected.)<br> |

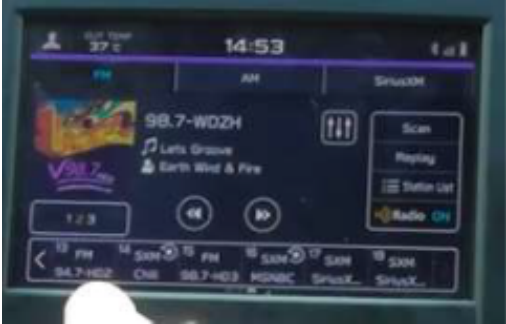
| Number | Symptoms to be Improved: |
|---|---|
| 12 | Sound is lost when changed to Subchannel 2 right after a preset HD radio channel has been selected.<br> |

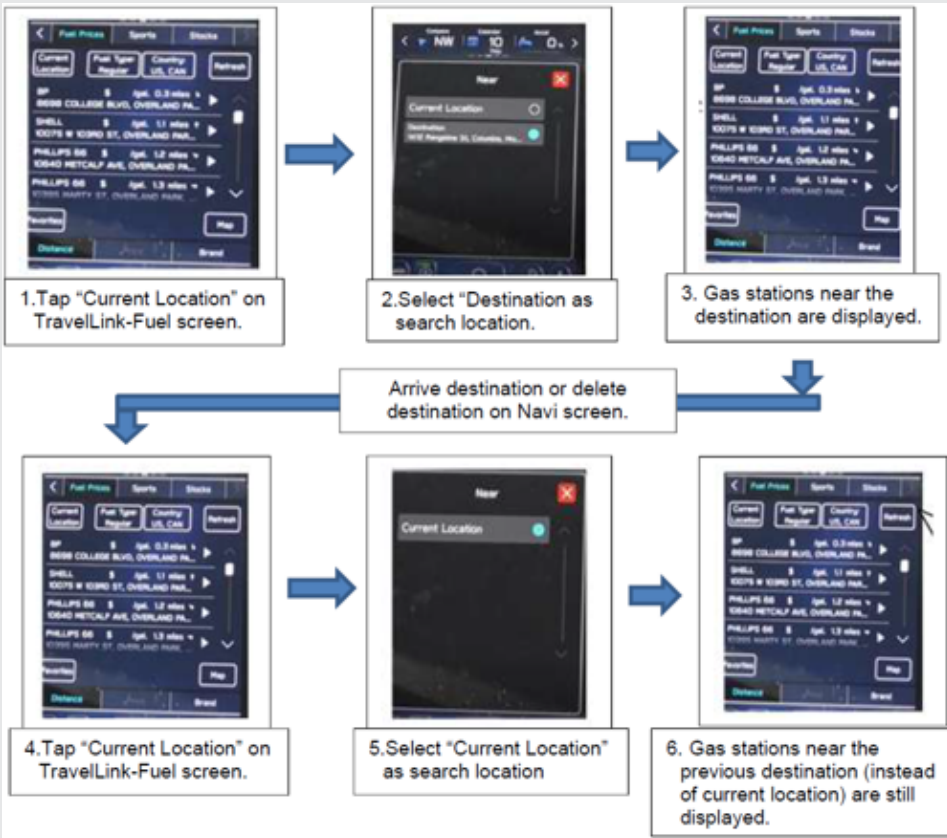
| Number | Symptoms to be Improved: |
|---|---|
| 17 | <p>A wrong search location is used on TravelLink function.<br/>Example of the symptom.</p> |

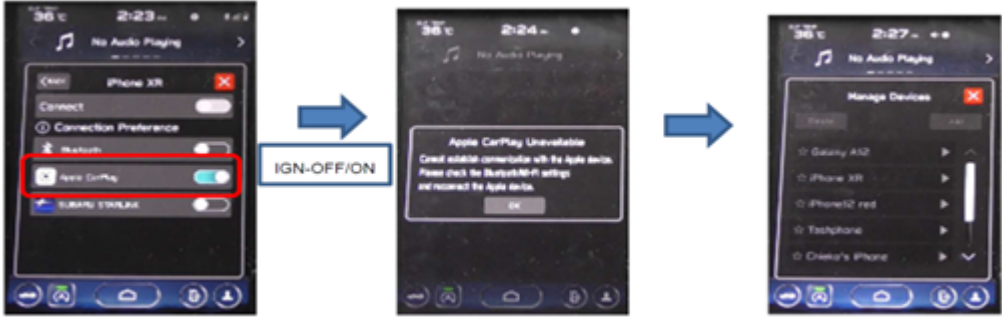
| Number | Symptoms to be Improved: |
|---|---|
| 7 | <p>Manage Device Screen becomes dark and inoperative when Ignition Switch is turned Off and On while starting CarPlay by CID operation.</p> |

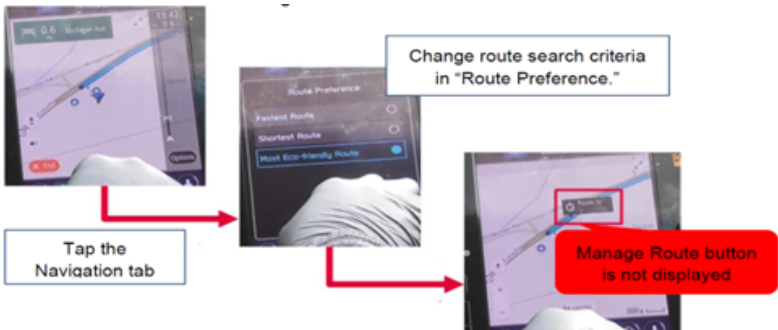
| Number | Symptoms to be Improved: |
|---|---|
| 11 | <p>“Manage Route” button is not displayed when touching the route line on Navigation system, when the route search criteria got changed in the Route Preference Screen after a route had been searched.</p> |

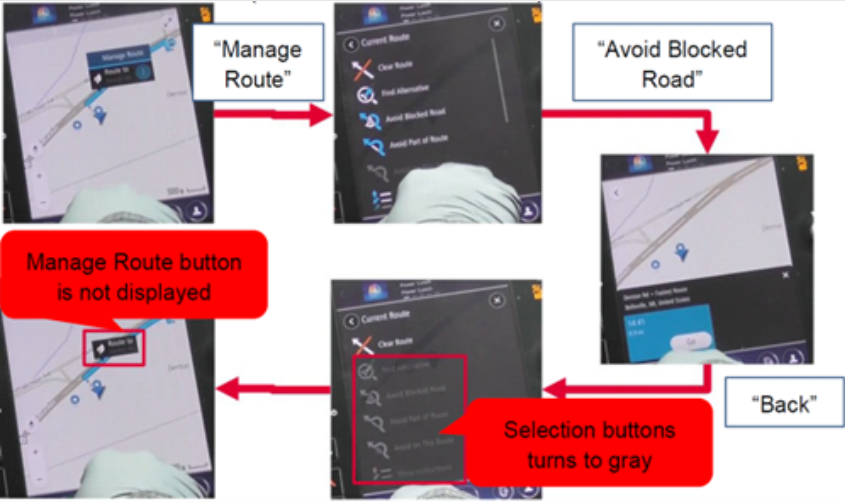
| Number | Symptoms to be Improved: |
|---|---|
| 12 | <p>“Manage Route” button is not displayed and buttons on the Current Route Screen become unselectable (turns to grayish fill) when the Navigation system is operated in the sequence of “Manage Route” &gt; “Avoid Blocked Road” (in the Current Route Screen) &gt; “Back.”</p> |
