## SERVICE INFORMATION BULLETIN

**APPLICABILITY:** 2018-23MY Legacy and Outback  
 2017-23MY Impreza  
 2018-23MY Crosstrek  
 2019-23MY Forester  
 2019-23MY Ascent

**NUMBER:** 16-132-20R

**SUBJECT:** Diagnostic Information for Alleged Chain Slip Condition  
 on TR580 / TR690 Transmissions

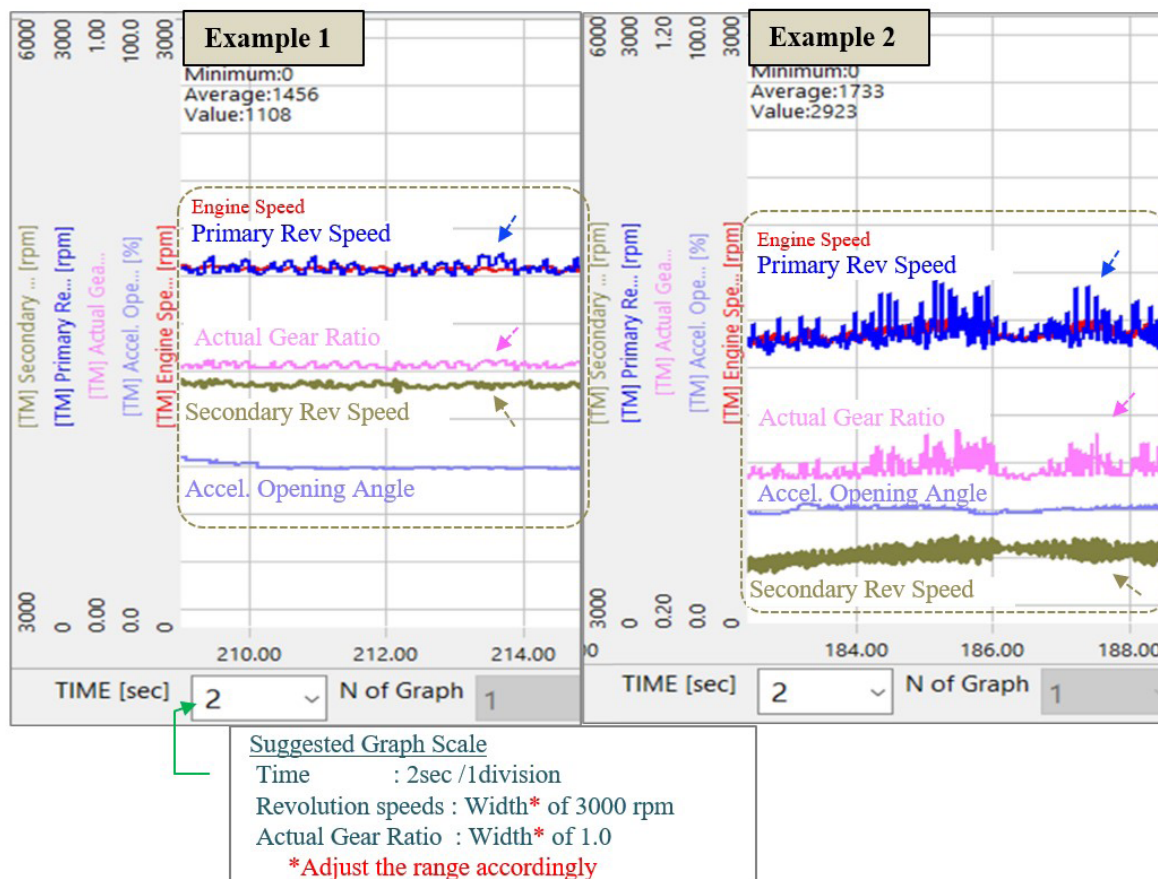
#### 1. Continuous Micro-Slip:

During a continuous micro-slip, while the Accelerator Opening Angle monitor displays a stable value for more than one second, there are fluctuations in the Actual Gear Ratio monitor:

**Peak to Peak > 0.02**

**Frequency > 3 cycles per 1 second**

There are fluctuations in the Primary Rev Speed and/or Secondary Rev Speed monitor:

**Peak to Peak > 50 rpm**

Below are two examples of the data monitoring during Continuous Micro-Slip

Using Subaru Select Monitor (SSM), check and record data monitors and compare to the three examples listed below. If the recorded data from the vehicle matches the examples below, the CVT will require replacement. The SSM data will be required for claim submission. A QMR containing the same information will also be required.

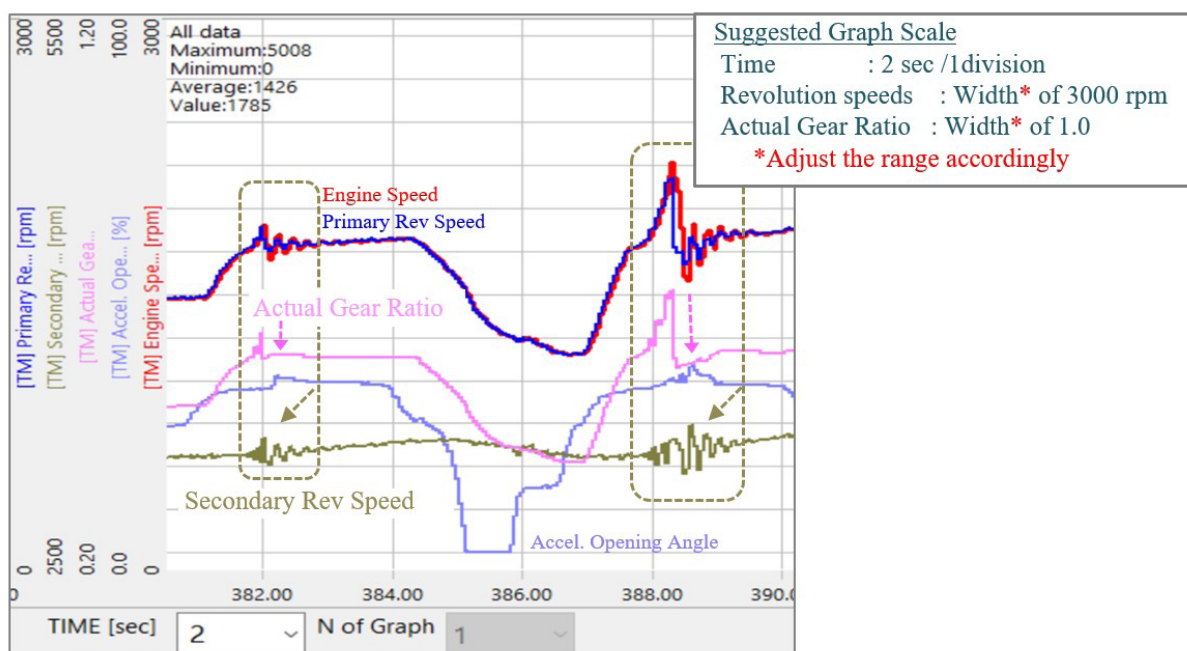
## 2. Short-Time Slip:

When a short-time slip occurs, the changes in the Actual Gear Ratio monitor will be larger than 0.1 per 0.1 second. After the Actual Gear Ratio monitor resumes to stable conditions, distinct fluctuations in revolution speed continues.

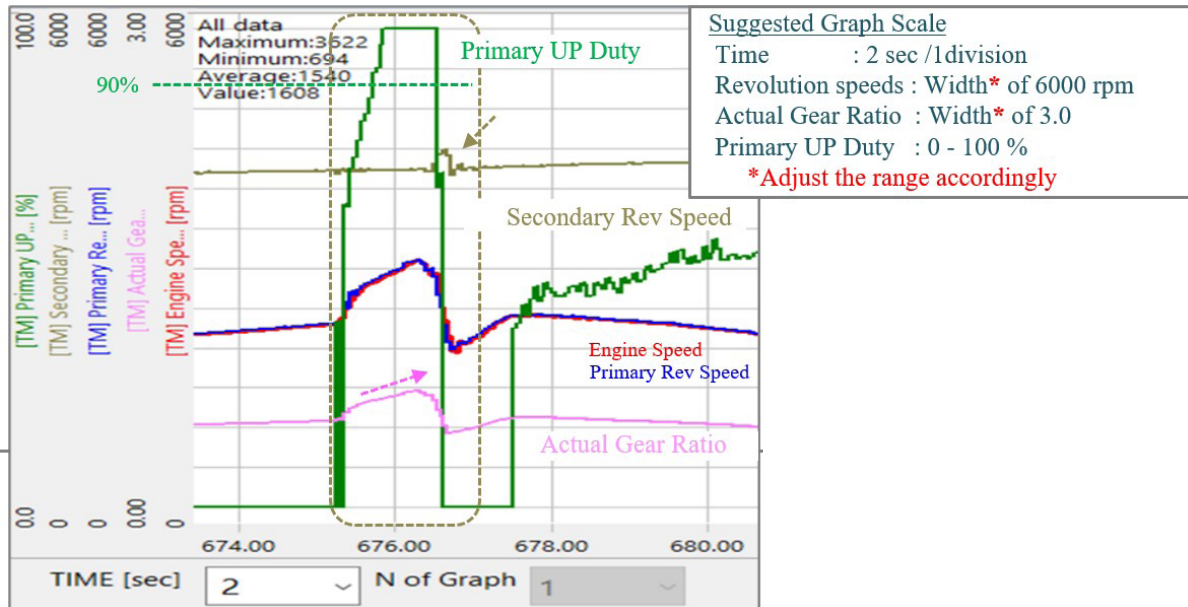
### 3. Long-Time Slip:

When a long-time slip occurs, the Primary UP Duty monitor will be larger than 90% and the Actual Pulley Ratio monitor lowers for a duration of 0.5 seconds or more. Even after the Actual Gear Ratio monitor resumes to stable conditions, distinct fluctuations in revolution speed continues.

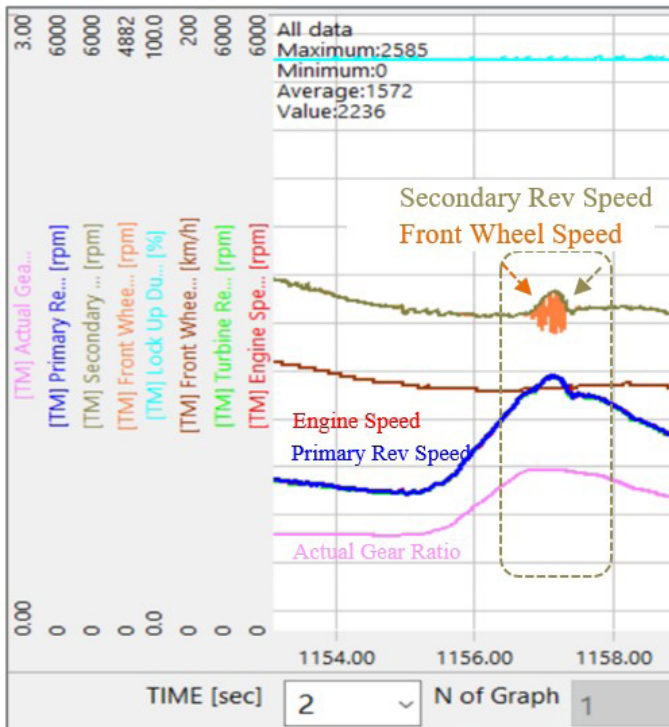
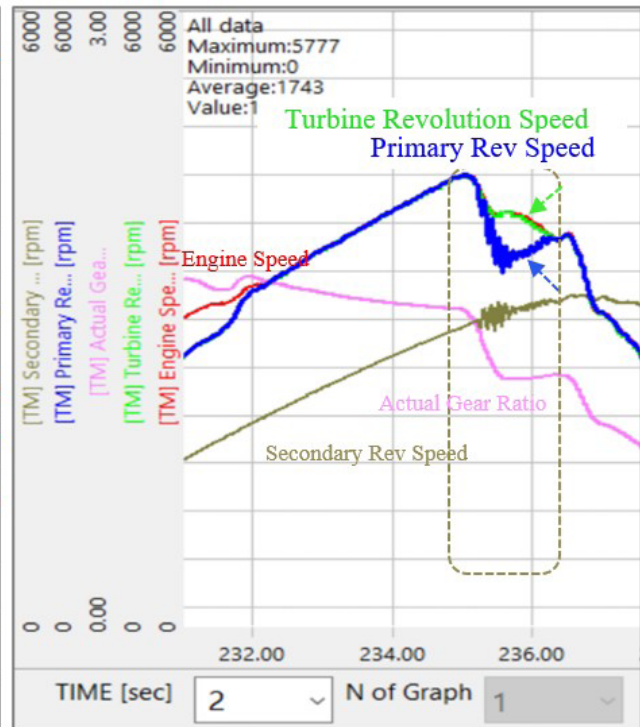
#### 1. Forward Clutch Slip Shock:

This shock can occur when the forward clutch slips. If this situation is reported, reprogram the TCM with new software if it is available.

The rotation speeds for the upstream and downstream sides of the forward clutch do not synchronize when driving.

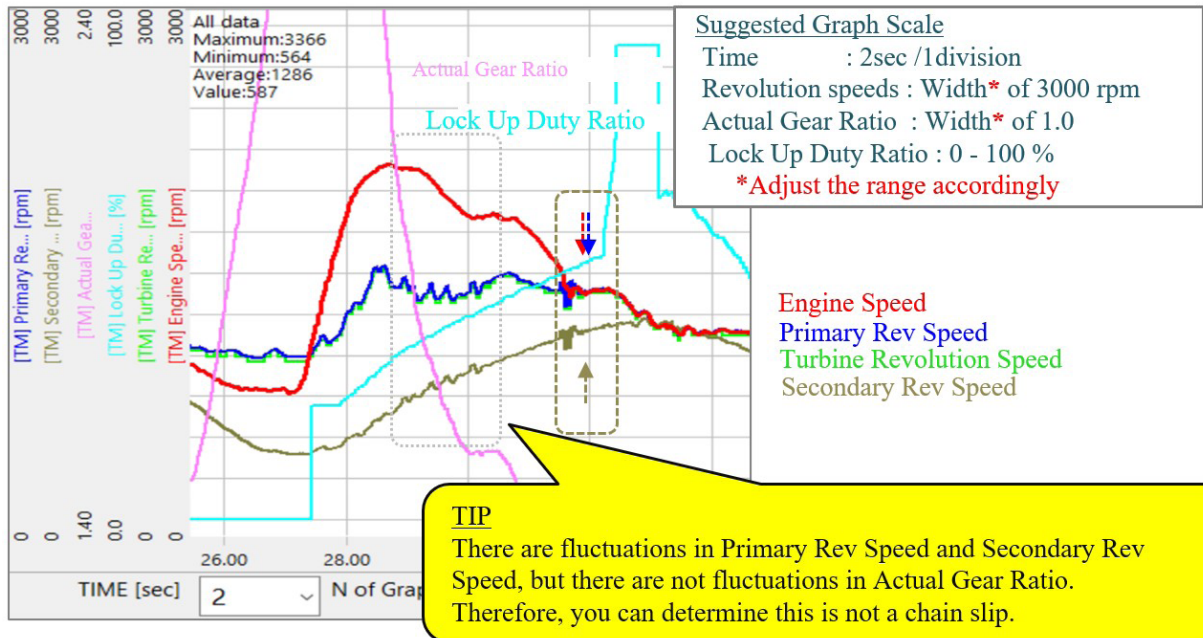
## 2. Lock Up Clutch Engagement Shock:

This shock can occur when the lock up clutch engages rapidly. If this situation is reported, reprogram the TCM with new software if it is available.

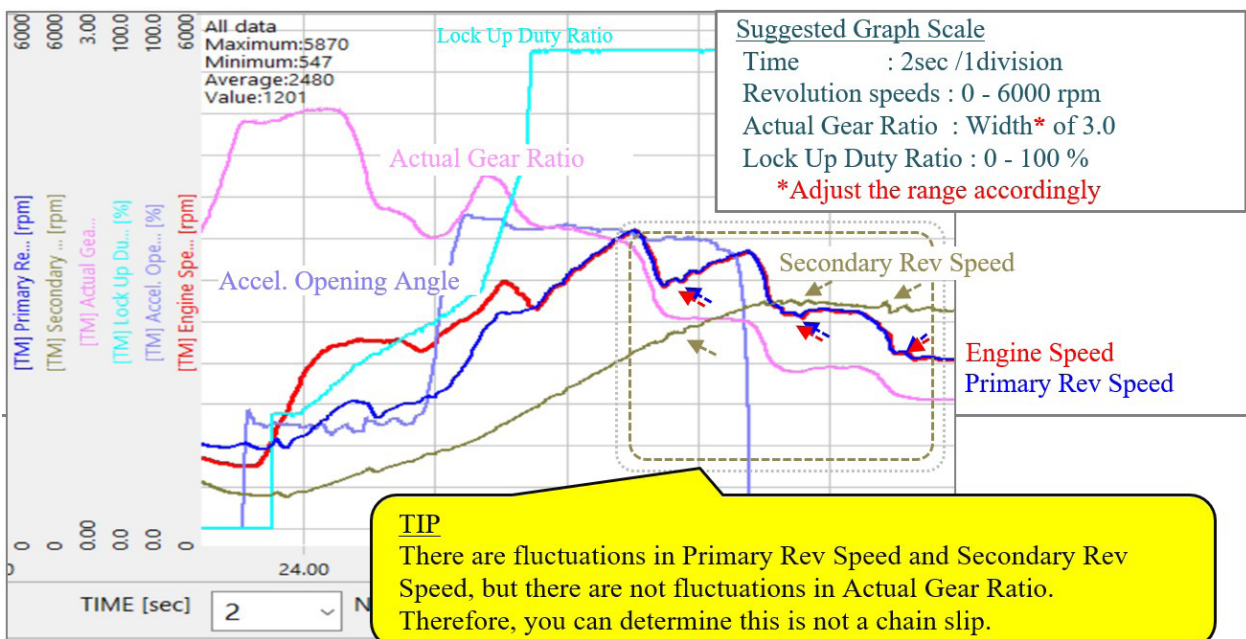
## 3. Shift Up Shock:

This shock can occur when the CVT upshifts. If this situation is reported, reprogram the TCM with new software if it is available. If there is no new software available or the reprogramming does not remedy the issue, report the situation to Techline.

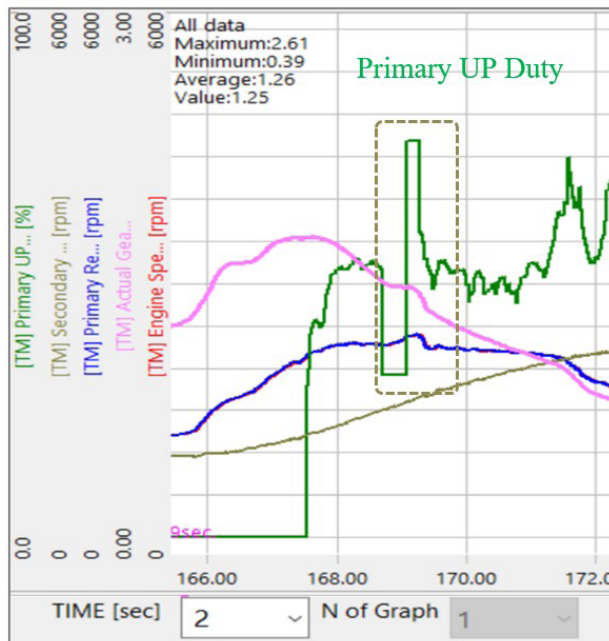
#### 4. Primary Up Duty Square Control (Ascent Models up to 2021MY):

A harsh shift can be felt while driving. If this situation is reported, reprogram the TCM with new software if it is available. If there is no new software available or the reprogramming does not remedy the issue, report the situation to Techline.
