## SERVICE BULLETIN

**APPLICABILITY:** 2020-24MY Legacy 2.4L  
 2020-24MY Outback 2.4L  
 2019-24MY Ascent  
 2022-24MY WRX  
 2022-25MY Outback Wilderness

**NUMBER:** 16-150-24R

**SUBJECT:** Transmission Control Module (TCM) /  
 Software Enhancement

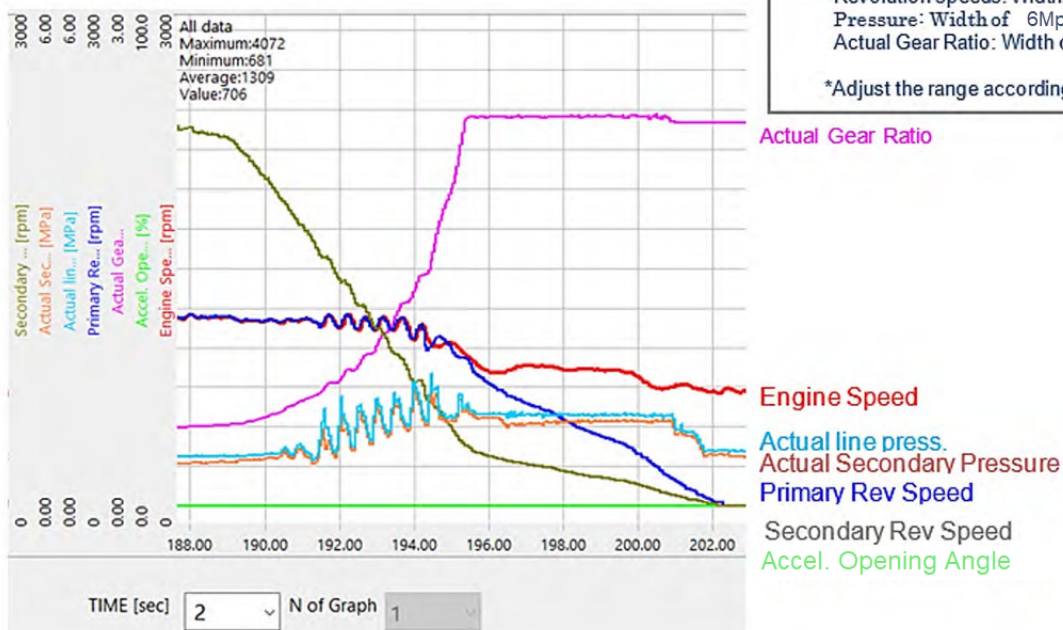
Sample Graph for Shudder when slowing down

#### Reference: Judgement Criteria

Actual line press. and Actual Secondary Pressure are fluctuating while feeling shudder when slowing down

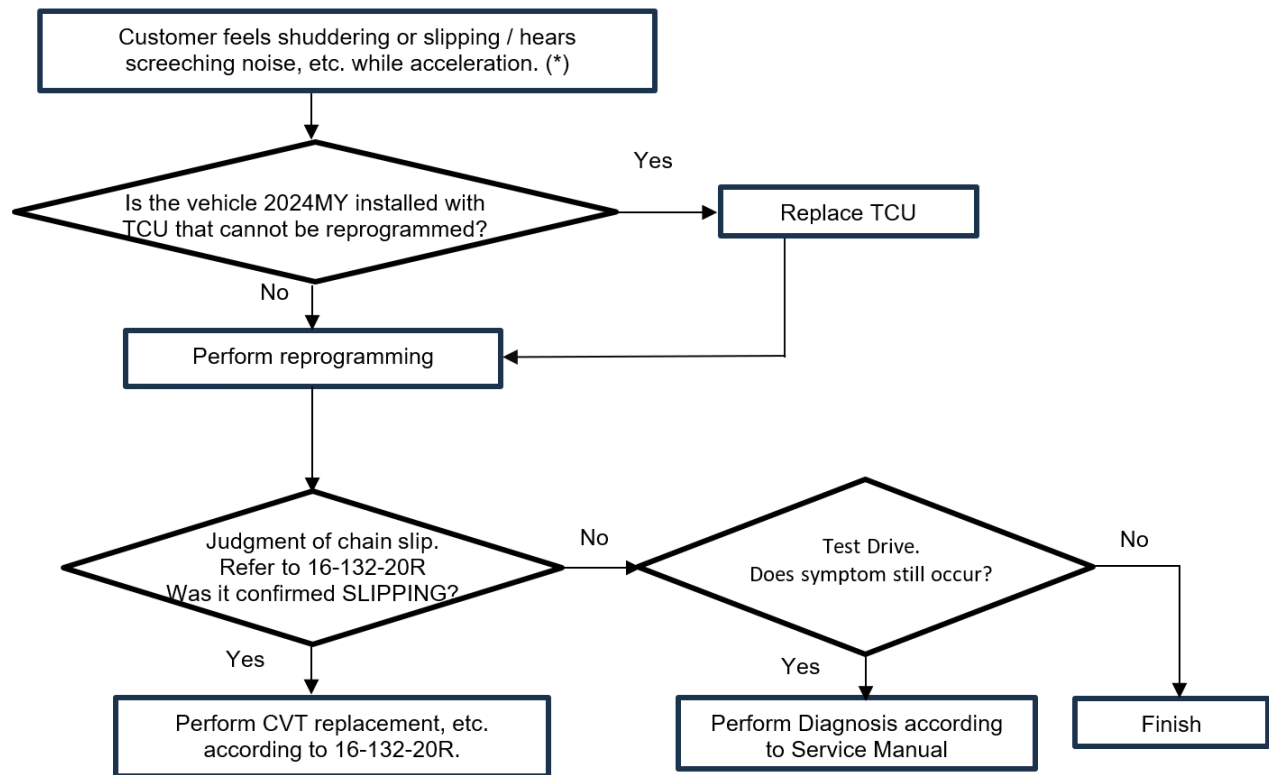
## SYMPTOM 2:

(\*) **NOTE:** In case of chain slip caused by input clutch slip, customers may experience symptoms under the following driving conditions.

- (1) Constant speed driving between 25 and 62 mph.
- (2) Gentle acceleration between 25 and 62 mph.

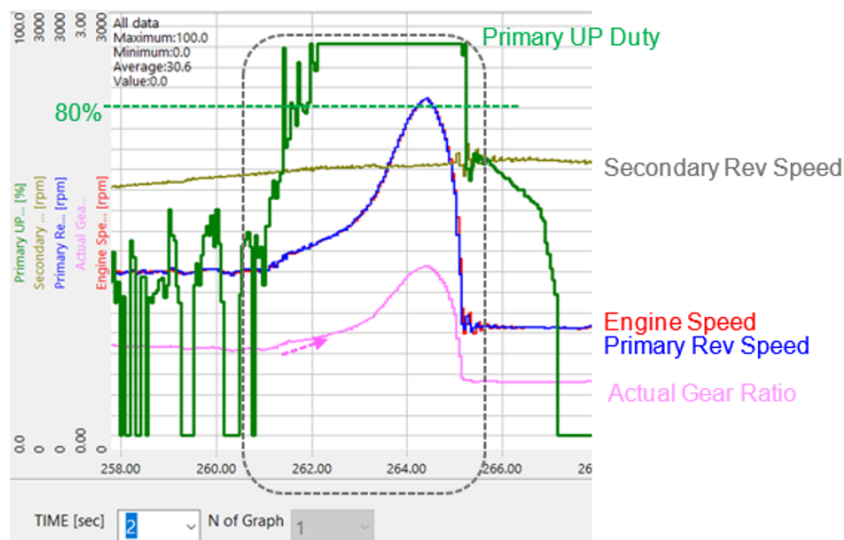
Sample Graph for Input Clutch Slip

### Reference: Judgement Criteria

All of the following are satisfied.

- Primary UP Duty > 80 %
- Actual Pulley Ratio changes to Low
- Above conditions last for 0.5sec or more
