## SERVICE BULLETIN

**APPLICABILITY:** 2012-23MY Impreza  
 2013-19MY Crosstrek 2.0L  
 2014-23MY Forester 2.5(excluding Wilderness)  
 2013-19MY Legacy & Outback 2.5L

**NUMBER:** 16-156-25R  
**DATE:** 09/15/25  
**REVISED:** 08/20/26

**SUBJECT:** CVT Control Valve Body Design  
 Change / P2757, P2762, P06EF, & Shudder

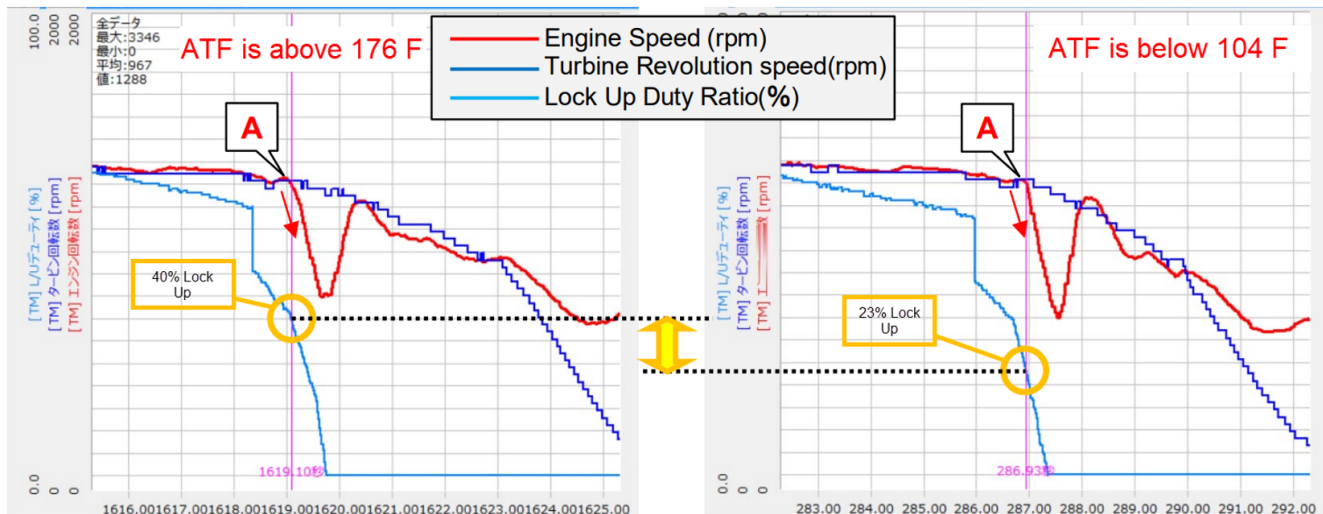
the graph (see example graphs below). At these points, determine whether there is a 10% or greater difference in the Lock-Up Duty Ratio (%) between the data recorded at 176°F and 104°F, specifically when the torque converter clutch is released.

NOTE: ‘A’ indicates a point where a difference occurs between the engine speed and the turbine revolution speed, marking the moment when the lock-up clutch is disengaged.

Example: 40%-23%=17%

Note: To determine the difference of Lock-Up duty Ratio Subtract the Lock-Up Duty Ratio when ATF temperature is below 104°F from the Lock-Up Duty Ratio when ATF temperature is above 176°F.

**Yes** – Replace the valve body and go to step 7.
