**SUBARU**

## SERVICE BULLETIN

**NUMBER:** 02-196-26R

**SUBJECT:** White Exhaust Smoke /  
Diagnostic and Repair Procedure

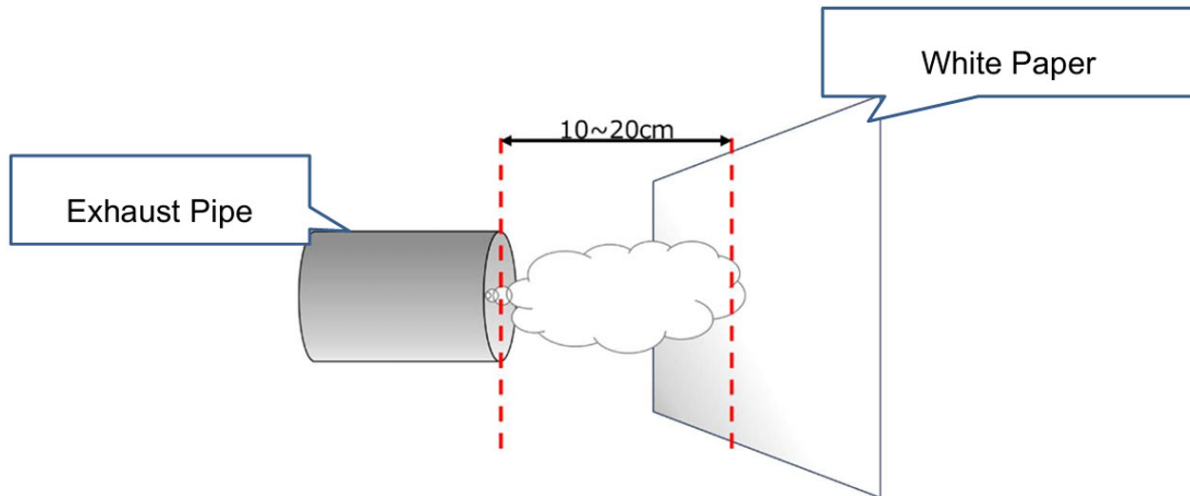
**Step 2:** Determine whether white smoke or vapor is being emitted from the exhaust. Mount a paper towel 4-8 inches (10-20cm) from the exhaust. Start the engine and let it idle for 30 seconds. Turn the engine off and wait for the paper towel to dry.

If yellow or brown stains appear on the paper towel, continue to the next diagnostic step. If no stains are present on the paper towel, only vapor was emitted from the tailpipe.

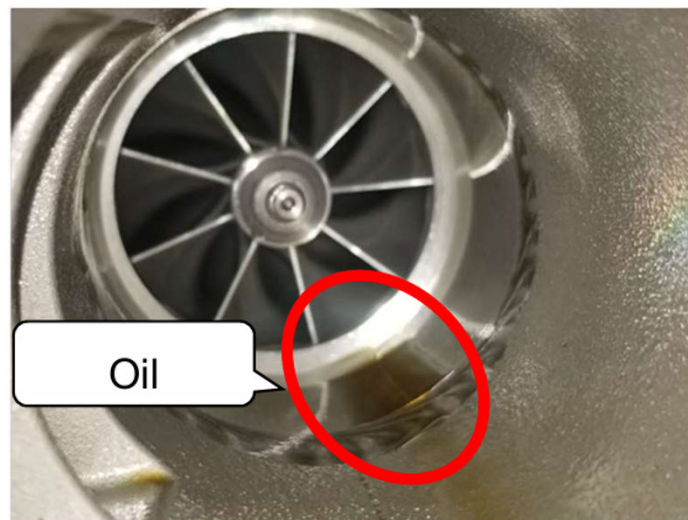
**Step 4:** Check the turbo inlet for oil. See examples below:

If oil is found, proceed to **Step 6**.

If no oil is found, proceed to **Step 5**.

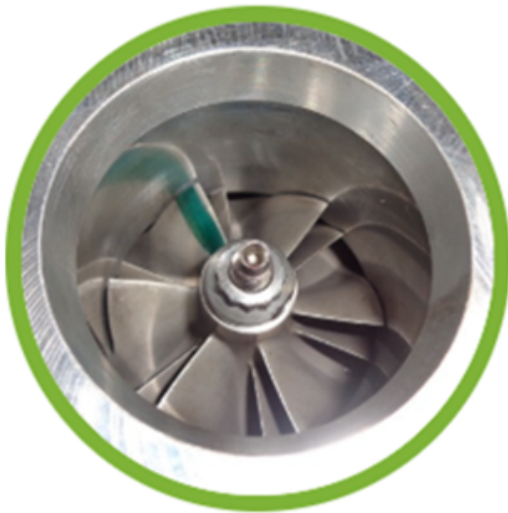
No damage to turbo fins

If no damage to the turbo is found, contact Techline via TechShare and provide the following items:

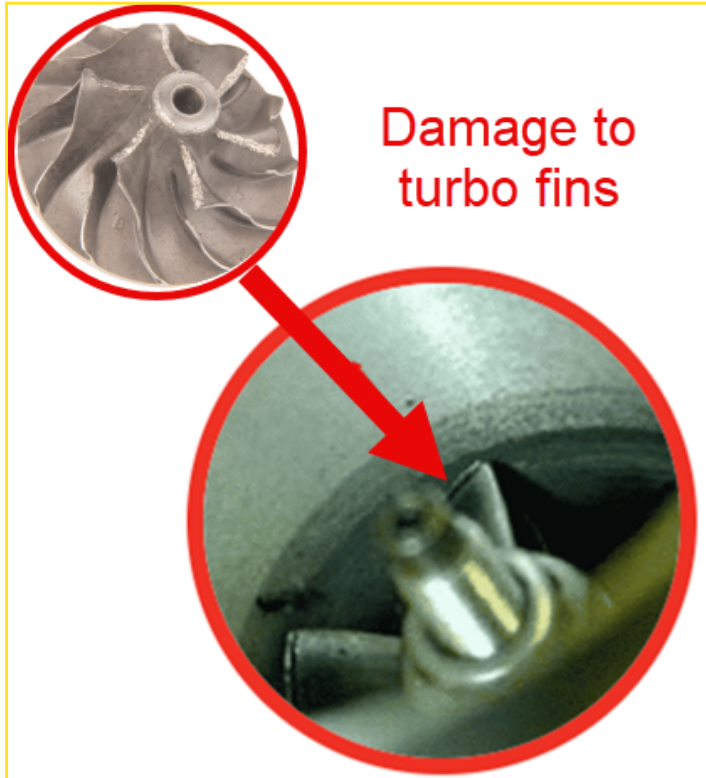
Damage to  
turbo fins

If the turbo fins have damaged, replace the turbo charger assembly.

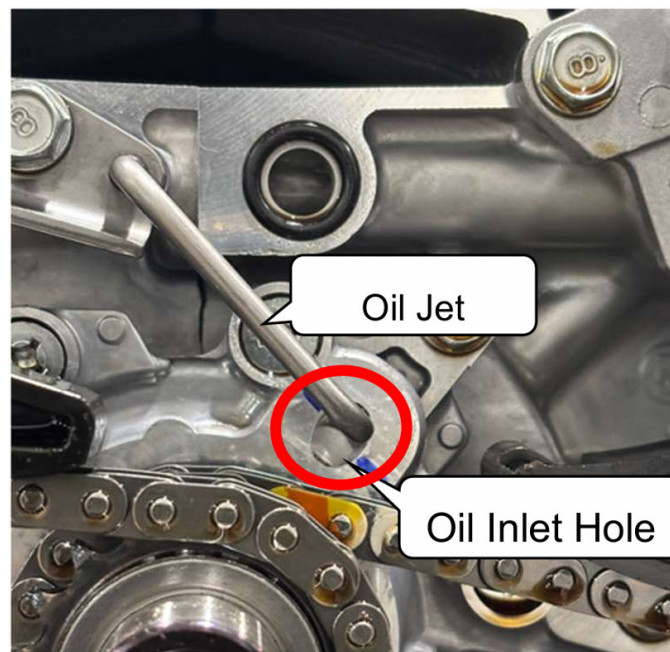
**Step 6:** Remove the timing cover and inspect the oil jet alignment.

If the oil jet is directed at the lower half of the oil inlet hole, loosen the bolt securing the oil jet and adjust it so it is directed toward the upper half of the scavenge pump oil inlet, as shown below. Torque the jet bolt while supporting the jet tip in the correct position. Replace the timing cover and any one-time-use parts with new ones.

If the oil jet is already directed toward the upper half of the scavenge pump oil inlet, replace the scavenge pump and timing cover, along with any one-time-use parts.

**CAUTION: Do not bend the oil jet, as this will cause damage.**

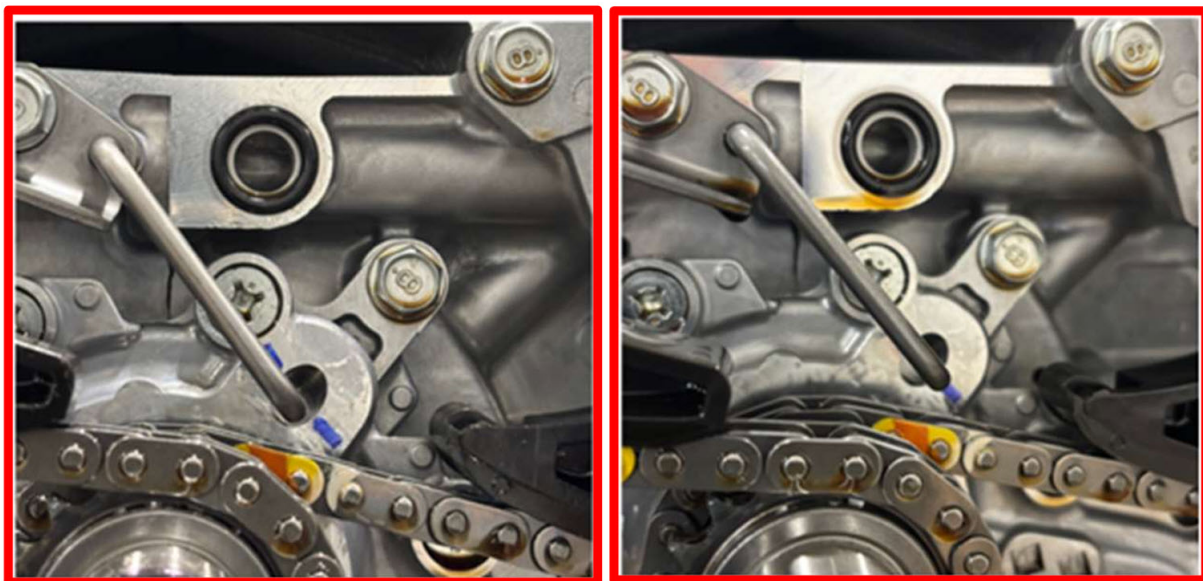
**Examples of misaligned jets:**

**Note:** If replacement of the scavenging pump is necessary, ensure the oil jet remains directed at the upper half of the scavenging pump. Failure to do so will cause white smoke.
