## SERVICE BULLETIN

**APPLICABILITY:** 2018-25 Legacy 2.5L  
 2018+ Outback 2.5L  
 2017+ Impreza  
 2018+ Crosstrek(Non-Hybrid)  
 2019+ Forester(Non-Hybrid)

**NUMBER:** 16-158-26

**SUBJECT:** TR580 Chain Slip Judder, Shudder,  
 & Hesitation Concerns

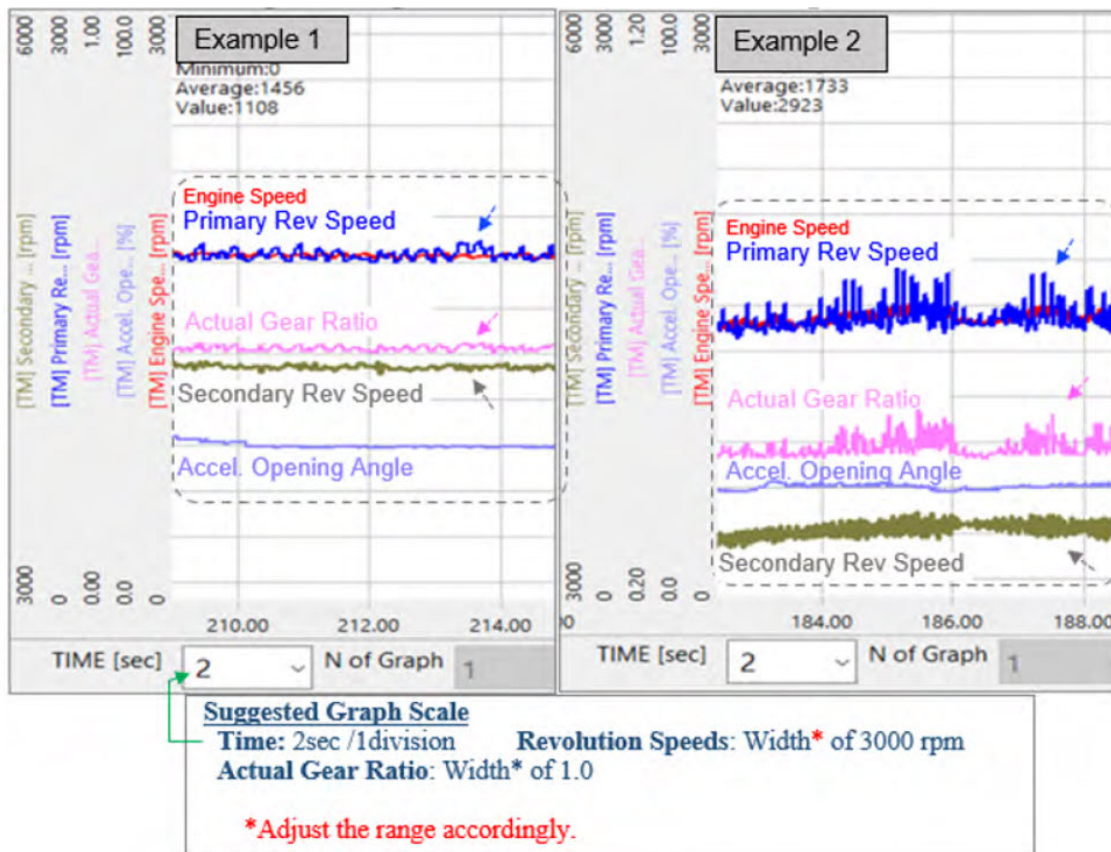
#### 1. Continuous Micro-Slip

During a continuous micro-slip, while the Accelerator Opening Angle monitor displays a stable value for more than one second, there are fluctuations in the Actual Gear Ratio monitor:

**Peak to Peak > 0.02      Frequency > 2 cycles per 1 second**

There are fluctuations in the Primary Rev Speed and/or Secondary Rev Speed monitor:

**Peak to Peak > 50 rpm      Frequency > 3 cycles per 1 second**

Using Subaru Select Monitor (SSM), check and record data monitors and compare them to the three examples listed below. If the recorded data from the vehicle matches the examples below, the CVT will require replacement. The SSM data will be required for claim submission. A QMR containing the same information will also be required.

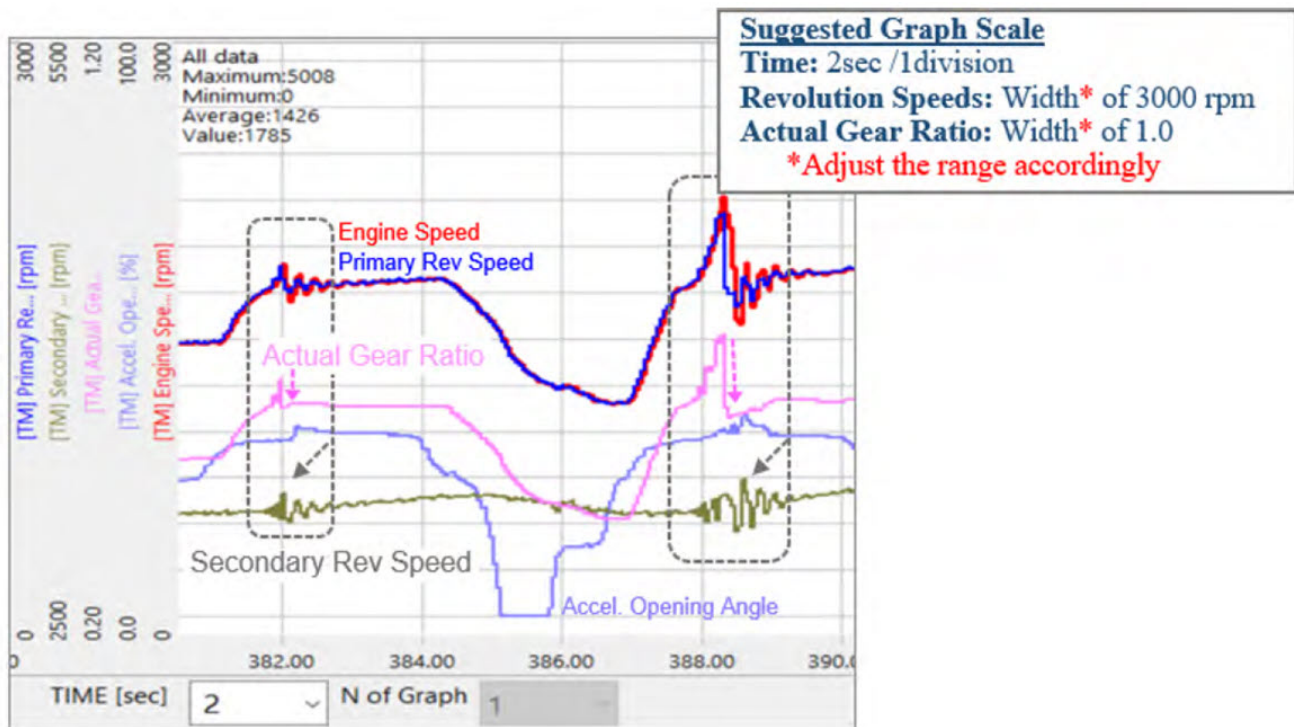
## 2. Short-Time Slip

When a short-time slip occurs, the changes in the Actual Gear Ratio monitor will be larger than 0.1 per 0.1 second. After the Actual Gear Ratio monitor resumes to stable conditions, distinct fluctuations in revolution speed continue.

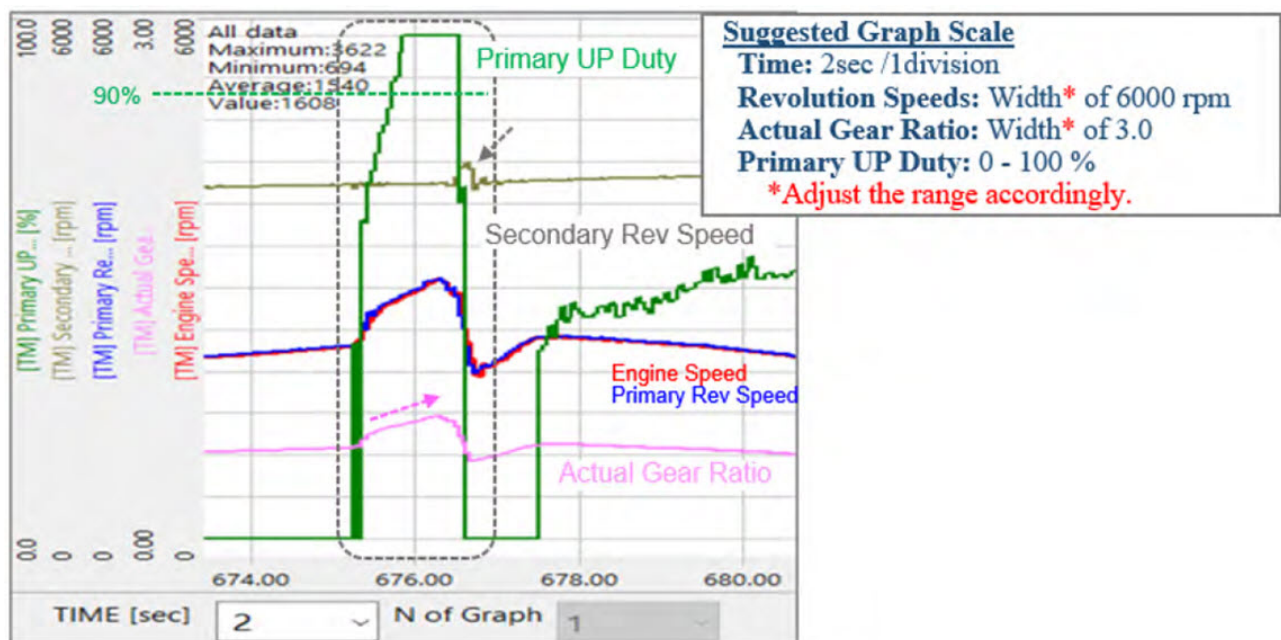
## 3. Long-Time Slip

When a long-time slip occurs, the Primary UP Duty monitor will be larger than 90% and the Actual Pulley Ratio monitor lowers for a duration of 0.5 seconds or more. Even after the Actual Gear Ratio monitor resumes to stable conditions, distinct fluctuations in revolution speed continues.

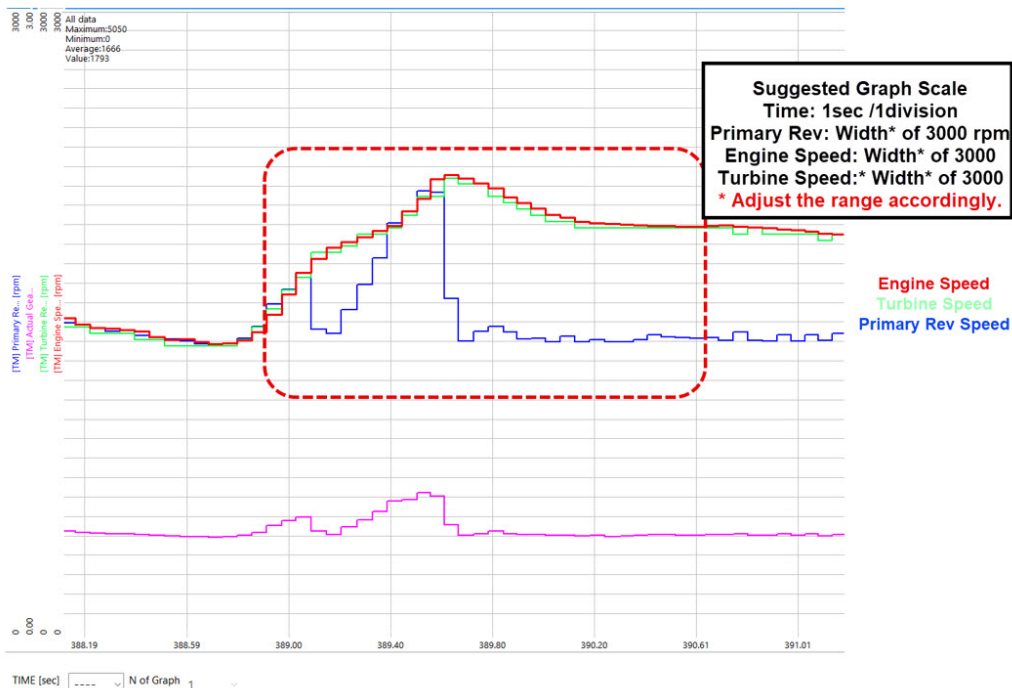
#### 1. Forward Clutch Slip Shock

The rotation speeds for the upstream and downstream sides of the forward clutch do not synchronize when driving.

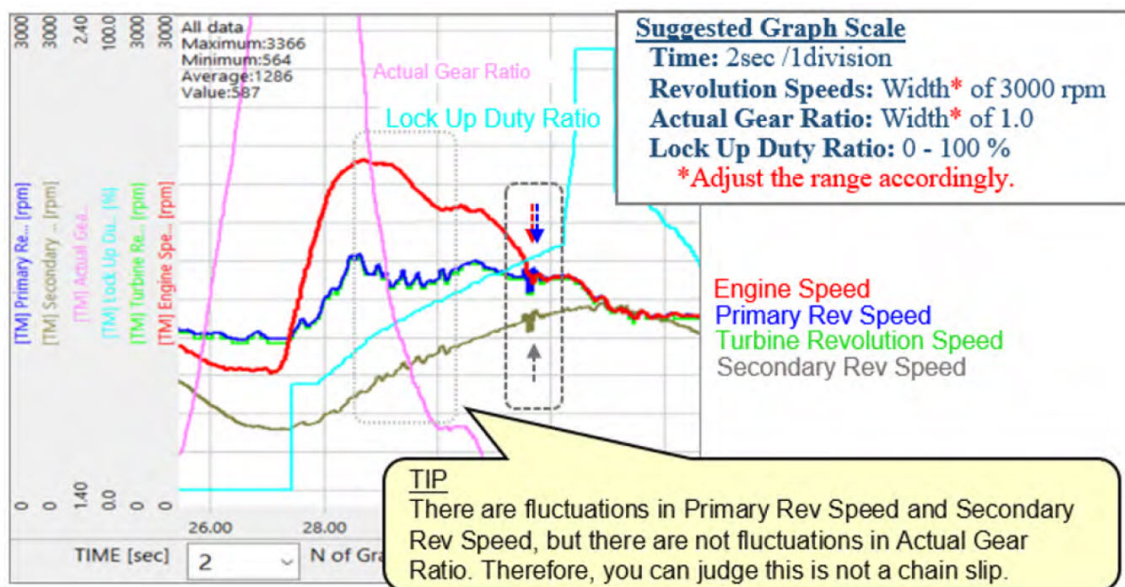
#### 2. Lock Up Clutch Engagement Shock:

This shock can occur when the lock up engages rapidly. If this situation is reported, reprogram the TCM with the newest software available.

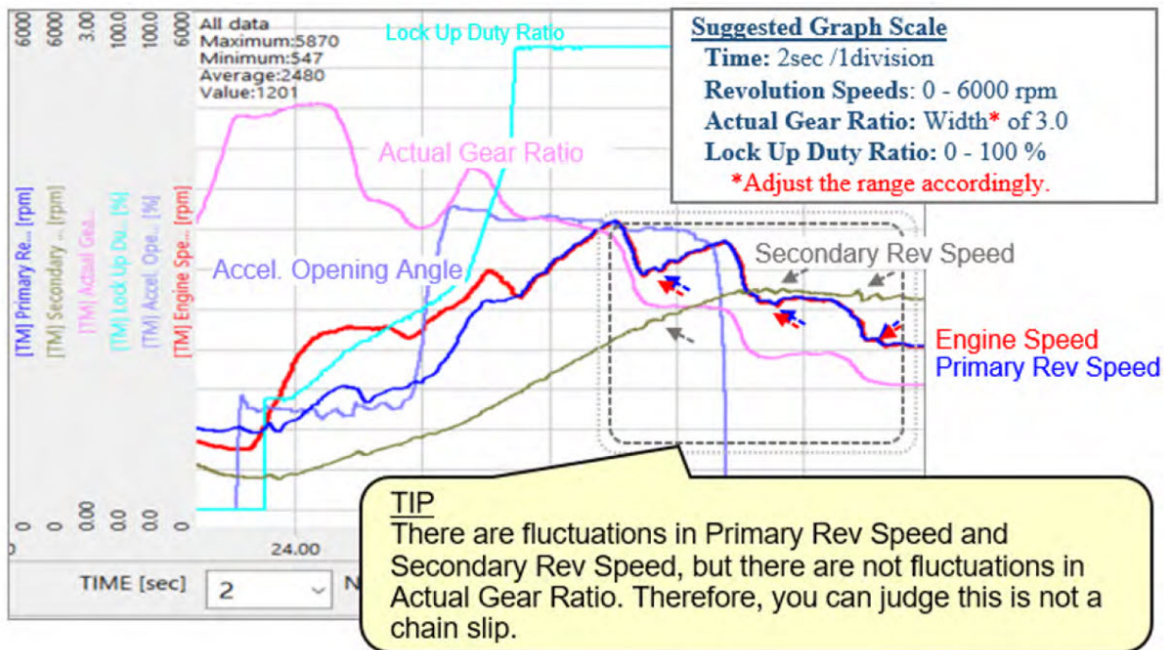
### 3. Shift Up Shock:

This shock can occur when the CVT upshifts. If this situation is reported, reprogram the TCM with new software if it is available. If there is no new software available or the reprogramming does not remedy the issue, report the situation to Techline.
