## SERVICE BULLETIN

**APPLICABILITY:** 2024MY Crosstrek

**NUMBER:** 12-264-26

**SUBJECT:** Front Fender Garnish Design Change

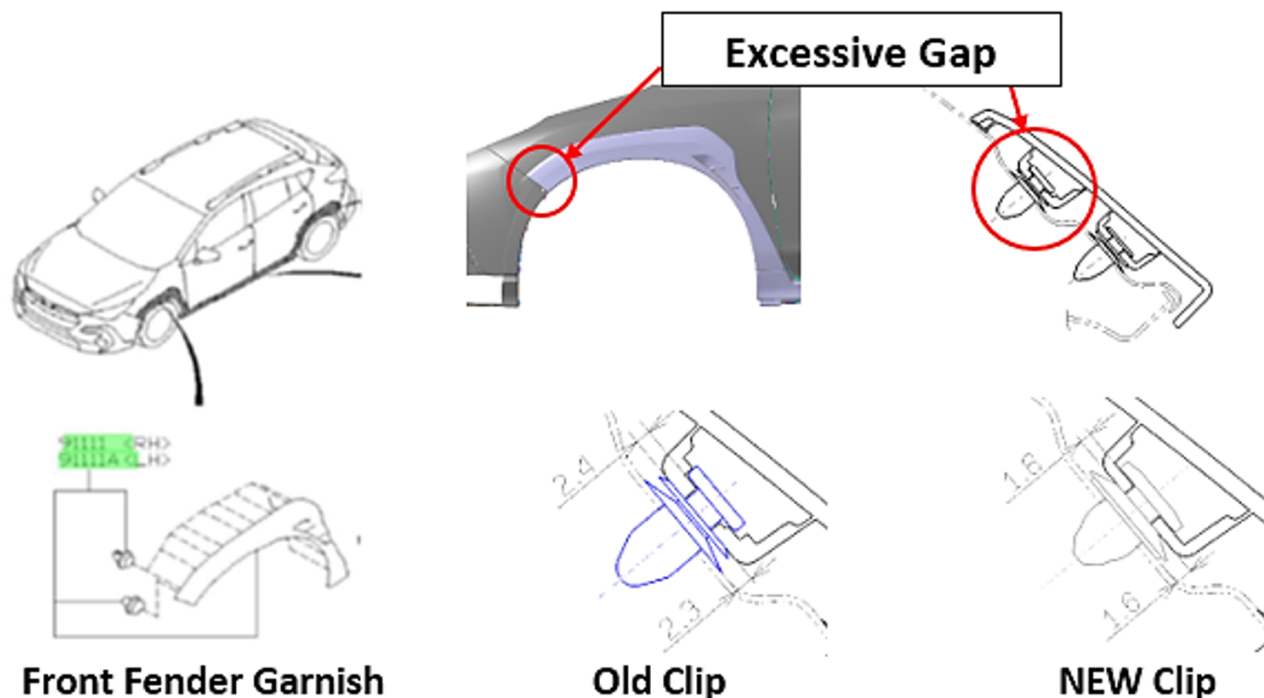
## DESCRIPTION OF DESIGN CHANGE:

This bulletin announces the availability of new front fender garnishes fitted with new clips to provide a more secure and streamlined fit. If excessive gap between the fender and the fender garnish is reported by a customer, replace the affected garnish with the new part(s).
