## SERVICE BULLETIN

**APPLICABILITY:** 2017-23MY Impreza  
 2018-23MY Crosstrek  
 2019-2022MY Forester  
 2020-2023MY Outback & Legacy  
 2019-2023MY Ascent

**NUMBER:** 05-62-18R

**SUBJECT:** Surface Rust Accumulation in Front  
 Strut Mounts

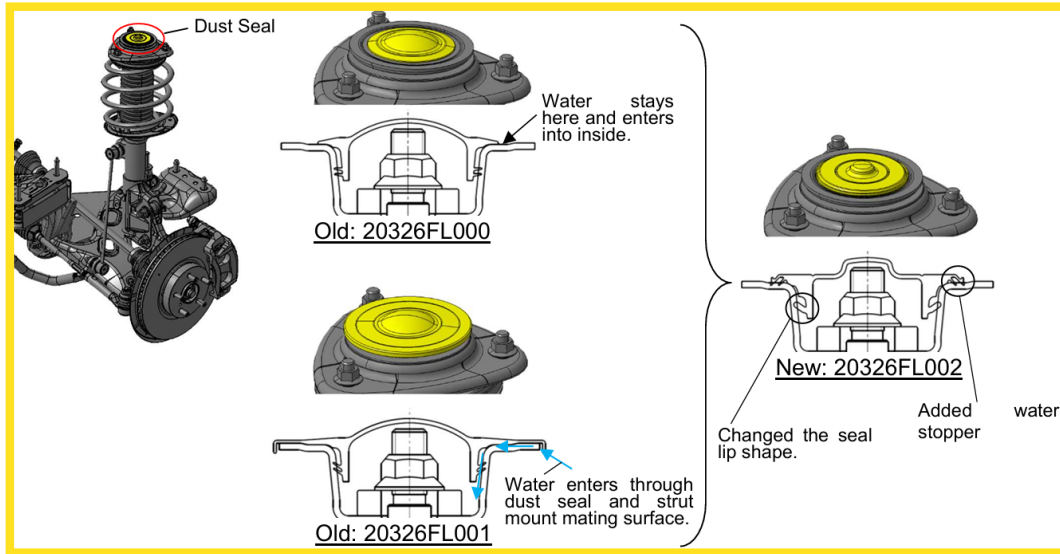
The part number for the new “DUST SEAL-FRONT STRUT” is: **20326FL002**.

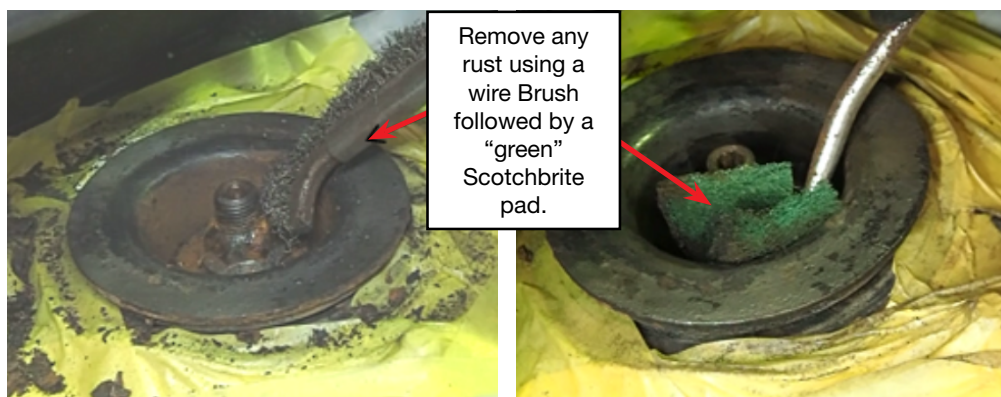
This bulletin provides a procedure to address customer concerns of surface rust accumulating in the top center retaining nut area of the front strut mounts. The strut mount cap / seal shape has been changed and reinforced to provide improved sealing against water intrusion. **NOTE:** Any rust accumulation as described here is cosmetic and will not impair functionality of the strut top.

- Remove the original dust cap from the strut mount.
- **CAREFULLY** mask the area around the top portion of the strut mount using masking tape and paper. The tape should be applied to the rubber portion and the tape's edge up under the top plate of the mount. This will provide a clean, sharp paint edge when removing the masking tape. Be generous with the masking materials to insure no paint overspray gets onto other components or onto the vehicle finish.
- Use a wire brush first then follow up with a 150-180 grit Scotchbrite® (green) abrasive scrubbing pad to remove any rust accumulation. **REMINER:** Always wear eye protection.
