## SERVICE BULLETIN

**APPLICABILITY:** 2020-22MY Legacy  
 2020-22MY Outback(Including Wilderness)

**NUMBER:** 15-261-20R

**SUBJECT:** Reprogramming File Availability for Optimization  
 of Gen 4 Denso CP1 Infotainment Systems

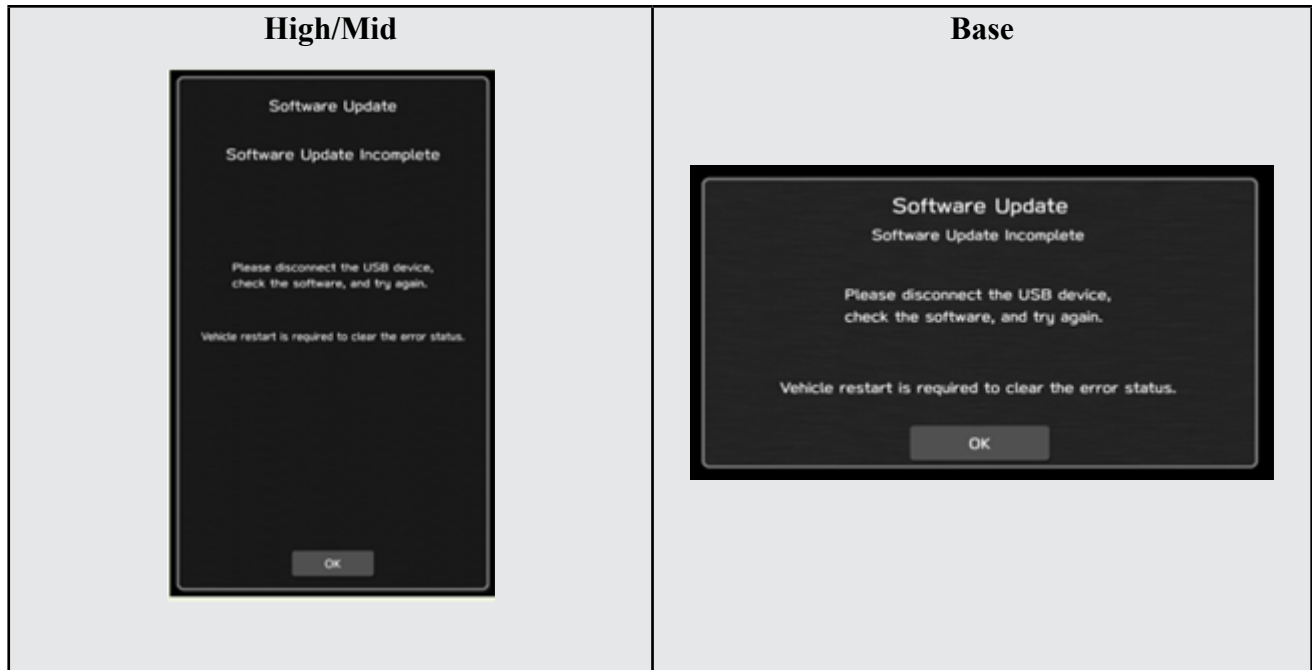
If you get the message Software Update Incomplete as shown below, please don't replace the hardware but retry updating the software according to the instructions in "Appendix B" on pg. 21.

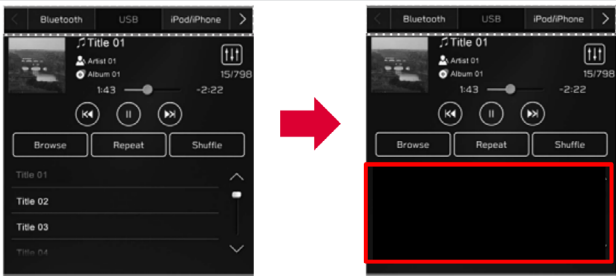
| Number | Symptoms to be Improved: |
|---|---|
| 4 | When selecting a track from the list within the currently playing playlist the track list display may disappear. (iPhone iOS 16.4 or later).<br> |

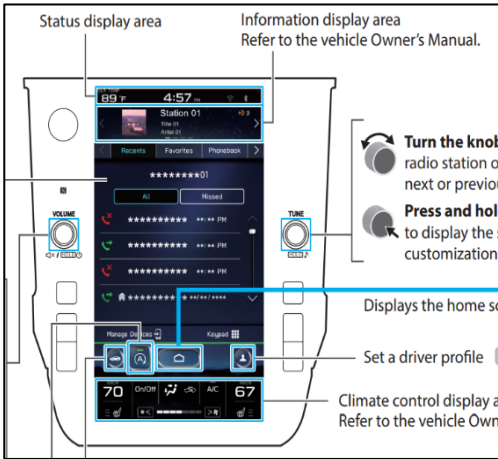
| Number | Symptoms to be Improved: |
|---|---|
| 5 | <p>The Information Display Area at the top of the CID screen displays a different information screen from the last time.</p> |

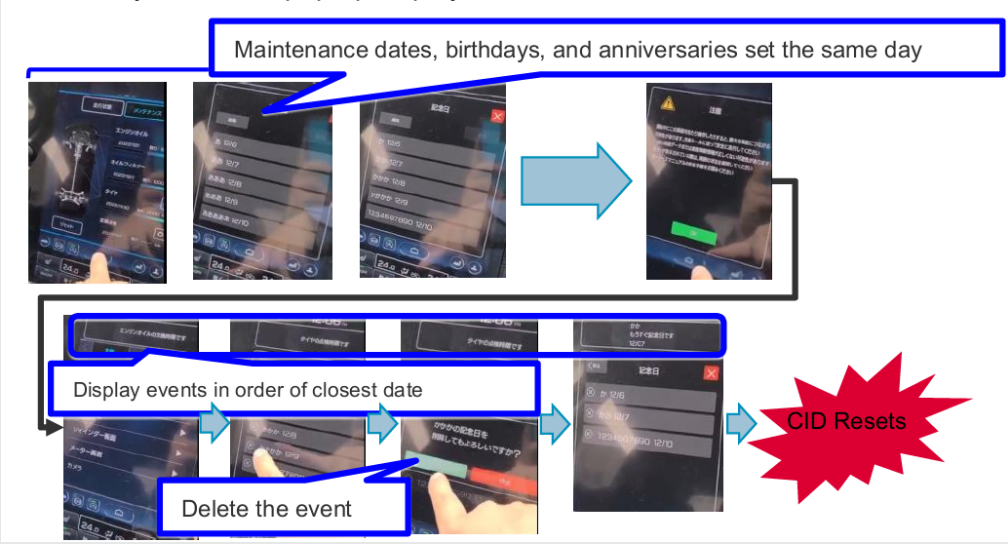
| Number | Symptoms to be Improved: |
|---|---|
| 10 | <p>If a same date is set to maintenance date, birthday, and anniversary date, pop-ups will appear in sequence on the top of the CID after engine is started when the day comes. Under this condition, if an operation is performed to delete the maintenance date, birthday or anniversary date registration within a few seconds immediately before the pop-up display, the CID screen will reset.</p> <p>The diagram illustrates the sequence of events leading to a CID screen reset. It shows three screens: 1. Maintenance dates, birthdays, and anniversaries set the same day. 2. Display events in order of closest date. 3. Delete the event. The final screen shows 'CID Resets'.</p> |

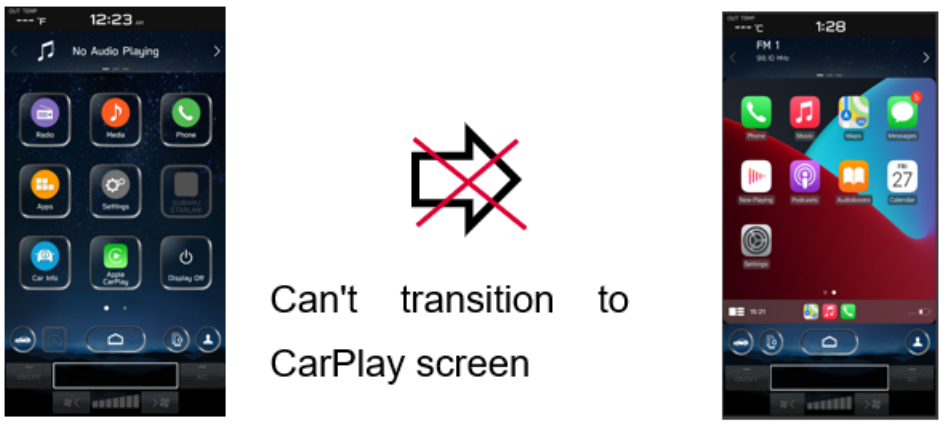
| Number | Symptoms to be Improved: |
|---|---|
| 14 | <p>When the engine is started with the iPhone connected via USB, CarPlay does not start even if the CarPlay icon on the home screen is pressed.</p> <p>&lt;Hint&gt; This can be resolved by reinserting the USB cable.</p> <div data-bbox="435 289 1377 716"> <p>Can't transition to CarPlay screen</p> </div> |

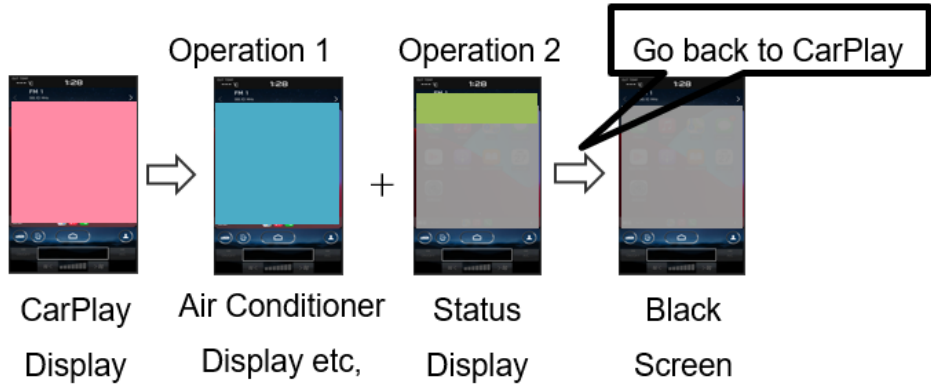
| Number | Symptoms to be Improved: |
|---|---|
| 15 | <p>After performing operations 1 and 2 below from the CarPlay screen, returning to the CarPlay screen causes the CarPlay screen to be black screen.</p> <p><b>Operation 1:</b> Switching to a pop-up screen such as the air conditioner screen</p> <p><b>Operation 2:</b> Interrupt pop-up screen display due to volume operation, etc.</p> <div data-bbox="451 1041 1377 1423"> <p>CarPlay Display    Air Conditioner Display etc.    Status Display    Black Screen</p> </div> |

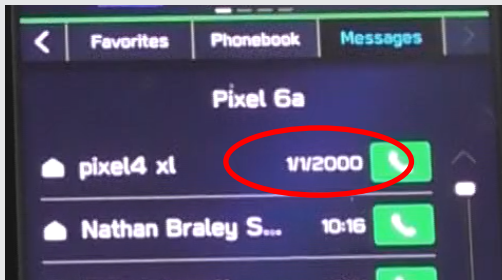
| Number | Symptoms to be Improved: |
|---|---|
| 28 | <p>The date of receipt of a received message is displayed as "2000/1/1."</p> <p>This occurs on some models of phones with Android OS 13 or later.</p> |

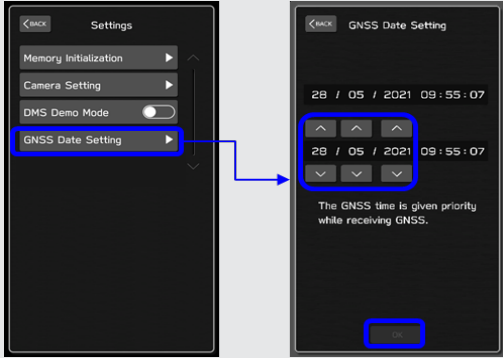
| Number | Symptoms to be Improved: |
|---|---|
| 39 | When the clock was set to "AUTO," the date and time are shifted to a date approximately 20 years in the future due to anomalous values received from GPS or other reasons. If it occurs, the date and time cannot be corrected manually and have to be reset by disconnecting the battery terminal. As a countermeasure, a setting screen to manually adjust the clock display in the "AUTO" setting is to be added to the Dealership Mode (Dealership Mode->Settings->GNSS Data Setting).<br> |

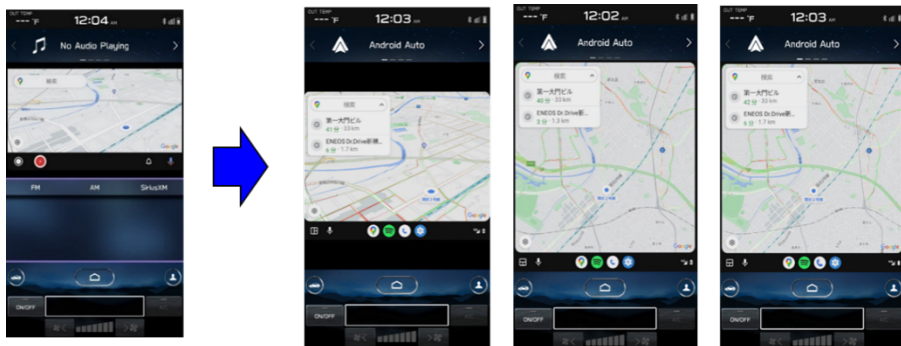
| Number | New Functions and Enhancements |
|---|---|
| 2 | CCU Support vertical screen displays for Android Auto, but the actual display screen size differs depending on the Android device's OS version.<br> |

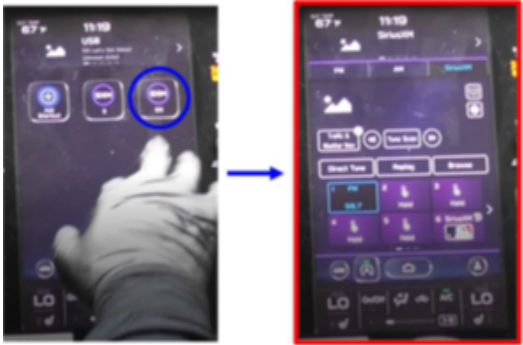
| Number | Symptoms to be Improved: |
|---|---|
| 23 | <p>When selecting shortcut for SXM channel on “Home” screen, the screen is changed to SXM but no sound is coming or no channel name is displayed.</p> |

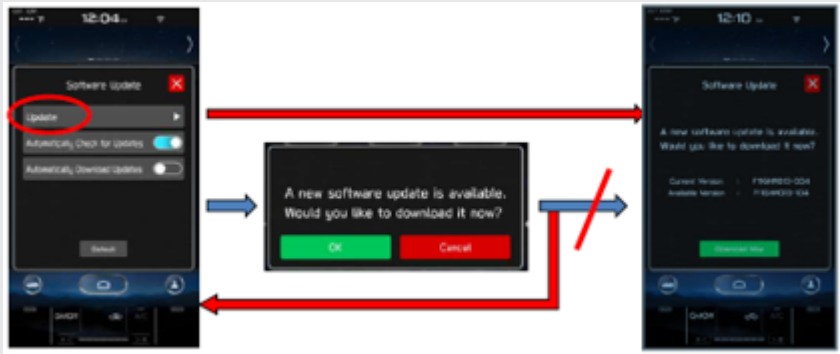
| Number | Symptoms to be Improved: |
|---|---|
| 24 | <p>When using FOTA service to update the software by selecting “Setting” &gt; “Software Update,” a message of “A new software update is available. Would you like to download it now?” is displayed but the downloading does not start after pressing “OK.” When this symptom occurs, it comes back to the “Software Update” screen. The downloading can be started by pressing the “Update” on the “Software Update” screen. (Temporary solution.)</p> |

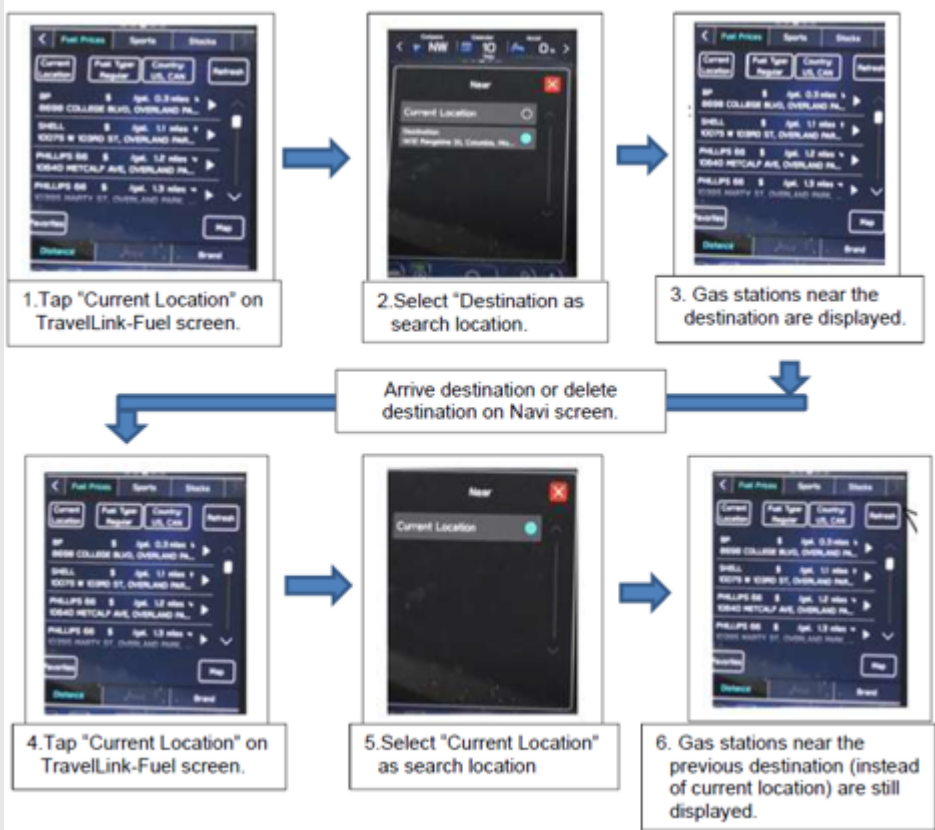
| Number | Symptoms to be Improved: |
|---|---|
| 30 | <p>A wrong search location is used on TravelLink function. Example of the symptom.</p> |

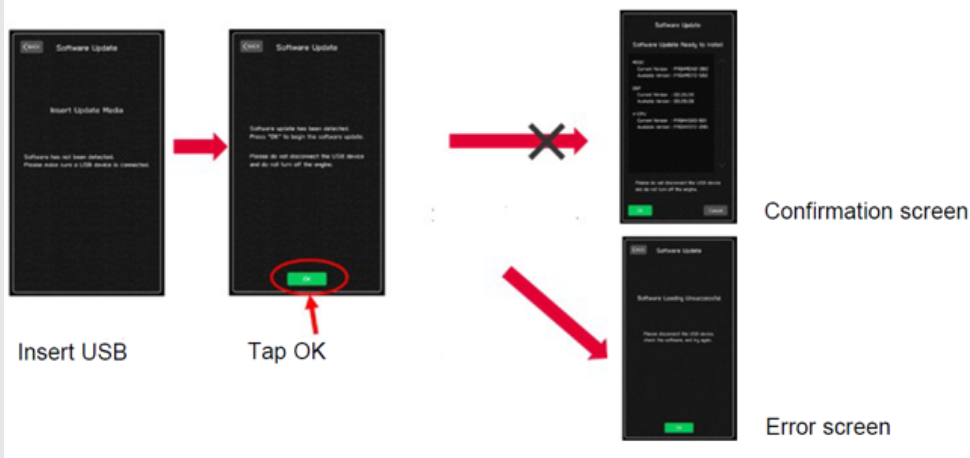
| Number | Symptoms to be Improved: |
|---|---|
| 12 | <p>When conducting USB reprogramming, the screen transition to error screen instead of confirmation screen.</p> <p>Insert USB</p> <p>Tap OK</p> <p>Confirmation screen</p> <p>Error screen</p> |

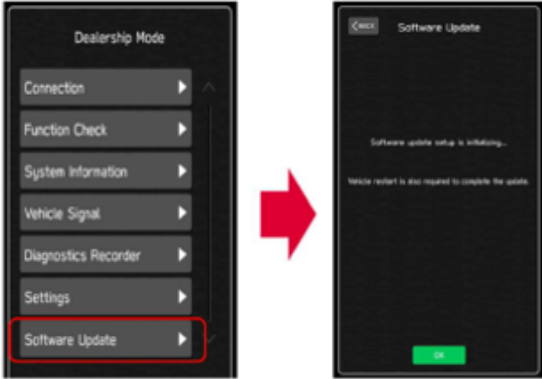
| Number | Symptoms to be Improved: |
|---|---|
| 13 | <p>When “Software Update” is selected in the Dealership Mode, the following initialization process does not end more than 20 minutes. *</p> <p><b>Note*</b> In case this USB update failure occurs, retry updating according to the instructions in “Appendix A</p> |

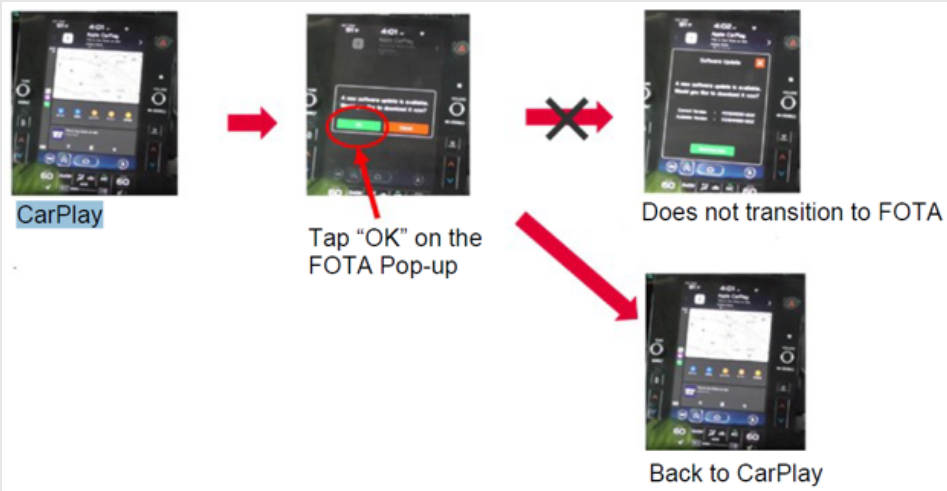
| Number | Symptoms to be Improved: |
|---|---|
| 14 | <p>When the FOTA pop-up (new software availability notification) is displayed while the CarPlay is being used, the display comes back to CarPlay screen even if the customer tries to get into the FOTA screen.</p> <p>CarPlay</p> <p>Tap “OK” on the FOTA Pop-up</p> <p>Does not transition to FOTA</p> <p>Back to CarPlay</p> |

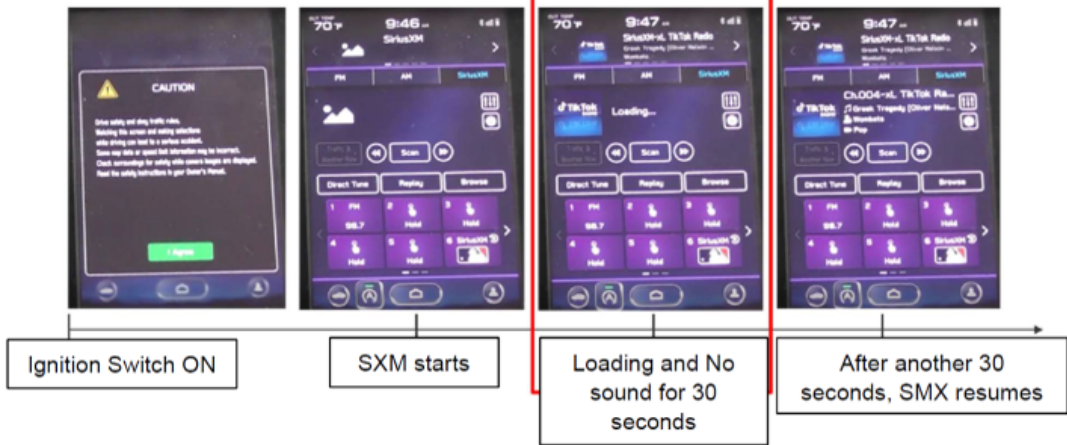
| Number | Symptoms to be Improved: |
|---|---|
| 27 | <p>About 30 seconds after starting the SXM the operation is paused with loading screen and resume after another 30 seconds. This symptom occurs when the SXM screen had been selected as audio source at the previous ignition off timing.</p> |

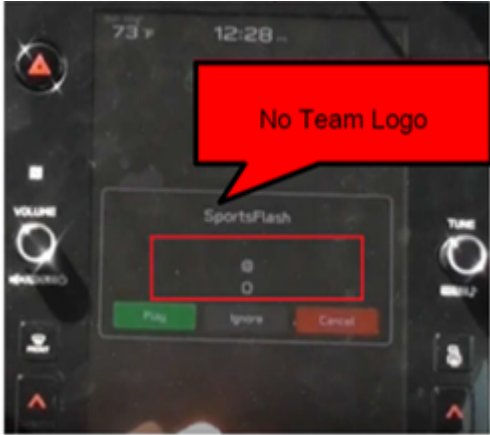
| Number | Symptoms to be Improved: |
|---|---|
| 31 | <p>The team logo is not displayed on Sports Flash screen when the SXM screen had been selected as audio source at the previous ignition off timing.</p> |

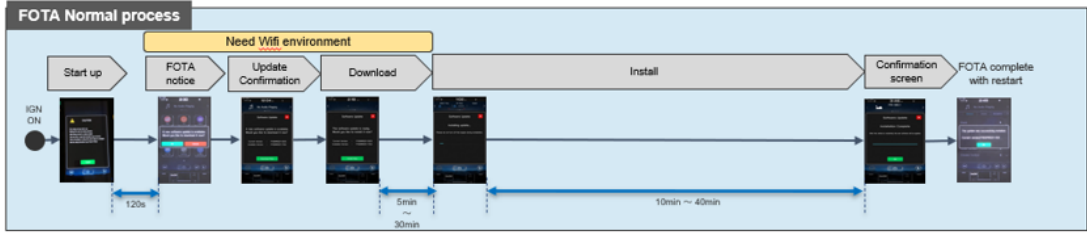
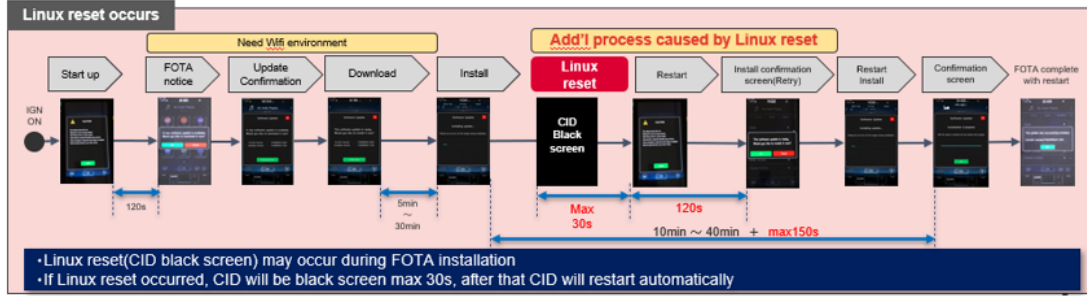
| Number | Symptoms to be Improved: |
|---|---|
| 1 | <p><b>System restarts itself during FOTA (Firmware Over The Air) update. FOTA operation is conducted in two processes: downloading (from the server to the Cockpit Control Unit via Wi-Fi) and installation (inside the Cockpit Control Unit). During the FOTA operation, after the new software has been downloaded to the Cockpit Control Unit (CCU) customer is to push “Install Now” on the Center Information Display (CID) to start installation of the software.</b></p> <p><b>FOTA Normal process</b></p> <p><b>However, in rare case, the CCU restarts itself* during installation.</b></p> <p><b>Linux reset occurs</b></p> <p><b>Note*</b> Even if this symptom occurs, after approximately 2 minutes, the system resumes, and the CID comes back to the below screen. Customer can then push the “Install Now” to proceed with the installation.</p> |

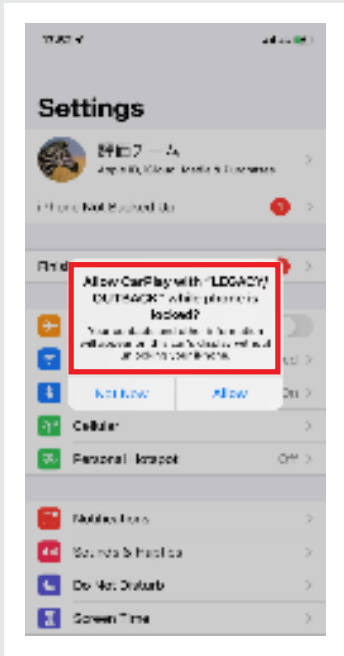
| Number | Symptoms to be Improved: |
|---|---|
| 3 | <p>While using Apple CarPlay, “SUBARU” is displayed on the iPhone Setting menu instead of vehicle name &lt;LEGACY/OUTBACK&gt;.</p> |

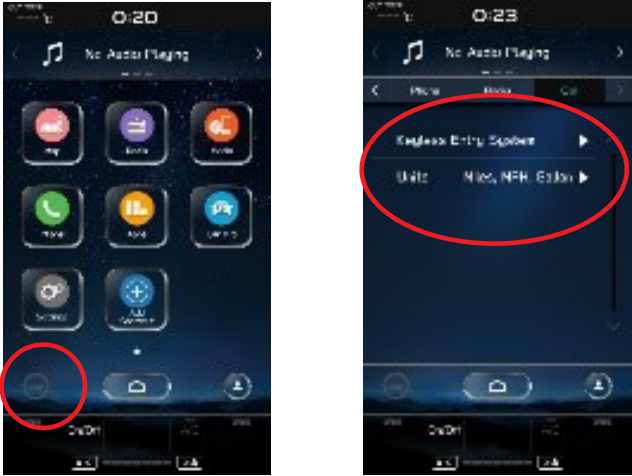
| Number | Symptoms to be Improved: |
|---|---|
| 4 | <p>Vehicle Setting Icon in &lt;Home&gt; menu is grayed out.<br/>Menu list in the “Car” tab in the Setting Menu is not displayed.</p> |

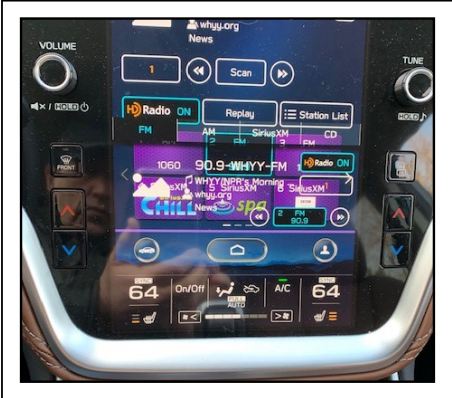
| Number | Symptoms to be Improved: |
|---|---|
| 6 | <p>CID shows multiple images simultaneously.</p> |

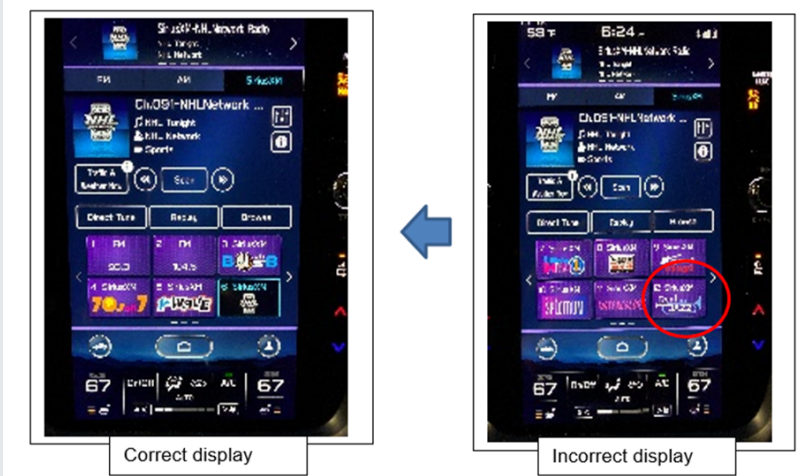
| Number | Symptoms to be Improved: |
|---|---|
| 29 | Preset outline is not shown following station selection using steering switch <div style="display: flex; justify-content: space-around; align-items: center;"> </div> |

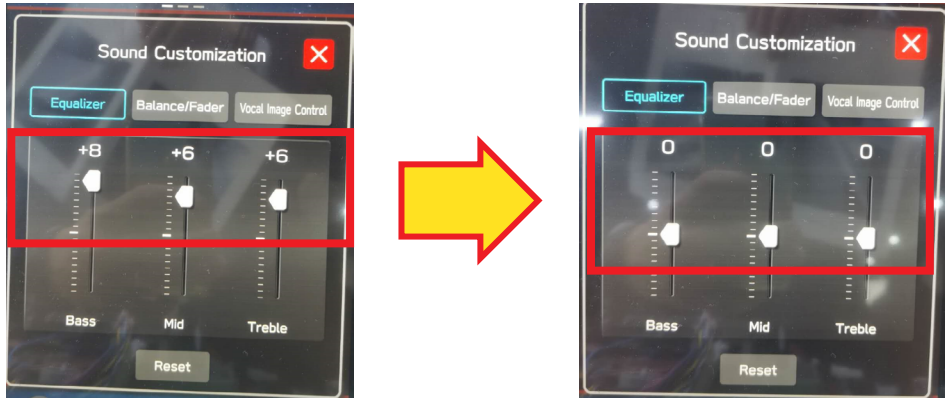
| Symptom # | Description of Symptom: |
|---|---|
| 7 | Customer-selected Equalizer settings are lost. Equalizer returns to the default settings after ignition switch is turned OFF and back ON.<br> The diagram consists of two screenshots of the 'Sound Customization' menu, specifically the 'Equalizer' tab. The left screenshot shows custom settings: Bass at +8, Mid at +6, and Treble at +6. The right screenshot shows the default settings: Bass at 0, Mid at 0, and Treble at 0. A large yellow arrow points from the left screenshot to the right screenshot, indicating a reset or defaulting of the settings. The 'Equalizer' tab is highlighted in blue in both screenshots, and the 'Reset' button is visible at the bottom. |

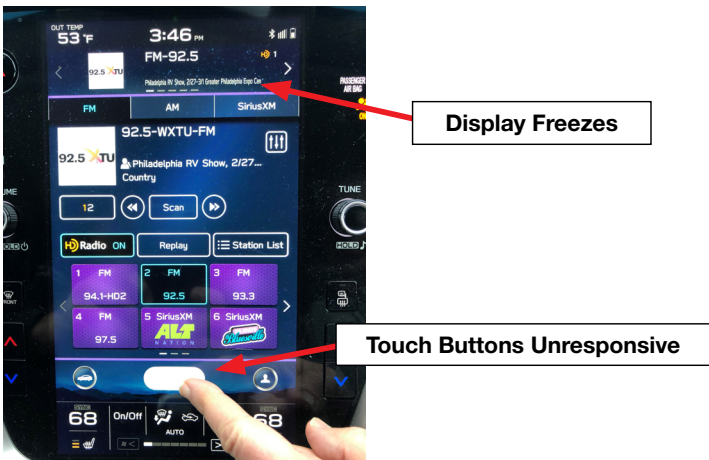
| Symptom # | Description of Symptom: |
|---|---|
| 1 | <p>The CP1 display and/or center Combination Meter display freezes. No response from touch screen or voice guidance. After switching the ignition off and opening the driver's door, the system does not recover**.</p> <p><b>**NOTE:</b> After switching the ignition off and leaving the driver's door open more than 70 seconds, the system <i>may</i> recover after switching the ignition back on.</p> |

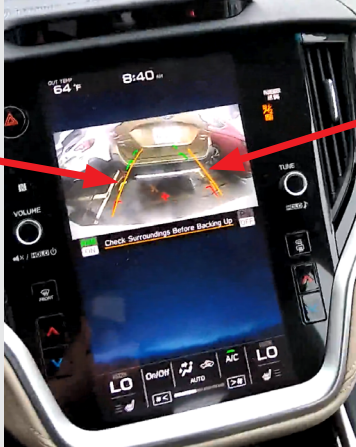
| Symptom # | Description of Symptom: |
|---|---|
| 2 | <p>Delayed response of rear view camera guide lines.<br/>When the rear view camera is activated and the steering wheel is turned, there is a delay before the steering-responsive guide lines respond to the steering wheel input.</p> <p>The image shows a rear view camera display on a vehicle's infotainment screen. The screen displays a rear view of the vehicle with yellow guide lines. Two red arrows point to the guide lines, indicating a delay in their response to steering wheel input. The screen also shows a 'Check Surroundings Before Backing Up' warning and a 'LO' indicator.</p> |

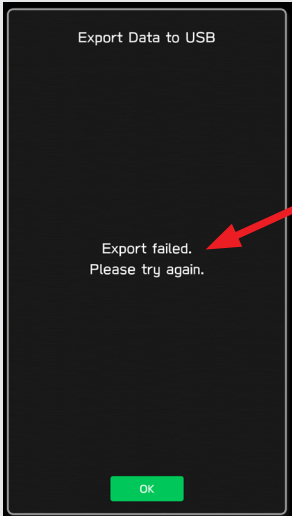
| Symptom # | Description of Symptom: |
|---|---|
| 4 | <p>Diagnostics Recorder Data cannot be exported to the USB memory device. When the diagnostic log data is being downloaded (by selecting: Dealership Menu &gt; Diagnostics Recorder &gt; Export Data to USB), it fails after the progress bar reaches almost 90% with an error message of Export failed. Please try again.</p> <p>The image shows a screen titled 'Export Data to USB'. The screen displays the message 'Export failed. Please try again.' and an 'OK' button. A red arrow points from the text 'Export Failed. Please Try Again.' to the message on the screen.</p> |
