# 765LT Polycarbonate FAQ's

**Topic:** 765LT Polycarbonate Tailgate Fastener Installation – Recall 14 A 005 & Campaign 14 A 006

**Condition:** FAQs and Further Guidance

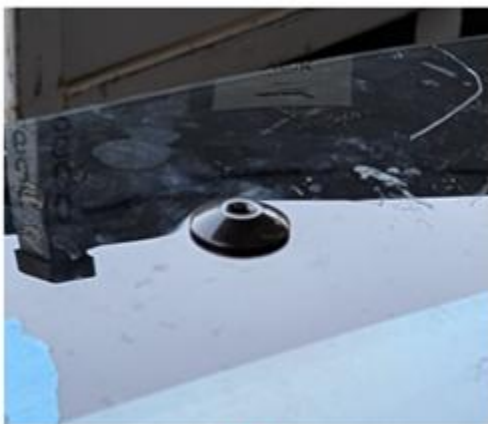
### **Visual deformation of polycarbonate tailgate panel after rework**

NOK

NOK – The shim stack is too large. Re-check and adjust the shimming according to the Recall/Campaign instructions.

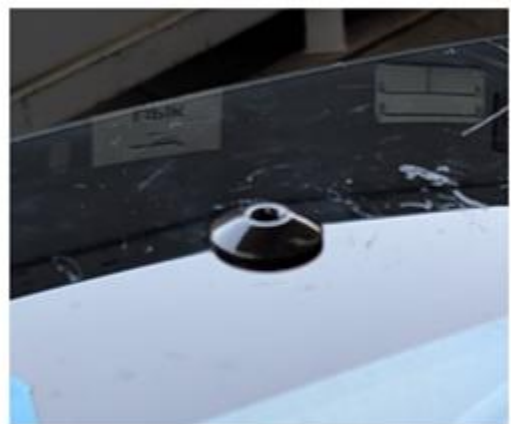
OK
