# McLaren Artura Oil Leak Diagnosis Guide - Rear of Engine

**Location:** Powertrain

**Topic:** McLaren Artura Oil Leak Diagnosis Guide - Rear of Engine

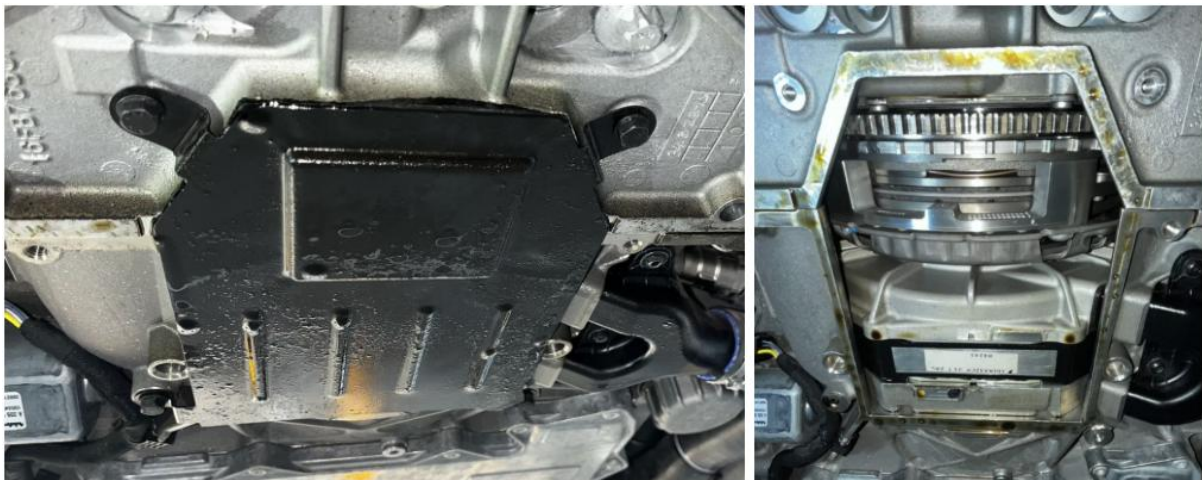
If an Artura is found to have oil traces on the underside of the powertrain at the rear, specifically the rear interface between the engine, transmission and e – motor, please follow the steps below

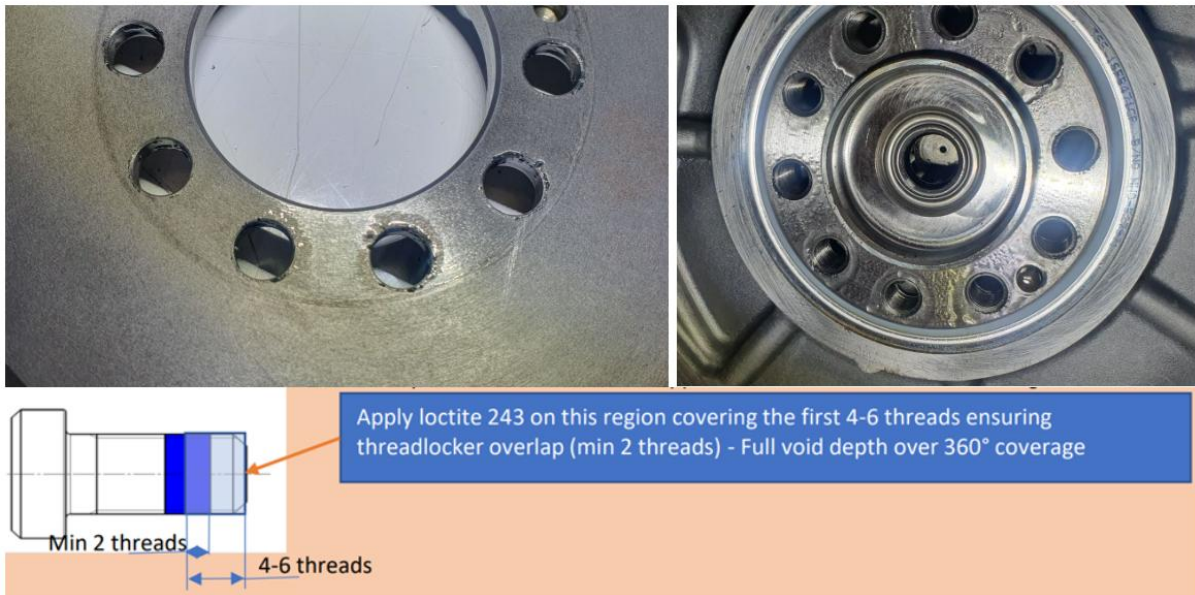
- Remove and inspect each flywheel bolt for signs of oil one at a time, starting from 12 O'clock position labeling the bolts in the order of removal (clockwise) and lay down each bolt on a piece of white A4 paper with the bolt head down (threads pointing up). If oil present on bolts, capture images of the oily bolts and their respective bolt holes on the crankshaft flange – label as "Oil Presence on Flywheel Bolt and Crankshaft Flange threaded hole"
- Capture images immediately of the flywheel, label as "Flywheel Inspection" and inspect. If oil is centralized around the flywheel on the surface this indicates the flywheel bolts are

potentially the cause of the leak and new flywheel bolts with added Loctite 243 to the top threads will rectify this

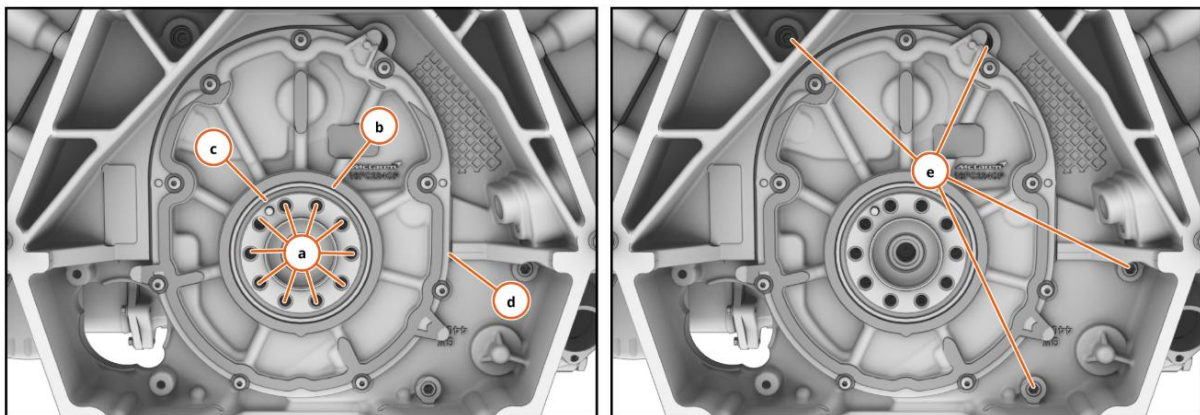
- Identify leaking area of the rear of the engine
  - 1. Flywheel threaded bolt holes (crankshaft flange)
    2. Rear crank seal OD
    3. Rear crank seal ID
    4. Rear cover (RTV Seal - identify exact location)
    5. M14 Pins – Tensioner (escalate with images)

- If it is determined that the outer diameter of the crank seal or the RTV joint of the rear cover is leaking then replacement of the whole rear cover assembly with pre-fit rear seal is required

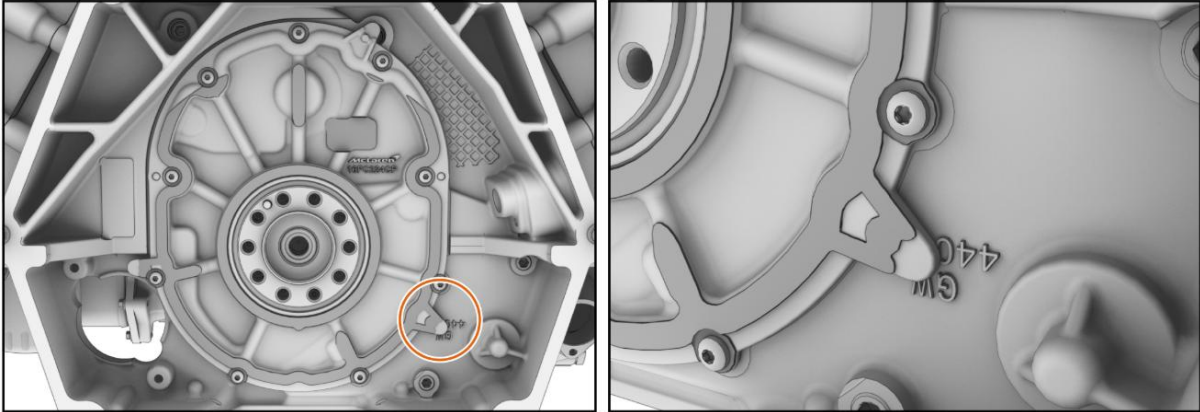
- Check if the rear cover has a tab that clashes with the cylinder block part marking

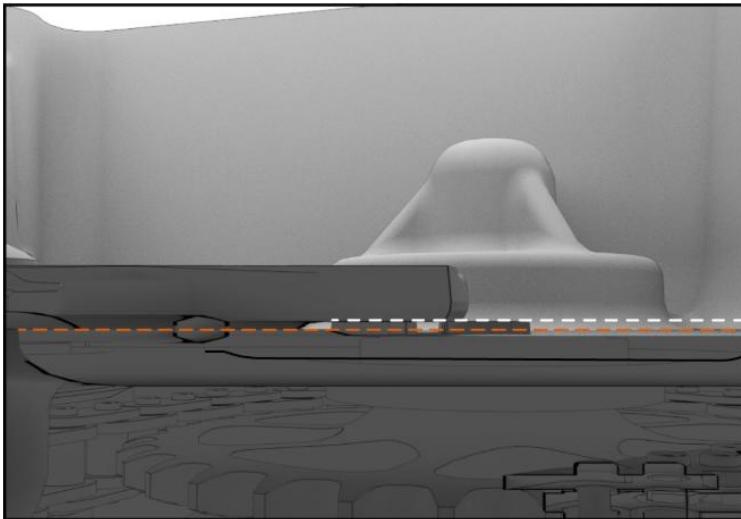
If the Part Marking on the Cylinder Block is present and not machined down, check if the top surface of the lettering is protruding the rear cover sealing surface on the cylinder block

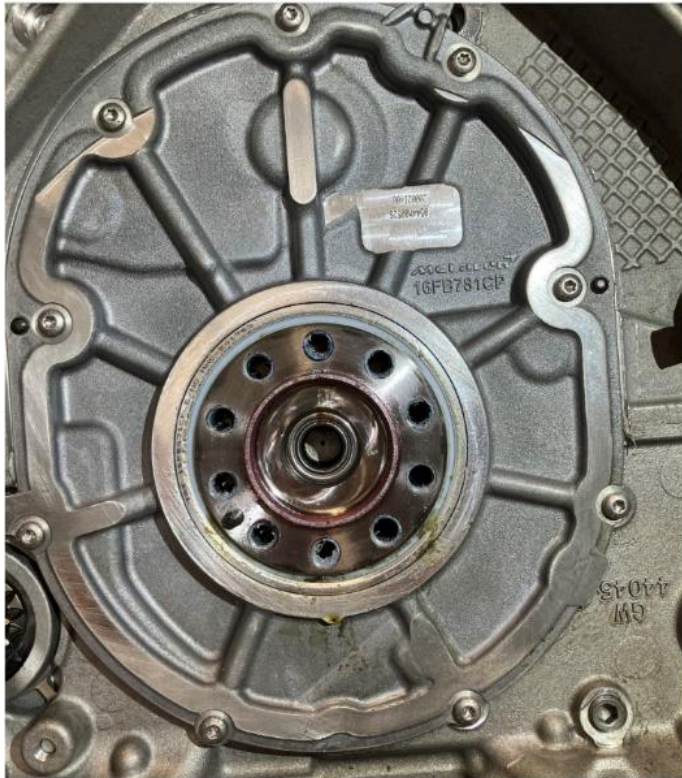
If the Part Marking protrudes, proceed with the tab removal to resolve the potential hard clash of the rear cover which would create a leak path
