# McLaren Artura Engine Oil Leak Diagnosis Guide - Oil Cooler

**Location:** Powertrain

**Topic:** McLaren Artura Engine Oil Leak Diagnosis Guide - Oil Cooler

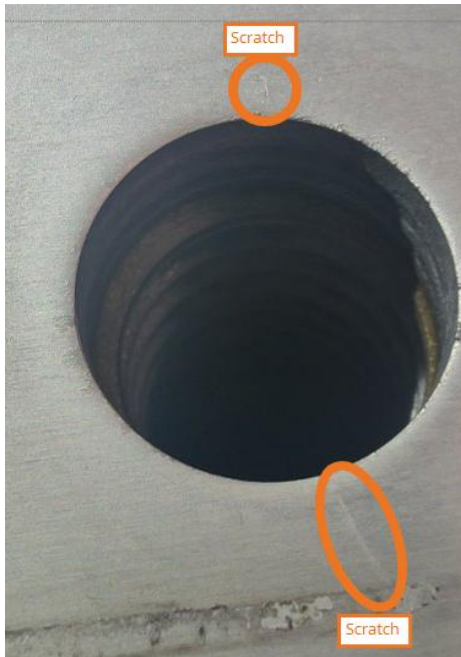
17. Inspect oil cooler face, and through holes escalate any concerns for review on TR providing images

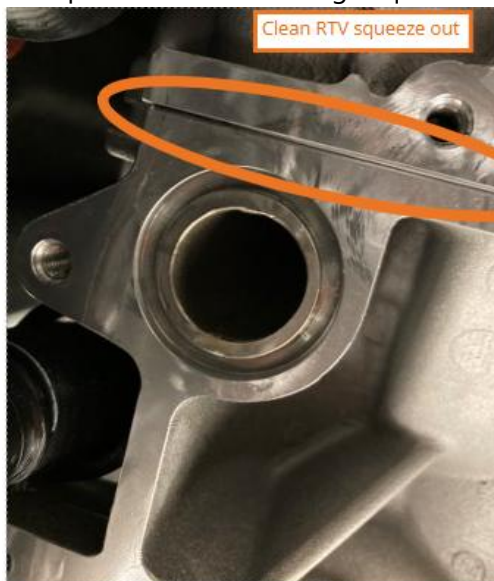
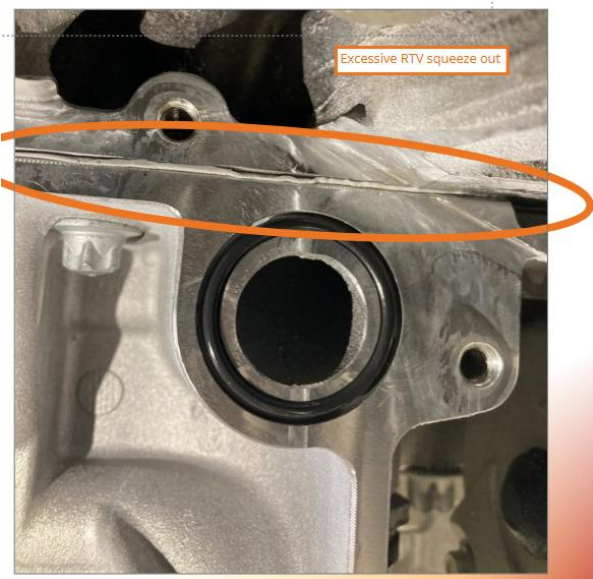
18. Inspect block interface for RTV Squeeze out, escalate if concerned with squeeze out on TR to the Technical Support team

Example of clean face vs high squeeze out:

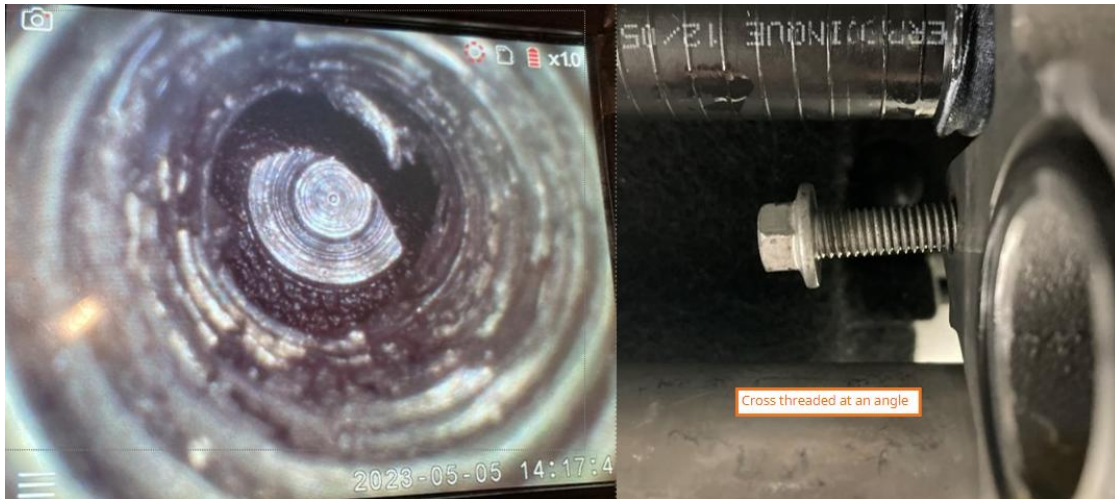
19. Check the block threads, are these clean and the bolts have not been fitted cross threaded/damaged?
