## Technical Service Bulletin

**2072282/3**

48-23-02 - Steering wheel / airbag: grinding/creaking/clacking noises when steering (cornering/parking/maneuvering)

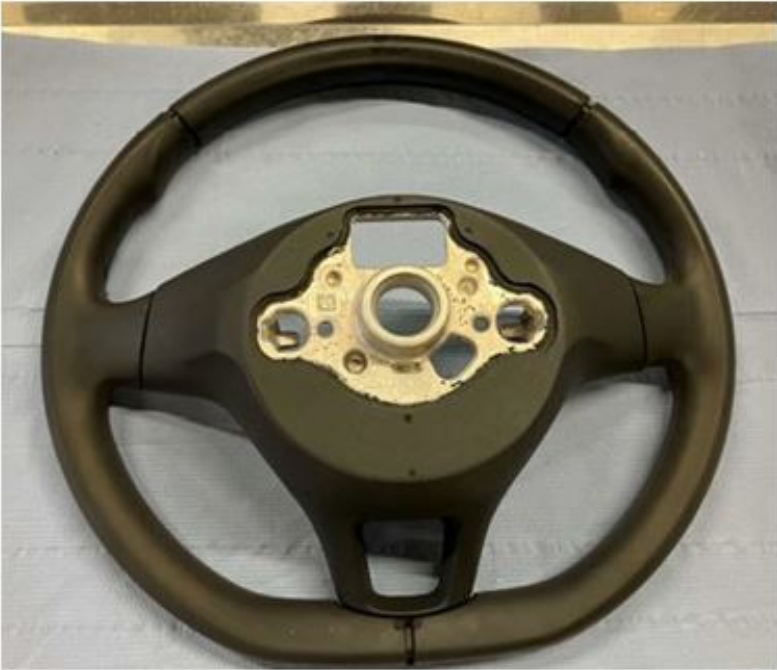
| Figure 1. | |

| | 1. Rear of steering wheel when removed. |
