## Technical Service Bulletin

Transaction No.: **2068999/4**

51 Service info: Cracked paintwork with corrosion at joint between roof and roof side member

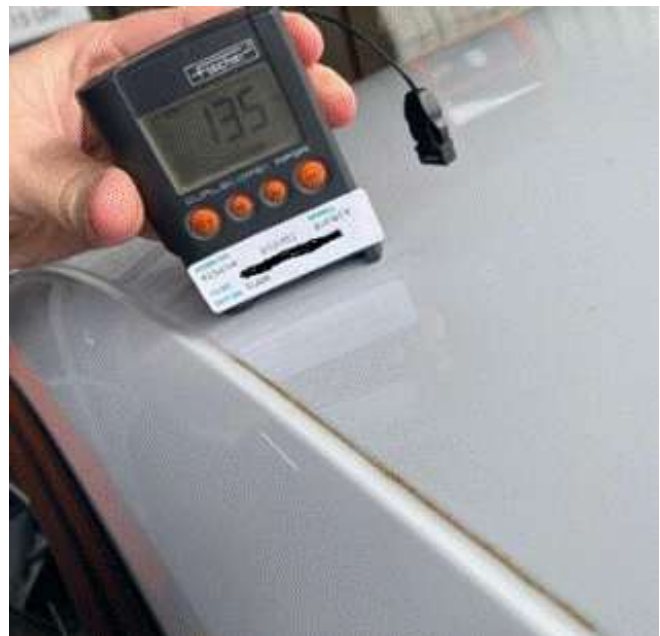
1. Figure 1 shows paint thickness measurement.

**Figure 1.** Paint thickness measurements.

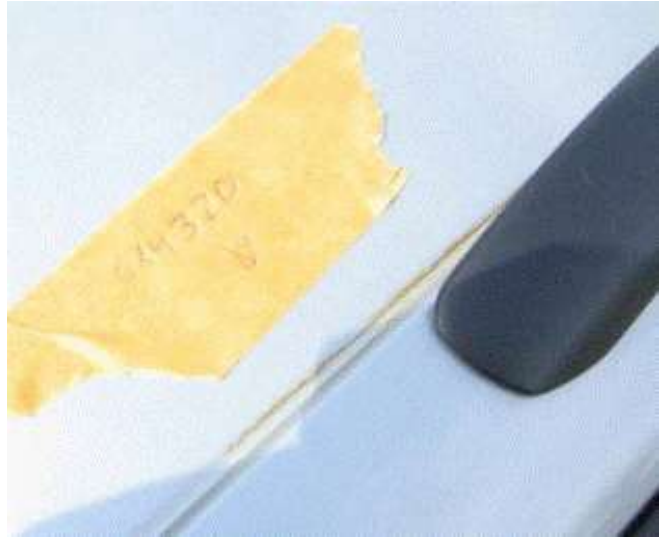
As the result of force applied to the roof skin panel, a crack in the paintwork forms in the area where the roof is joined with the roof side member.

The force involved may have been caused by hail, large amounts of snow falling off a roof, or other external forces. The crack in the paintwork is often not detected even after dent removal is carried out; it is therefore possible that a longer time period may have passed since the dent removal was performed.

2. Figure 2 shows an example of a typical case of corrosion formation due to paint cracking.

**Figure 2.** Resultant corrosion due to cracks in the paint.

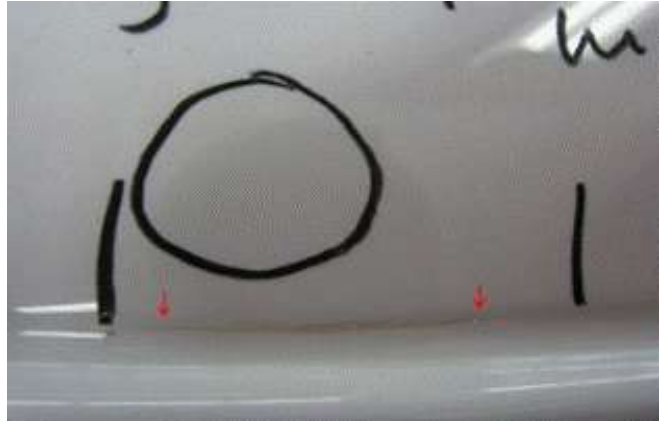
3. Figure 3 shows a closer view of the paint cracking.

**Figure 3.** Close-up view of paint cracking where the roof is joined with the roof side member.

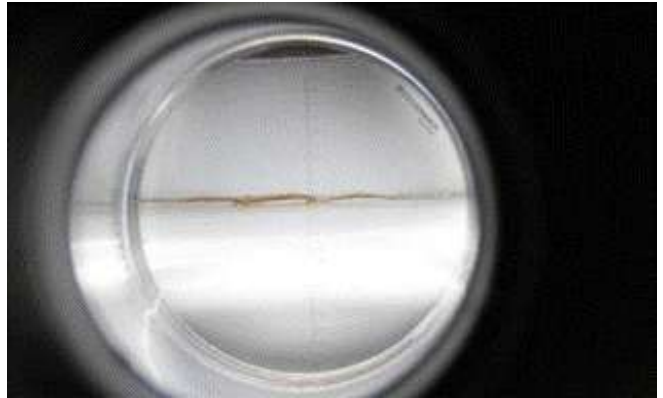
4. Figure 4 shows paintwork crack evaluation using a magnifying glass.

**Figure 4.** Paintwork crack evaluation using a magnifying glass.

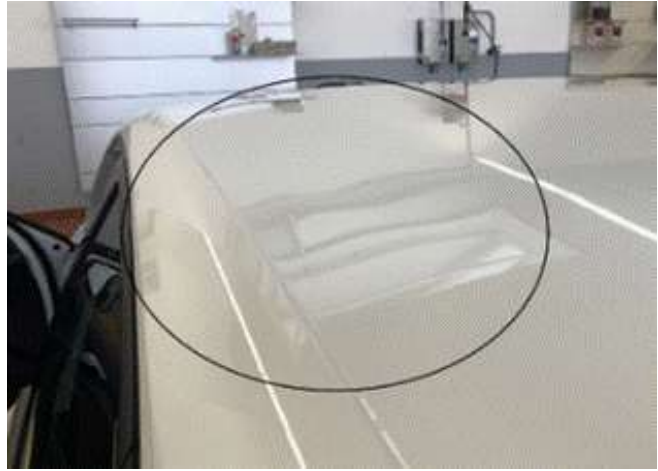
5. Figure 5 shows surface deformations caused by large amounts of snow falling off a roof.

**Figure 5.** Surface deformations caused by large amounts of snow falling off a roof.

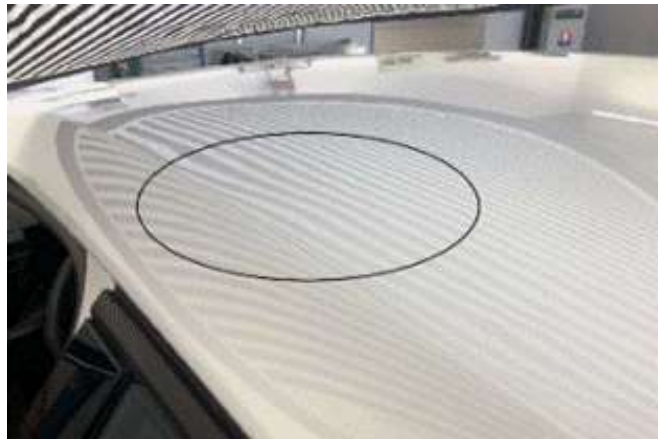
6. Figure 6 shows deformation identified using a dent mirror.

**Figure 6.** Deformation identified using a dent mirror.
