## Technical Service Bulletin

90 Horn sound quality poor

Transaction No.: **2074436/3**

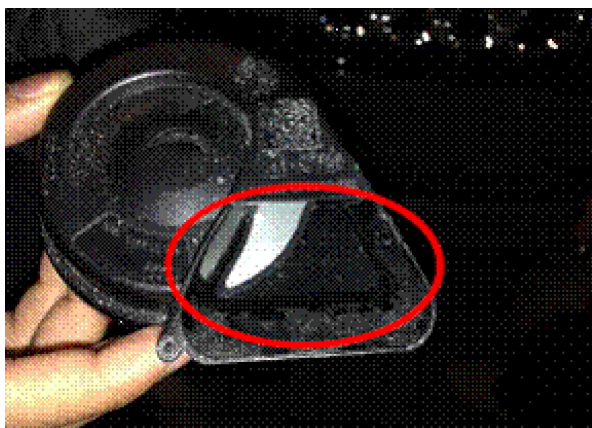
**Figure 1.** “Horn opening”.

**Massive** water ingress into the horn (steam jet pointed **directly** at it) impairs the function of the horn's membrane.

Then turn the horn so that the opening of the horn funnel (see red mark on illustration) points to the floor and the water can drain.

Shaking the horn slightly helps the water drain quickly.

**Do not open/disassemble the horn to dry it, as doing so may damage the seals and cause water to enter the electronics.**
