## Condition

### Customer states:

Power steering symbol lights up in instrument cluster.

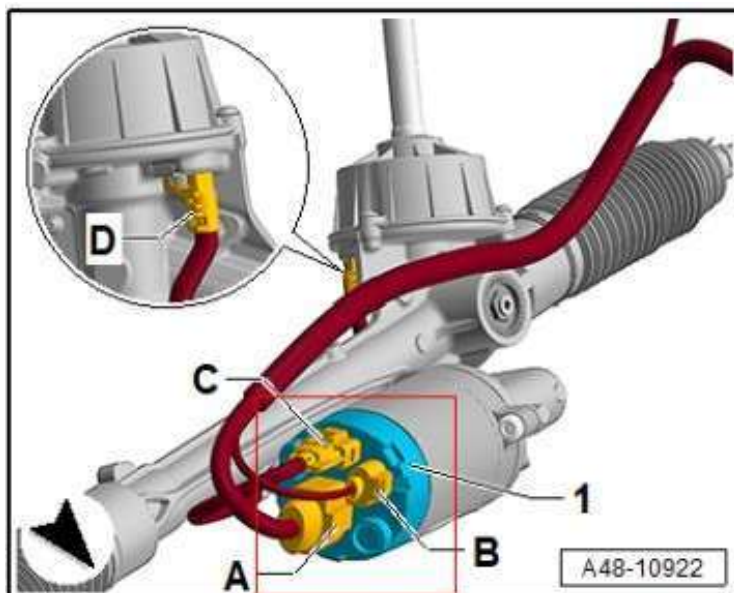
A6 e-tron GH / Q6 e-tron GF: Unplug the connector for power supply A (refer to photo).

Before performing the combined software update, perform a terminal 30 reset on J500 (DA0044). Otherwise, the combined software update may not be completed successfully in individual cases.
