## Technical Service Bulletin

Transaction No.: **2082702/2**

21 Engine Charge Pressure System - MIL on, DTC P003900 Overrun recirculation  
Valve N625 - 3.0L V6 TFSI

Release date: Aug 21, 2026

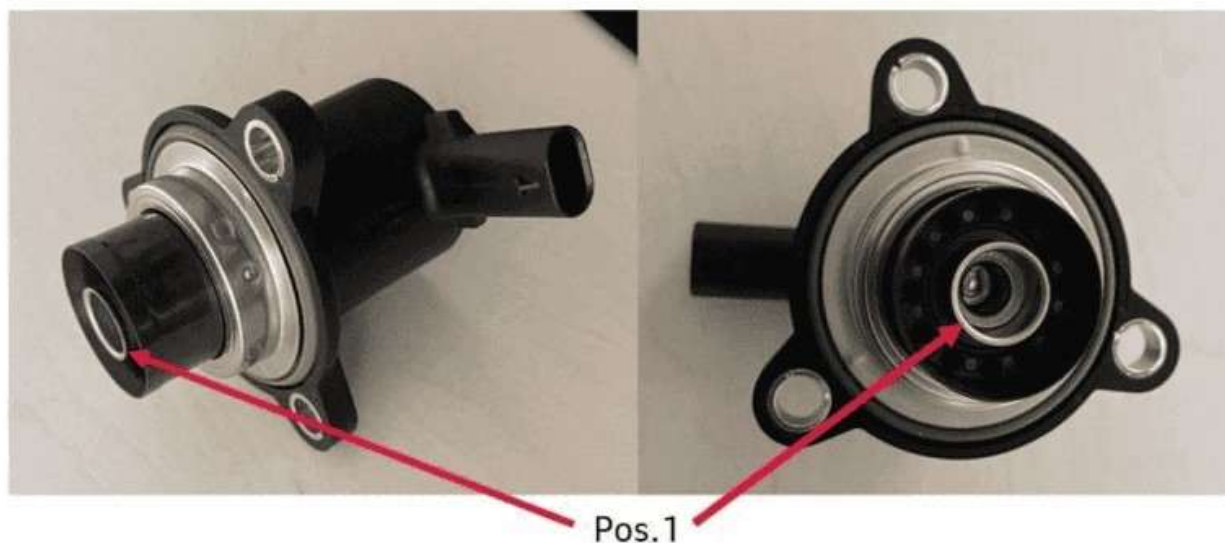
After removal, check whether the centering sleeve is located on the overrun air recirculation valve (refer to item 1 in the example image below).

- Overrun air recirculation valve N625 incl. centering sleeve (OK):

Please replace the turbocharger's overrun air recirculation valve N625.

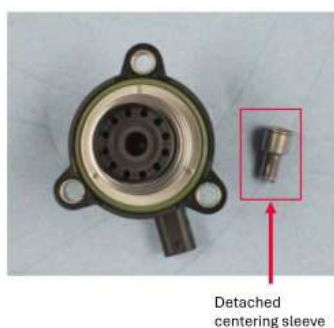
- **P003900** Turbocharger bypass valve, implausible signal
- Additional event memory entries relating to the throttle valve may be logged in some cases.

- Overrun air recirculation valve N625 with loose centering sleeve (not OK):

If the centering sleeve is not on the component, check the area around the throttle valve and/or the area between the throttle valve and the charge air coolers and remove the centering sleeve if necessary.

The throttle valve may need to be removed to do this.
