## Condition

An OTA (over-the-air) update was not completed successfully.

| Claim Comment: | As per TSB 2082848/1 | | |

An OTA (over-the-air) update failed. The vehicle must be updated in the workshop.

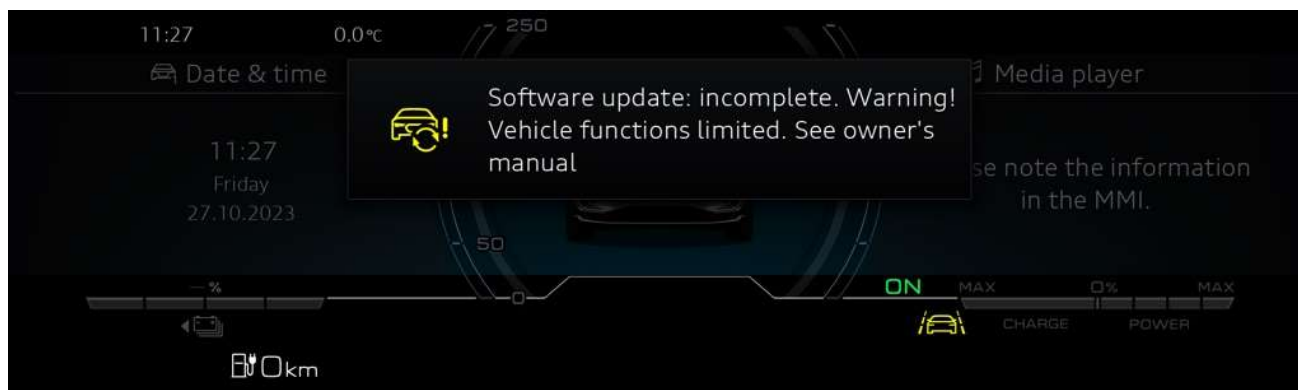
**Figure 1.** Software update: incomplete. Warning! Vehicle functions limited. See owner's manual.

**Scenario 1 (Figure 1):** An error occurred when installing the software update. The vehicle can be driven but some vehicle functions may not be available.

Run the ODIS test program "J1273 - Central Control Module for Data Bus Communication, over-the-air update function restriction" and follow the instructions on the tester.

The SVM code will appear during the test plan. Make sure to note it down! Continue following the test plan. The update will start.

If the update is not completed successfully, it can subsequently be restarted using the previously noted SVM code via the ODIS menu "Flash/SVM code input".

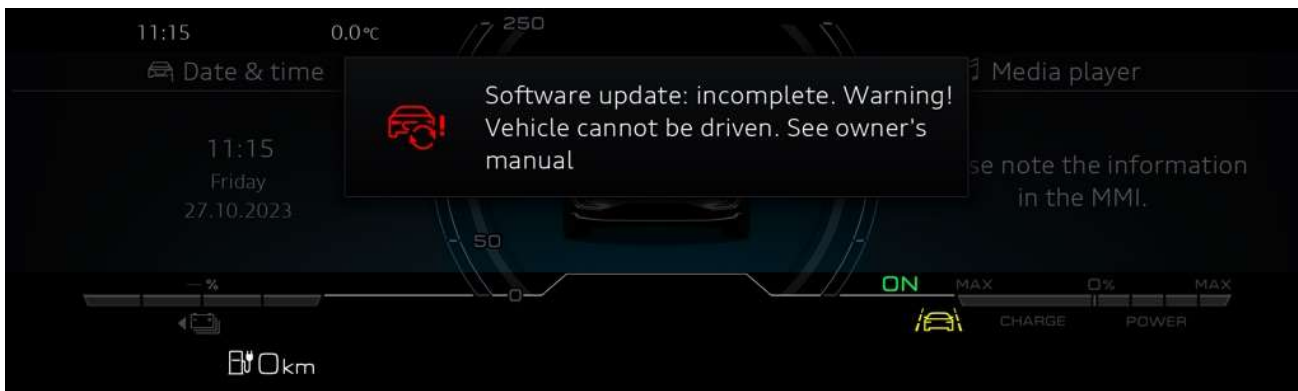
**Figure 2.** Software update: incomplete. Warning! Vehicle cannot be driven. See owner's manual.

**Scenario 2 (Figure 2):** An error occurred when installing the software update. The vehicle cannot be driven.

**The vehicle must not be moved on its own wheels on public roads (not even to transport it to the workshop) before completion of the software update.**

The vehicle's ability to roll can be restored using an ODIS tester and the vehicle should be loaded onto a recovery vehicle using a winch and transported to the workshop. Follow the attached instructions for preparing the ODIS tester. To do so, run the ODIS test program "J1273 - Central Control Module for Data Bus Communication, over-the-air update function restriction" before moving the vehicle and follow the instructions on the tester. The vehicle should then be able to roll so that it can be winched onto the recovery vehicle and transported to the workshop.

The vehicle must be loaded onto a suitable recovery vehicle with a loading crane and transported to the workshop.

The update described in scenario 1 must then be performed.
